**Memorandum**

TO: Hu Wen c/o PB Architects  
SITE: 8243 W Mercer Way, Mercer Island, WA 98040  
RE: Pneumatic Air Excavation Observations  
DATE: December 30, 2019  
PROJECT ARBORIST: Tyler Bunton  
ISA Certified Arborist PN-8715A  
ISA Qualified Tree Risk Assessor  
REVIEWED BY: Katie Hogan  
ISA Certified Arborist PN- 8078A  
ISA Qualified Tree Risk Assessor  
REFERENCED PLANS: Tree Plan A-1.02 (PB Architects, 10/18/19)

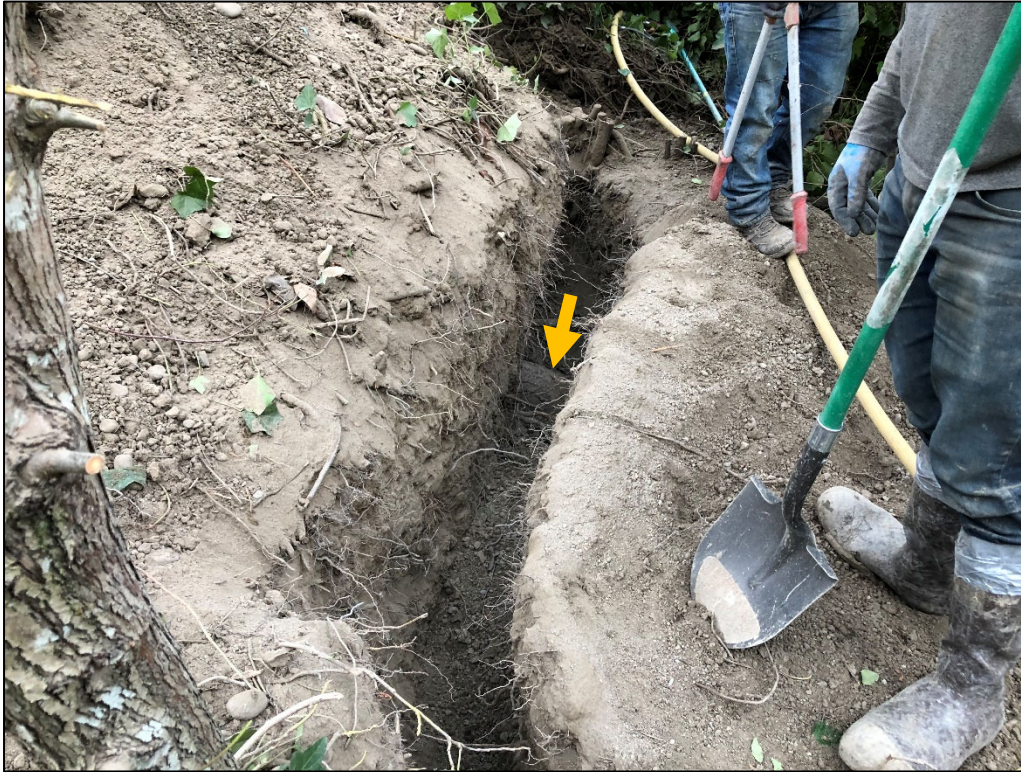
The excavation occurred to the southeast of tree 7 at the location of the proposed retaining wall to a depth of approximately 3 feet and approximately 25 feet in length centered on the tree. Three roots from tree 7 were encountered in the excavation; one 4 inch root, one 10 inch root, and one 3 inch root. In order to install the retaining wall these roots would be cut approximately 6 feet, 3 feet, and 5 feet from the base of the tree respectively.

In order to maintain the health of this tree the recommended limits of disturbance (RLOD) should be eight times the trunk diameter, which for the purposes of this memorandum will represent the critical root zone. For this 34 inch diameter tree the RLOD is 23 feet from the base of the tree. In order to maintain the stability of the tree, no root cuts should occur within the minimum limits of disturbance which is represented by a radial area of five times the trunk diameter, or 14 feet from the base of the tree. In my professional opinion cutting the roots observed for the installation of the proposed retaining wall would likely compromise the stability of the tree.

**Photograph 1.** Arrow indicates the location of the ten inch root within the excavation zone. The base of tree 7 is just outside of the frame in the top left corner.

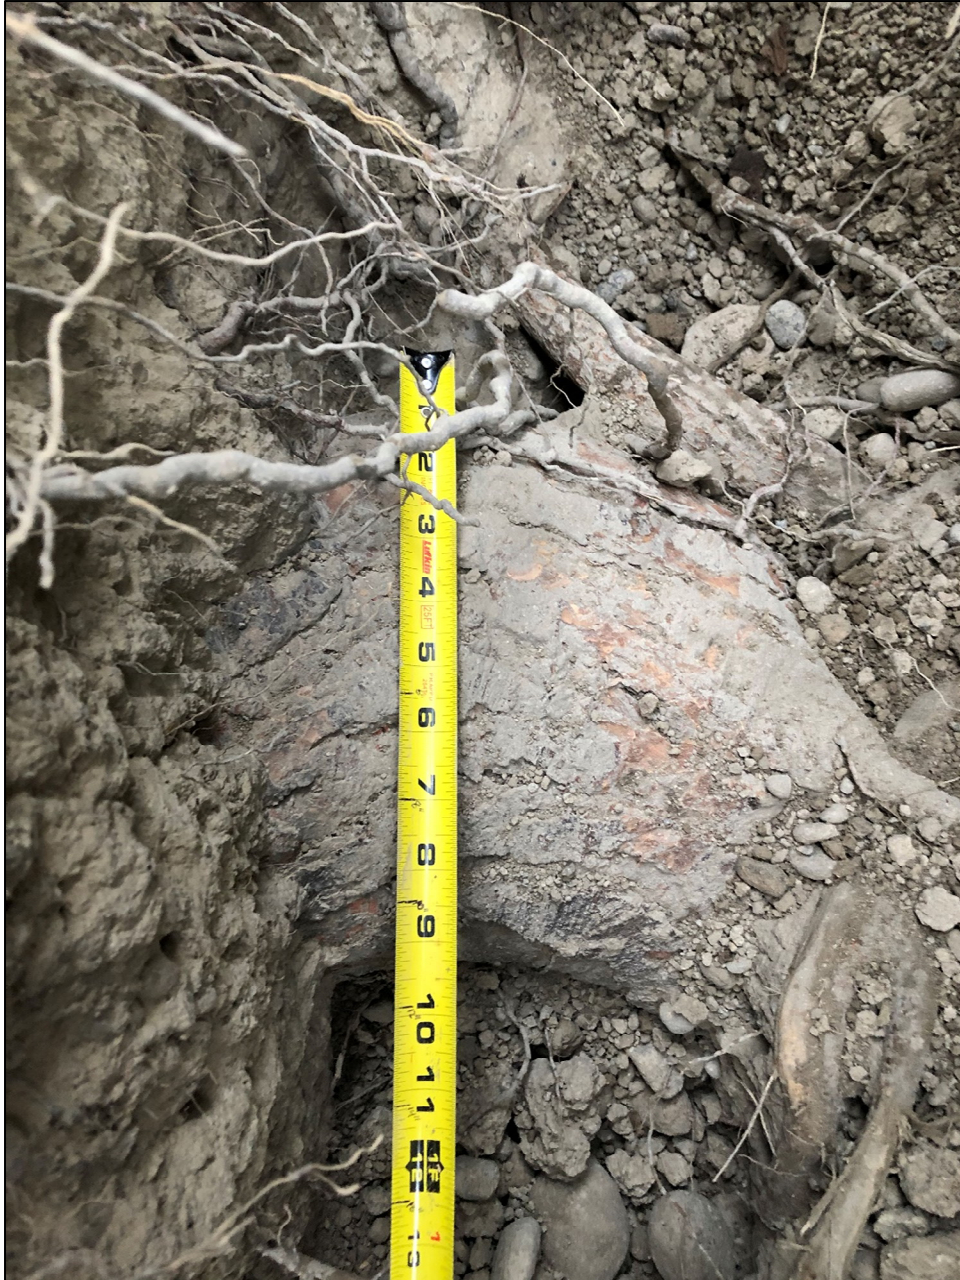
**Photograph 2.** Exposed portion of the approximately 10-inch diameter root originating from tree 7.
