6/14/2019 - revised 5/8/2020 to add tree 19

## **Arborist Tree Inventory Report and Retention Plan for:**

**3440 97th Ave SE**

Mercer Island WA

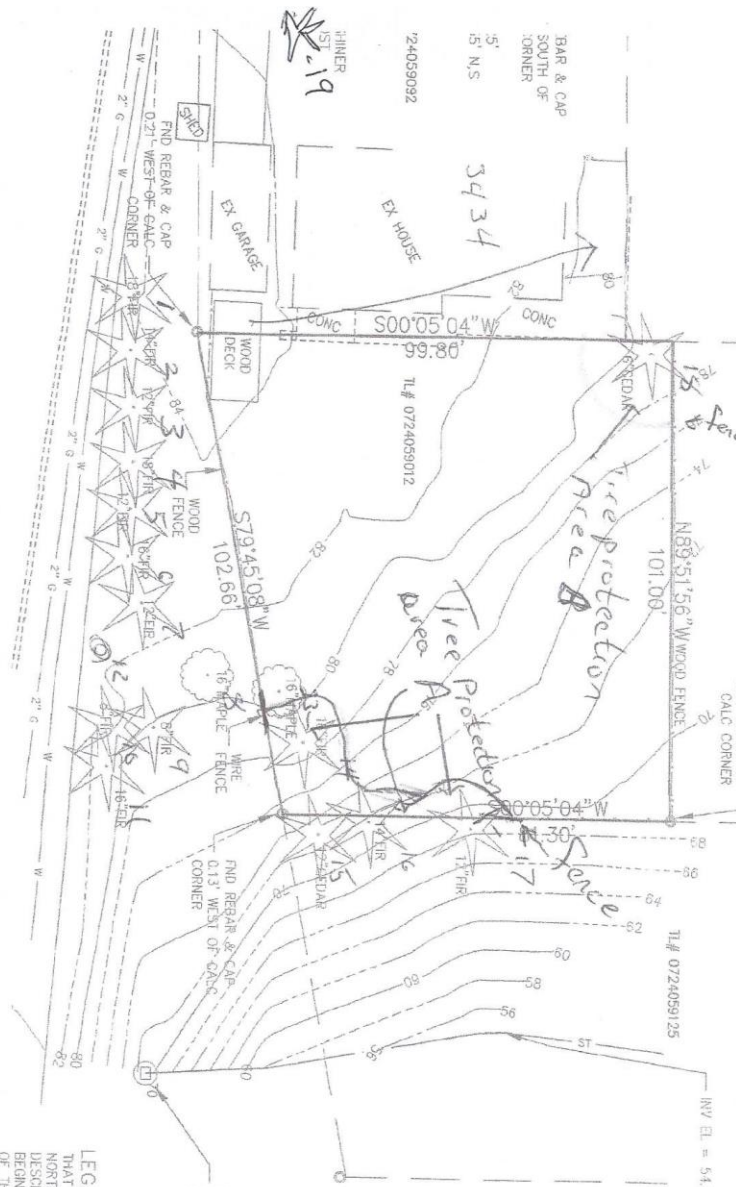
3440 97th Ave SE  
 Mercer Island WA  
 Tree Location Map

Off-site Trees 8, 15, 16, and 17 are near the property line and shall be protected with the tree protection area A as described below and drawn on the tree location map.

On site trees 14 and 18 shall be protected by tree protection areas A and B as described below and drawn on the tree location map.

Tree Protection Area A --Tree Protection Area A shall be created by fencing the area on the subject lot according to the location of the fencing marked on the tree location map. Fencing shall consist of 4' tall orange construction fencing. There shall be no site disturbance, traffic, storage of materials or washing of materials within the fenced area during the time of the development project. Any excavation within 3' of the tree protection fence shall be done by hand with shovels with care taken not to rip or tear any encountered roots but rather to cleanly cut or prune them.

Tree Protection Area B -- Tree Protection Area B shall be created by fencing the area on the subject lot that is within 11' of tree # 18 with 4' tall orange construction fencing. There shall be no site disturbance, traffic, storage of materials or washing of materials within the fenced area during the time of the development project. Any excavation within 2' of the tree protection fence shall be done by hand with shovels with care taken not to rip or tear any encountered roots but rather to cleanly cut or prune them.
