September 22, 2020
File No.19-338.500

**Subject: Geologic Hazards Assessment
Single-Family Residence Remodel
5472 West Mercer Way, Mercer Island, WA**

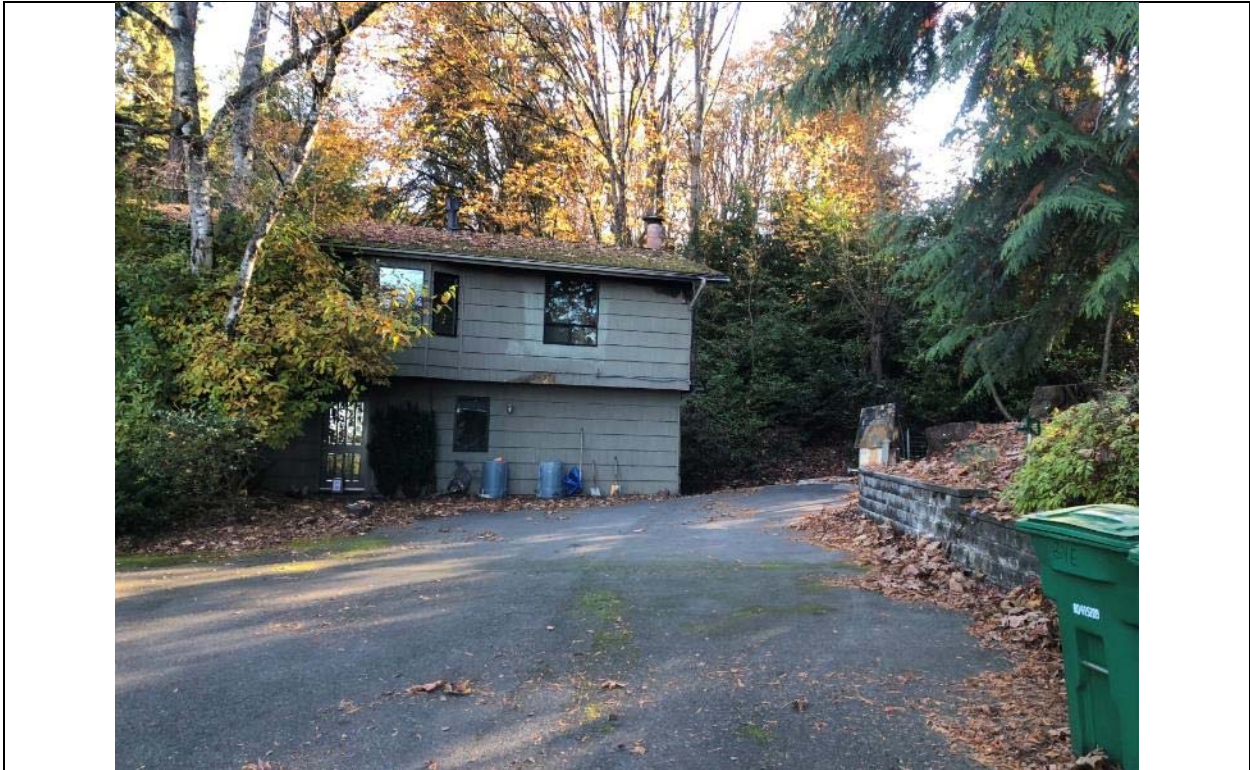
Plate 1. Vicinity of proposed three car garage near southwest portion of existing residence, facing east.

Considering that the 3-car garage is planned in a relatively level area west of the existing residence and a considerable distance from descending slopes, and the small bay on the north side of the residence is also within a relatively level area distanced from descending slopes, it is our opinion that these lightly loaded structures would not adversely affect the overall stability of the site or adjacent properties. Furthermore, it is our opinion that the Redi-Rock gravity retaining wall planned in the vicinity of an existing modular block wall would result in an increase in stability in that area, since Redi-Rock blocks are larger than the existing blocks.

It is our opinion that the proposed garage and small bay on the north side of the residence are planned sufficiently far away from the descending slopes at the site that they should not be subject to seismically-induced slope instability.

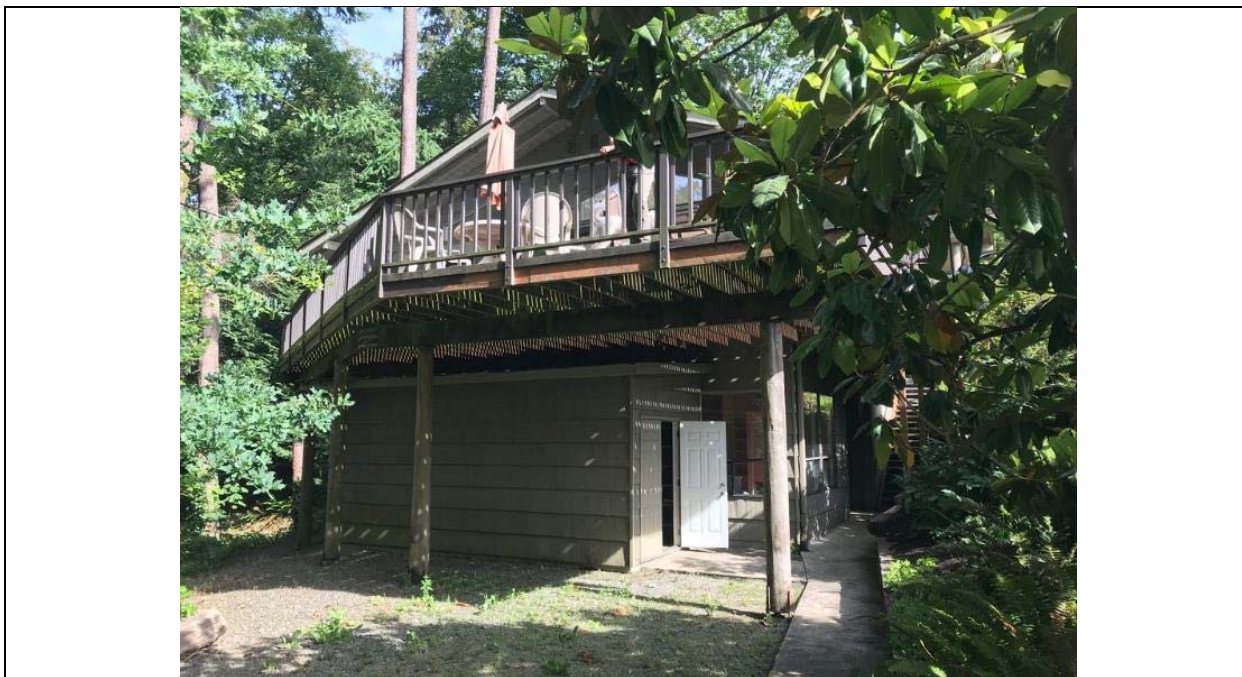
Plate 2. Proposed new bay on north side of basement level planned within footprint of existing storage room below deck, facing south.

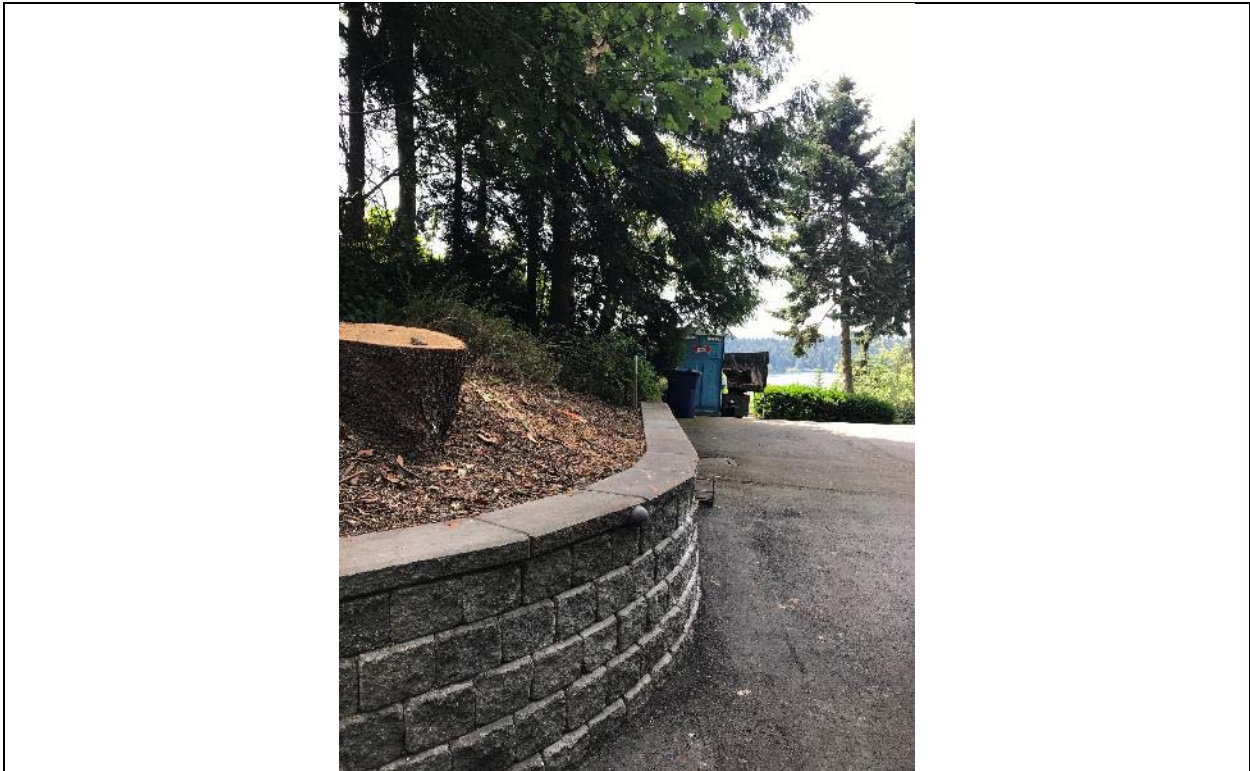
- Construct a new modular block gravity retaining wall using Redi-Rock concrete blocks in the southern portion of the site to accommodate driveway modifications. The new wall will have a maximum retained height of 6 feet. Currently there is an approximately 2½-foot high modular block wall in this area that is performing well (see Plate 3 below). PanGEO previously reviewed and concurred with the soil values used by the project structural engineer for the Redi-Rock wall design.

Plate 3. *New Redi-Rock gravity modular block wall planned south of existing modular block wall, facing west.*

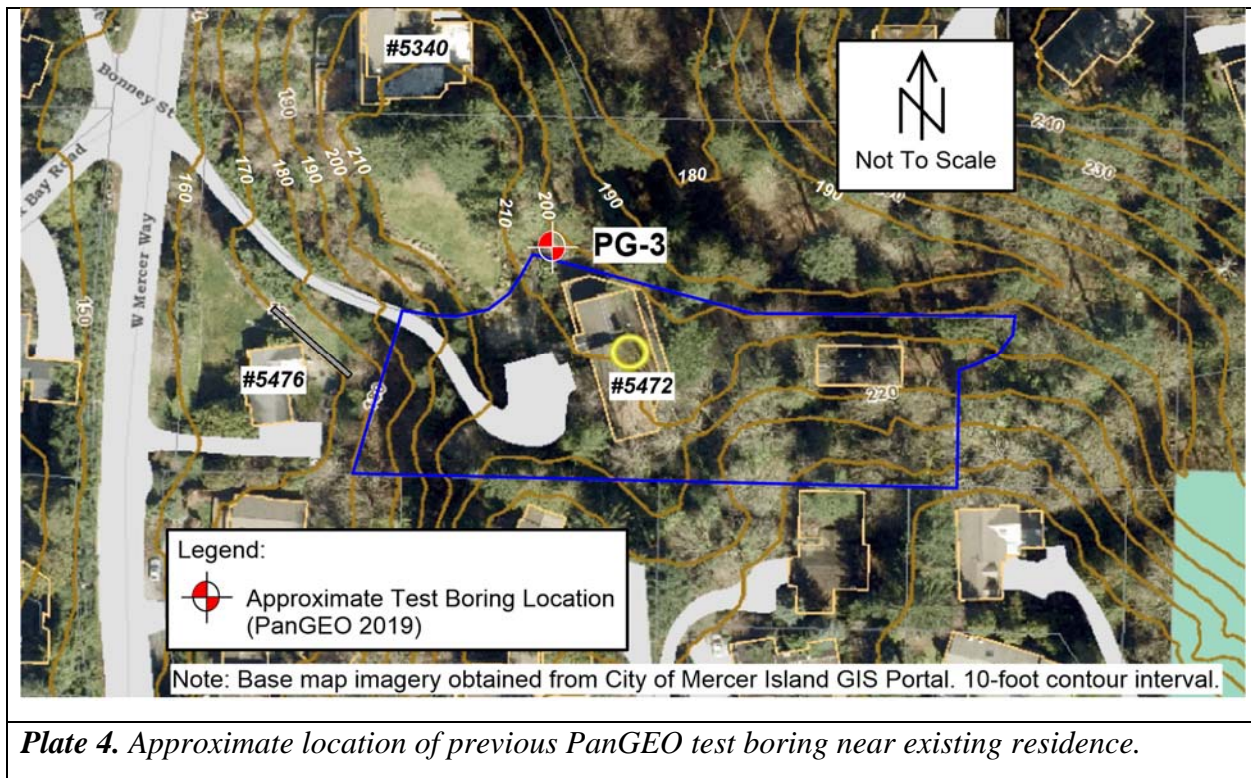
A topographic survey was not available at the time of our study. However, based on a review of topographic information available online, the existing residence is constructed on the east side of a relatively level ridge and the basement level is benched into the east side of the ridge. On the north/northeast side of the residence, slope gradients descend up to about 20 vertical feet at estimated gradients of about 20 to 30 percent to the bottom of a ravine. Please refer to Plate 4 on page 5 of this report for general topography at the site.

approximate location of PG-3 is indicated in Plate 4 on the following page. The test boring PG-3 summary log is included in Appendix A of this letter.

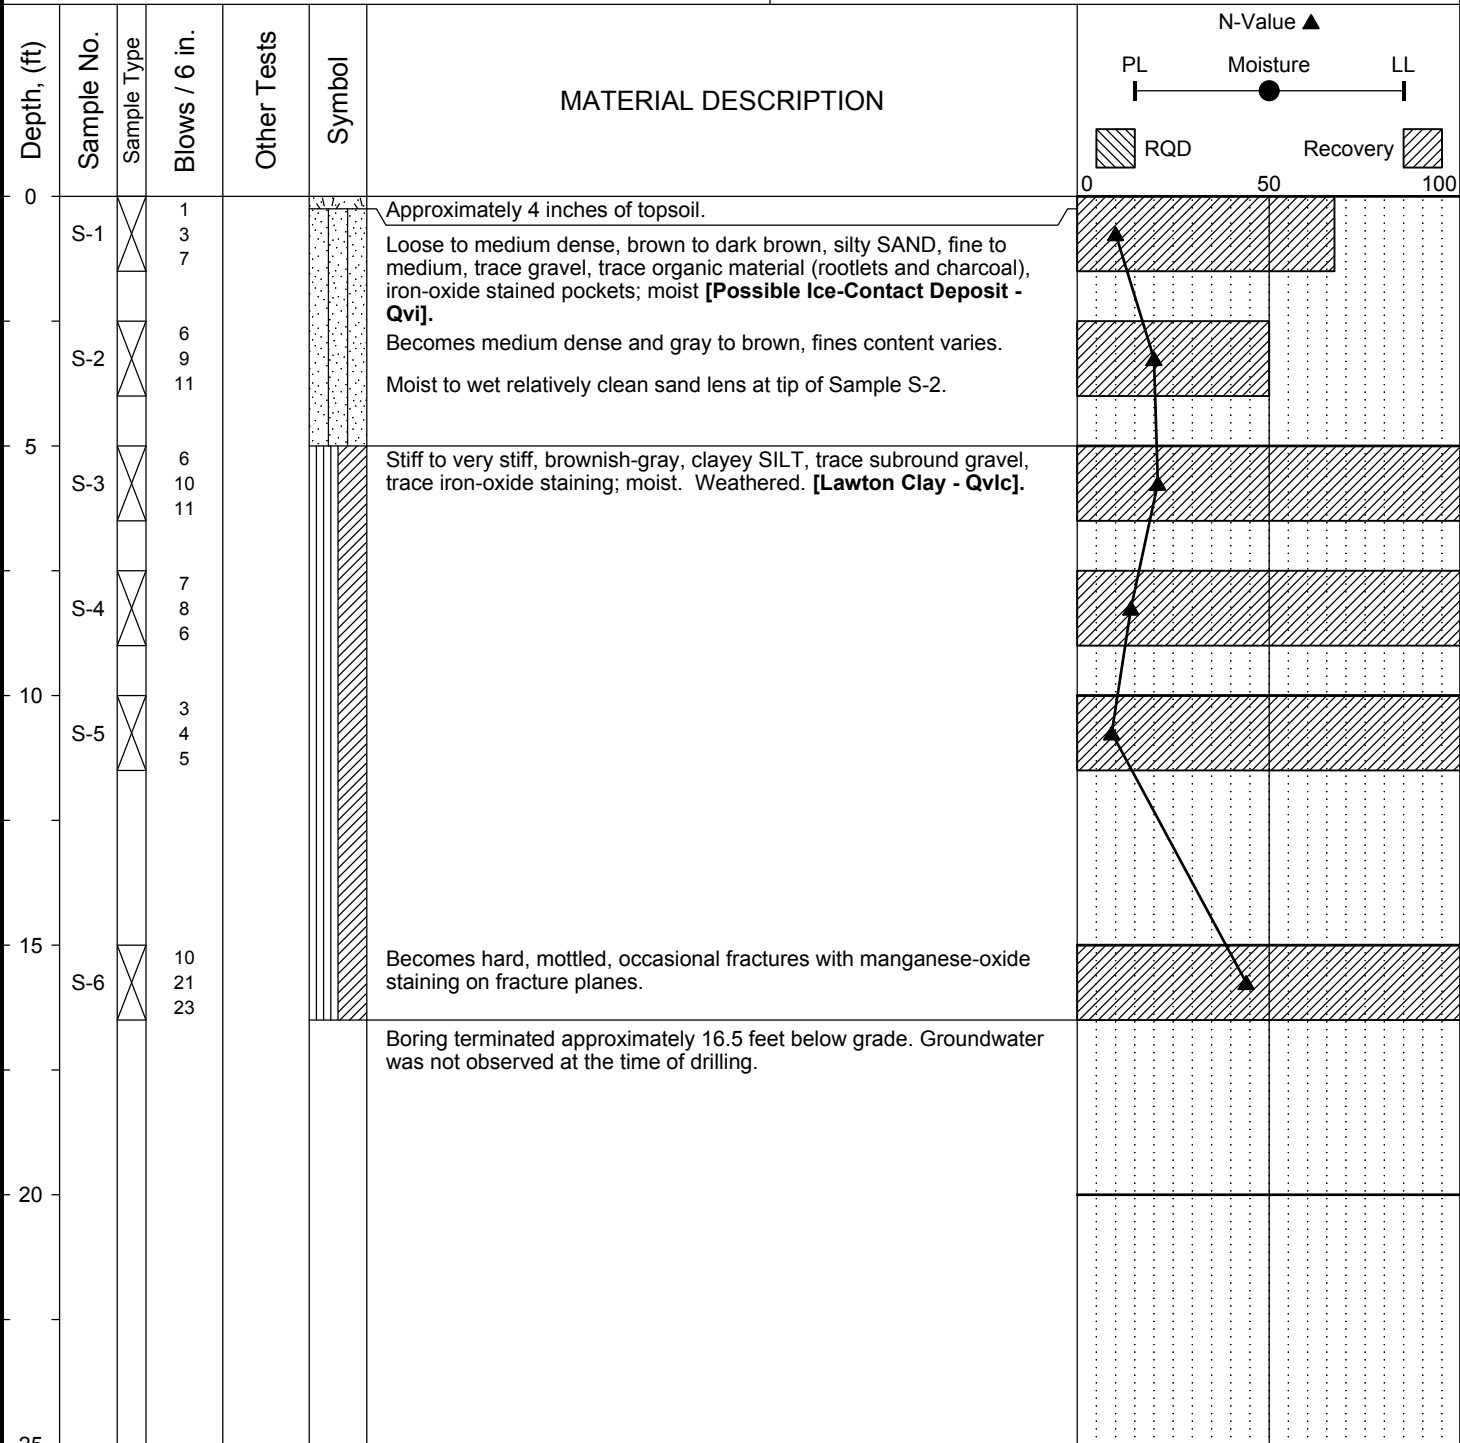
LOG OF PANGEO TEST BORING PG-3

Possible Ice-Contact Deposits (Qvi): Near the ground surface at PG-3, loose to medium dense silty fine to medium sand that we interpret as a possible ice-contact deposit was encountered. This soil unit generally resembled an outwash type deposit with a relatively high fines content. This soil unit was encountered to about 5 feet below grade at PG-3.

Lawton Clay (Qvlc): Underlying the possible ice-contact deposits at test boring PG-3, stiff to hard clayey silt that we interpret to be consistent with the mapped Lawton clay deposit was encountered. This soil unit was encountered to the maximum exploration depth of 16½ feet below grade.

Groundwater was not encountered at test boring PG-3 at the time of drilling in December 2019.
