Arborist Report

Revised August 2020

5472 W Mercer Way
Mercer Island, WA
206.399.6184
manader@hotmail.com

Davey Resource Group Inc.

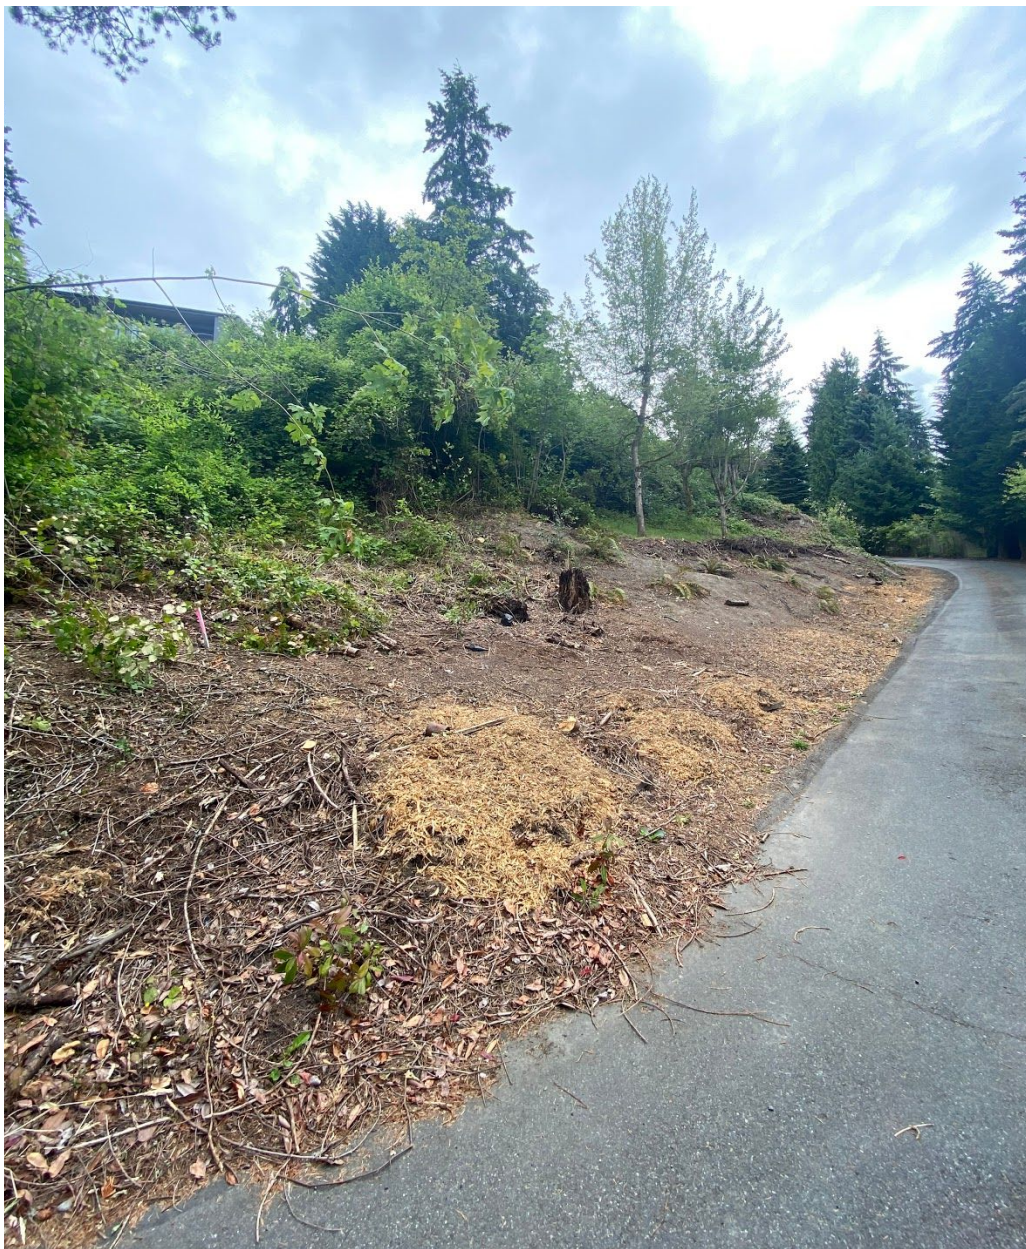
Trees and vegetation were removed on the North side of the driveway during the summer of 2020. This was necessary to run new utility service lines from the road to the home. The newly exposed area was cleared of trees but English ivy (*Hedera helix*) was still present in the area.

Image C1. Trees were removed from the project area.

Noxious and invasive vegetation will be removed in the project area and properly disposed of off-site. Removing these weeds is crucial to the success of the restoration as even a small amount can out compete native plants. Use of pesticides or machines to remove vegetation is prohibited unless authorized under a permit. A systematic regime of invasive weed and shrub removal will be completed at multiple times throughout the growing season as necessary. Where large patches of invasive plant growth is removed, planting of native species will occur to deter the reclamation of the area by the remaining invasives.

To enhance soil stabilization, due to the loss of tree roots as they decay, and deter the regrowth of English ivy, which tends to dominate recently exposed soil, the area will be replanted with native vegetation. Revegetation species were chosen based on their ability to thrive in the specific site conditions and have vigorous, dense root systems which will quickly contribute to soil stabilization.

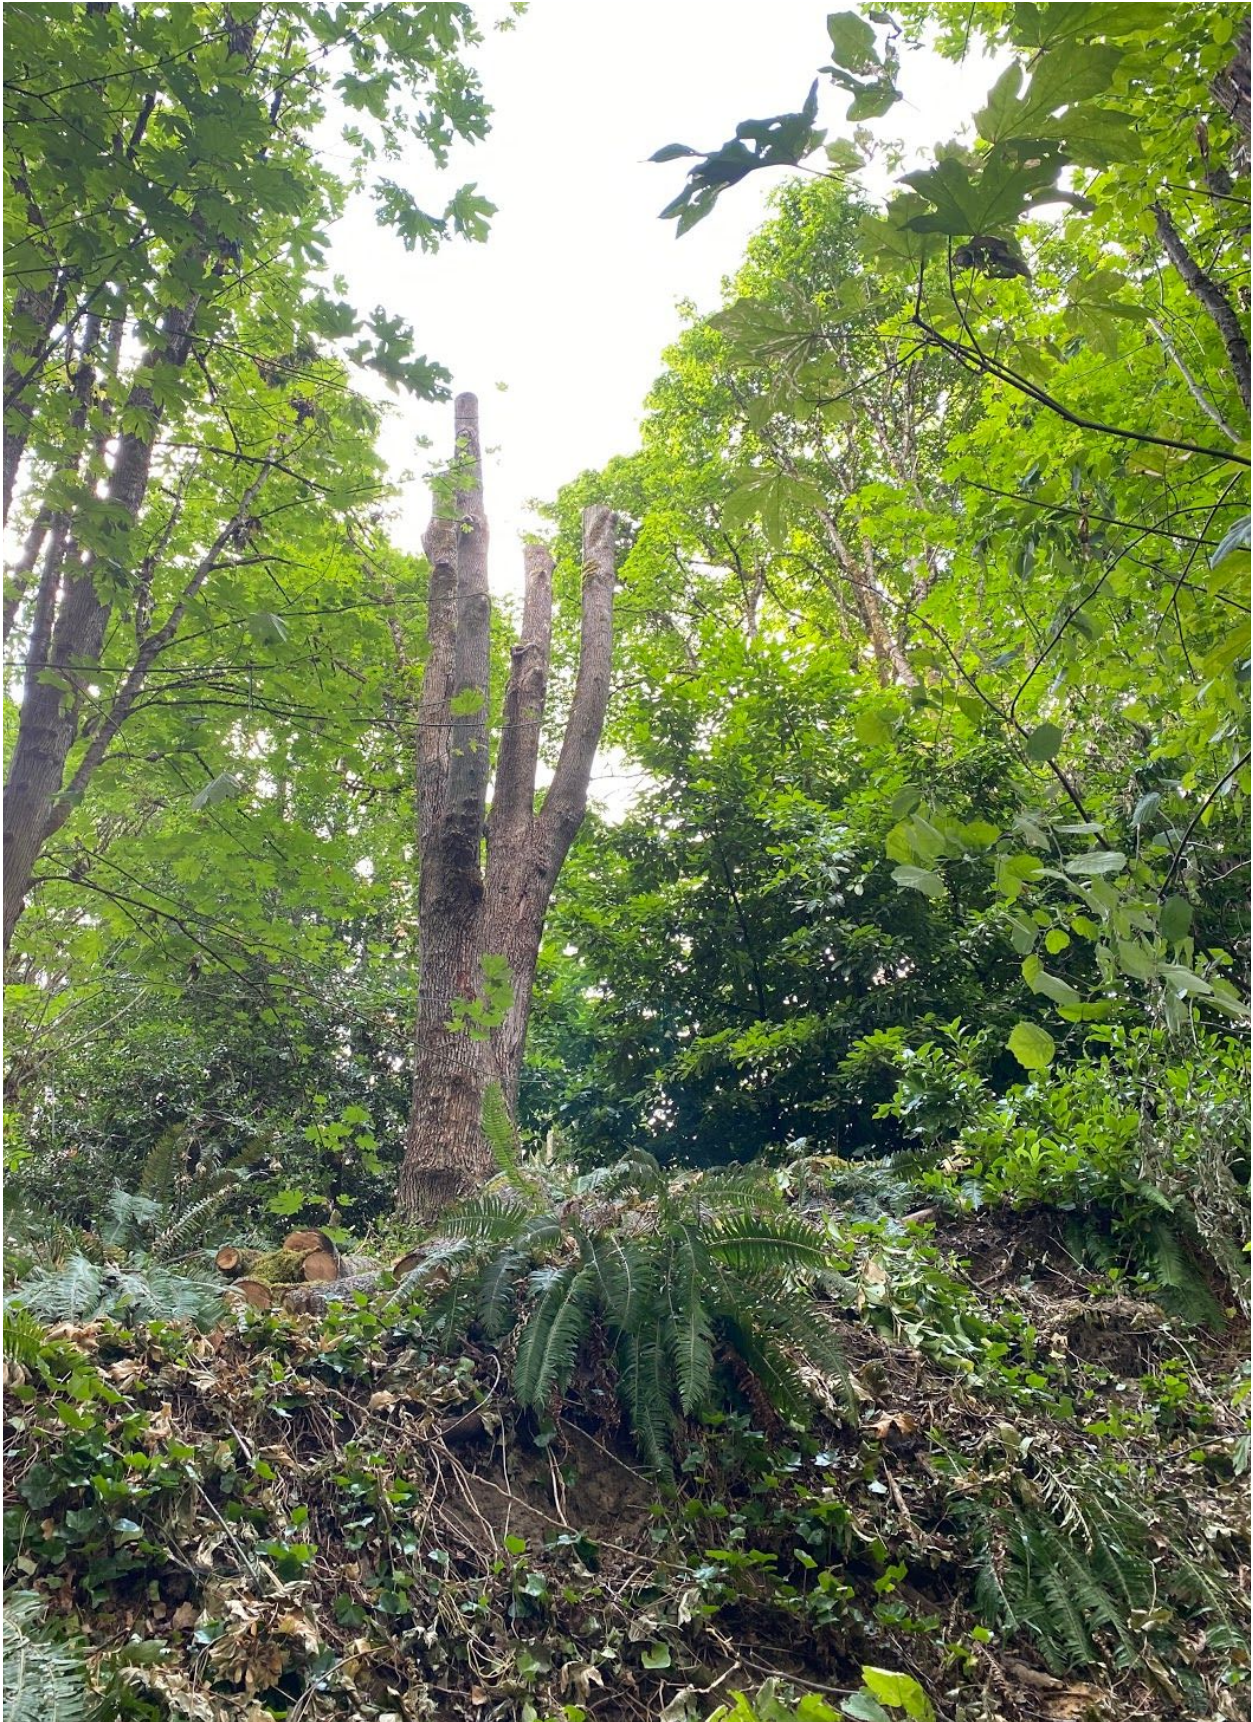
Image C3. Trees removed at the site were left as habitat snags, when it was safe to do so.

Trees to be removed at the project sight may be topped at a safe height and left as habitat snags for wildlife food, nesting, or shelter. Standing or downed deadwood plays an important role in the landscape. Tree removals at the site present an opportunity for designers to promote and increase wildlife activity and diversity at the site. The arborist performing the removals will be consulted to decide the potential for a habitat snag designation on a tree by tree basis. In some cases, guy wires may be attached to the tree and anchored in the ground to create a safe snag out of a taller tree.
