FIELD REPORT

Date of Site Visit: May 30, 2019 **Date of Report:** June 10, 2019

Project Name: Air Spade Trench Root Exploration for Driveway

Project Address: 4825 East Mercer Way, Mercer Island, WA 98040

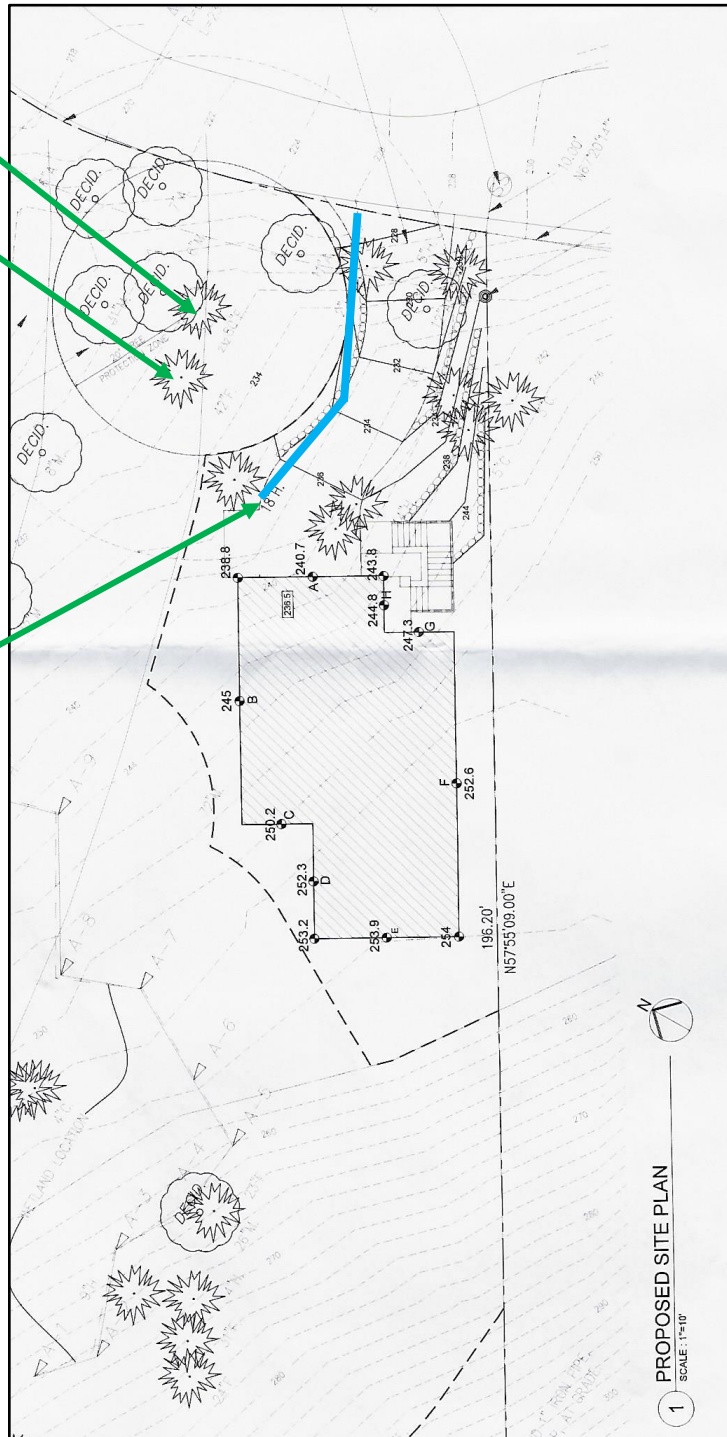
Proposed Site Plan:

Orientation Sketch: This sketch, taken from the proposed site plan shows the location of the 2 trees, the location of the proposed driveway, and the approximate location of the air spade trench,.

Tree # 916

Tree # 917

Approximate location
of the air spaded
trench

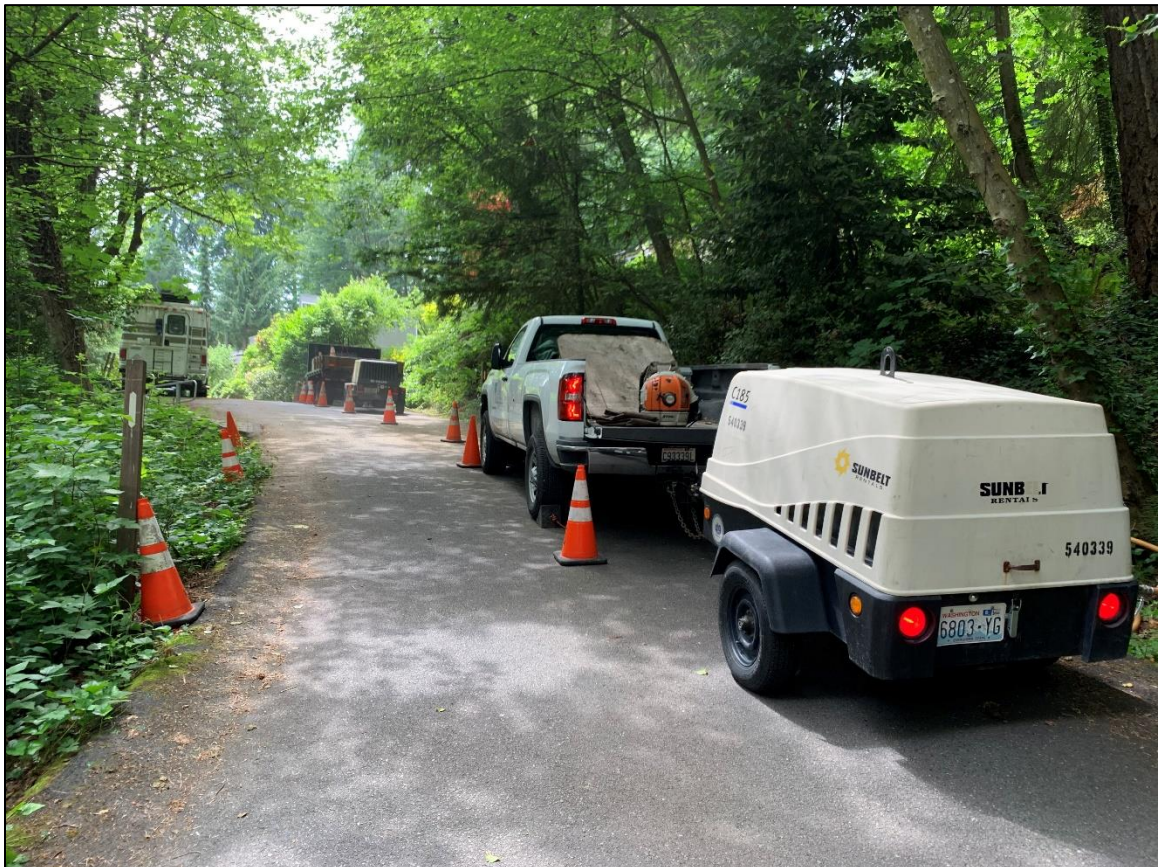
Photo # 1: Looking up the street at the coned off vehicles as they set up to work.

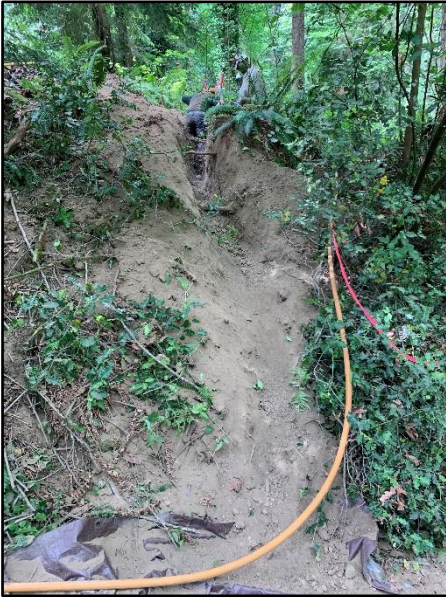
Photo # 2: Looking west from the road at the trench being blown and shoveled. Note the tarp under the soil in the roadside ditch to capture the soil as it moved down. This soil was then put back up into the trench. The roots observed appear to be from the adjacent shrubs.

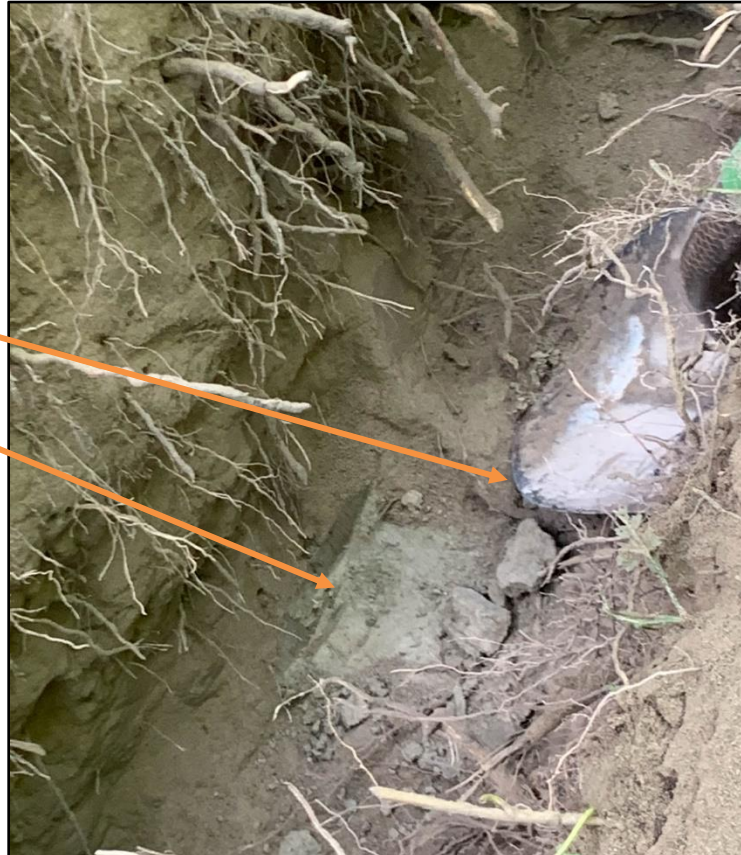
Photo # 3: Looking down into the trench. At approximately 26 to 34 inches below the surface solid blue clay was encountered. In a few random places the operators forced their way into the clay to a depth of 44 to 46 inches. They encountered solid clay at those depths also.

The small roots present are from the invasive English Ivy and ground cover shrubs.

Tip of shovel.

Blue, impenetrable clay layer 26 to 34 inches below the surface.

It appears that there is no layer of soil below the clay where large tree roots could be growing. It appears to be clay down for a very long way—well below the ability of tree roots to grow.

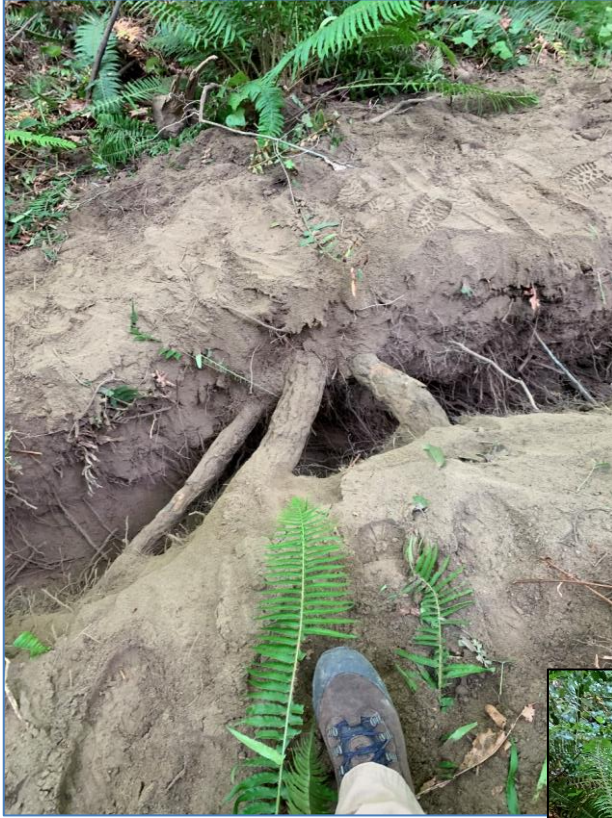
- The rest of the roots encountered were from nearby shrubs and the invasive English Ivy and English Holly.
- Douglas Fir Tree Roots:
 - Four root were found.
 - Diameters measured with a standard Spencer DBH tape), are:
 - Root # 1: 2.9”
 - Root # 2: 4.6”
 - Root # 3: 3.7”
 - Root # 4: Estimated to be 2.5”
 - Roots #'s 1 – 3 were in close proximity to each other and are growing in the duff layer or just at the bottom of the duff.
 - Root # 4 was directly under the other three and firmly attached to the top of the clay layer. Therefore, its diameter was estimated.

Photo # 4: Looking down at the only Douglas Fir tree roots encountered from the two subject trees. A fourth root was encountered at the bottom of the trench at approximately 30 inches of depth. They measured 2.9", 4.6", 3.7", & an estimated 2.5".

Tree roots cannot grow in clay. They are unable to penetrate. In addition, the solid clay, often moist, is a barrier to air penetration. Tree roots cannot survive in anaerobic conditions—that is, soil without air. Therefore, I conclude that the four roots we encountered are the only ones extending out beyond 20 feet from the bases of the two Fir trees. It may be possible to excavate the driveway as required to meet steepness/grade requirements from the roadway to the proposed house.

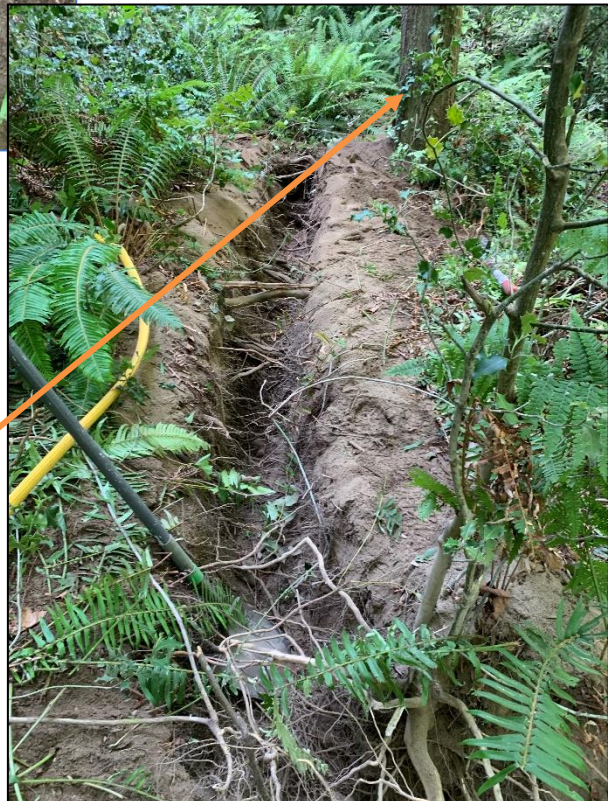
Photo # 5: The last several feet of the trench showing roots of shrubs and the Hemlock in poor condition, but no Fir Roots.

Hemlock Tree

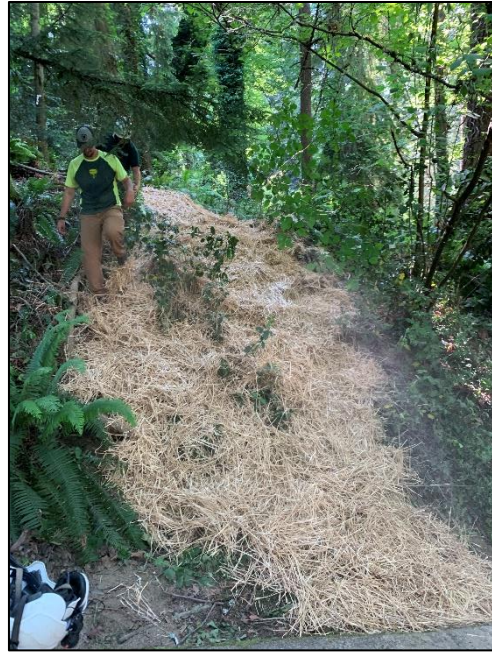
Photo # 6: The crew finishing the day with a bale of straw covering the open soil to minimize erosion.

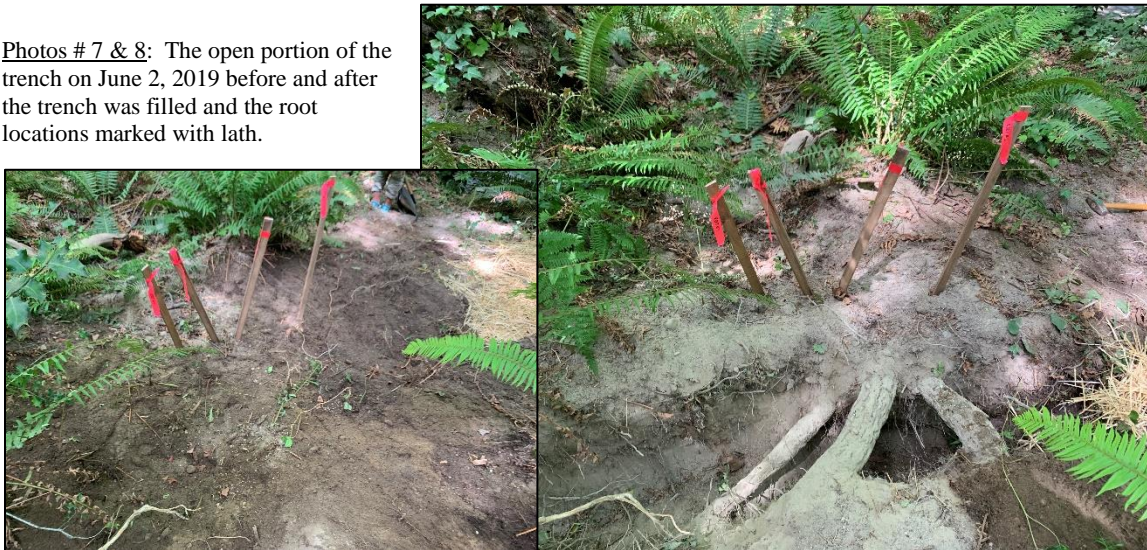
City Staff requested that we clearly mark the location of the only four roots that were encountered from trees # 916 & 917. Therefore, on May 30, a small length of the trench was left open where these four roots are. I returned on June 4, 2019 and put in four pieces of lath with the roots numbered. Then I refilled the trench.

Photos # 7 & 8: The open portion of the trench on June 2, 2019 before and after the trench was filled and the root locations marked with lath.
