7115 78th Ave SE, Mercer Island, WA

190610A

Seattle Sewer Inspection

Sewer Inspection Report

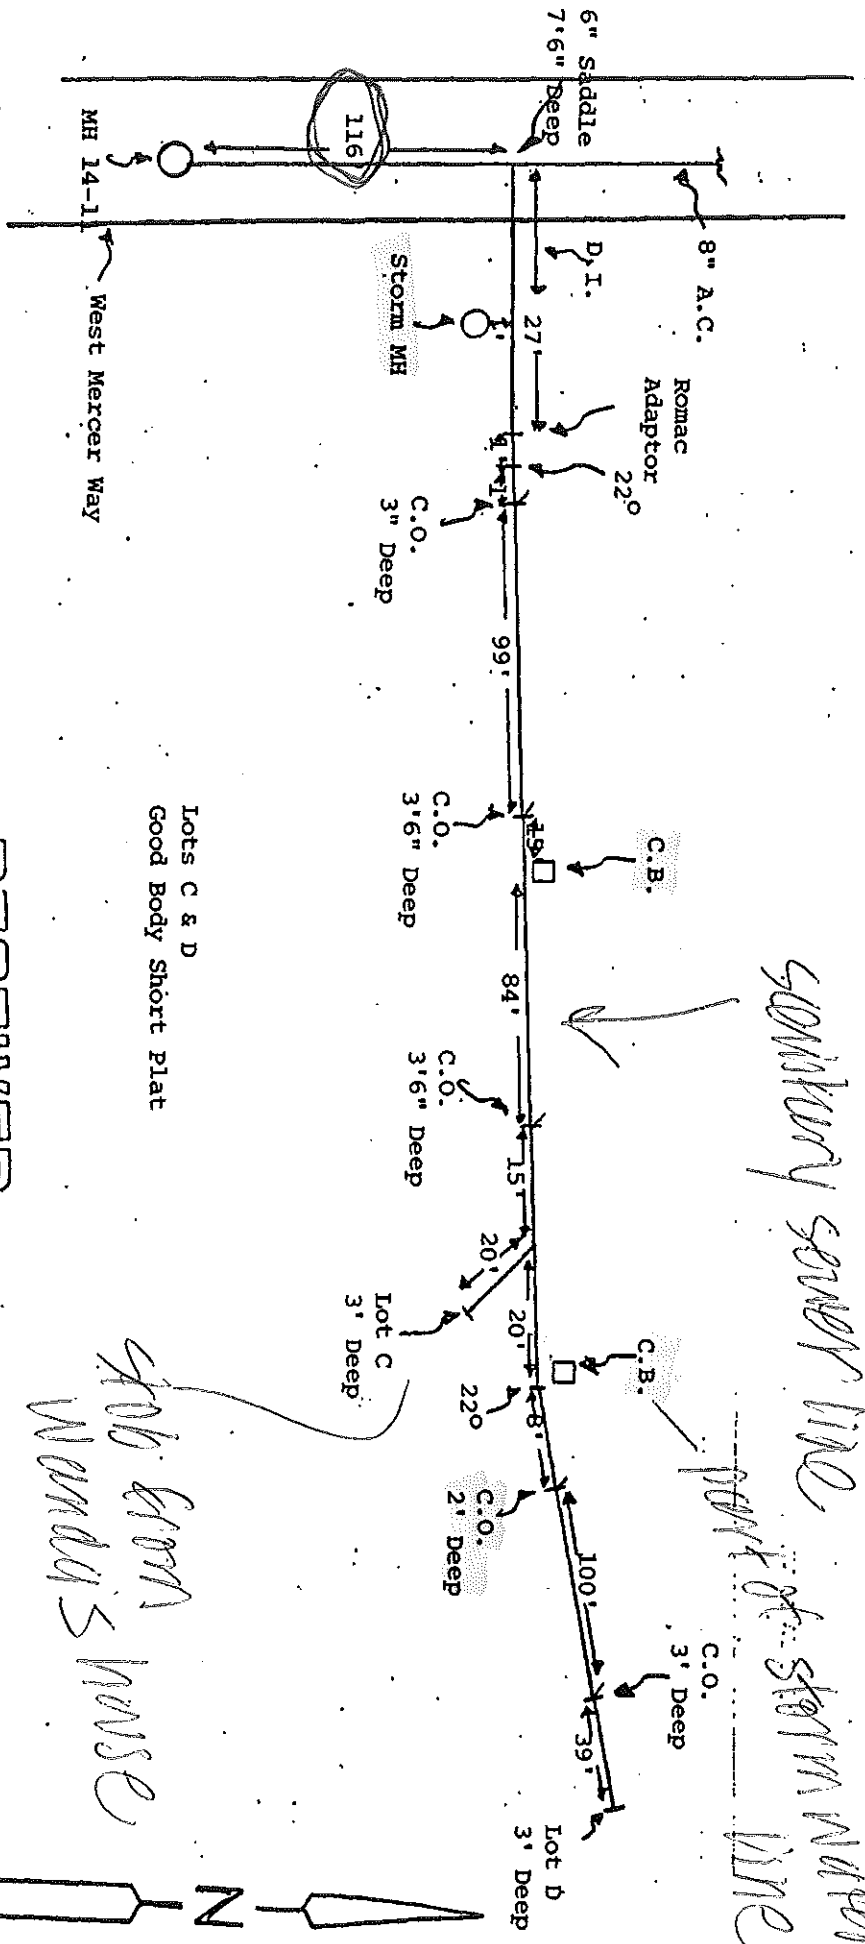
SIDE SEWER PLAT

sanitary sewer line
part of storm water line
