ARBOR INFO LLC

**Tree Assessment
For
Chen Residence
At
3869 80th Ave SE
Mercer Island, Washington**

**Date
Rev 3/3/2020**

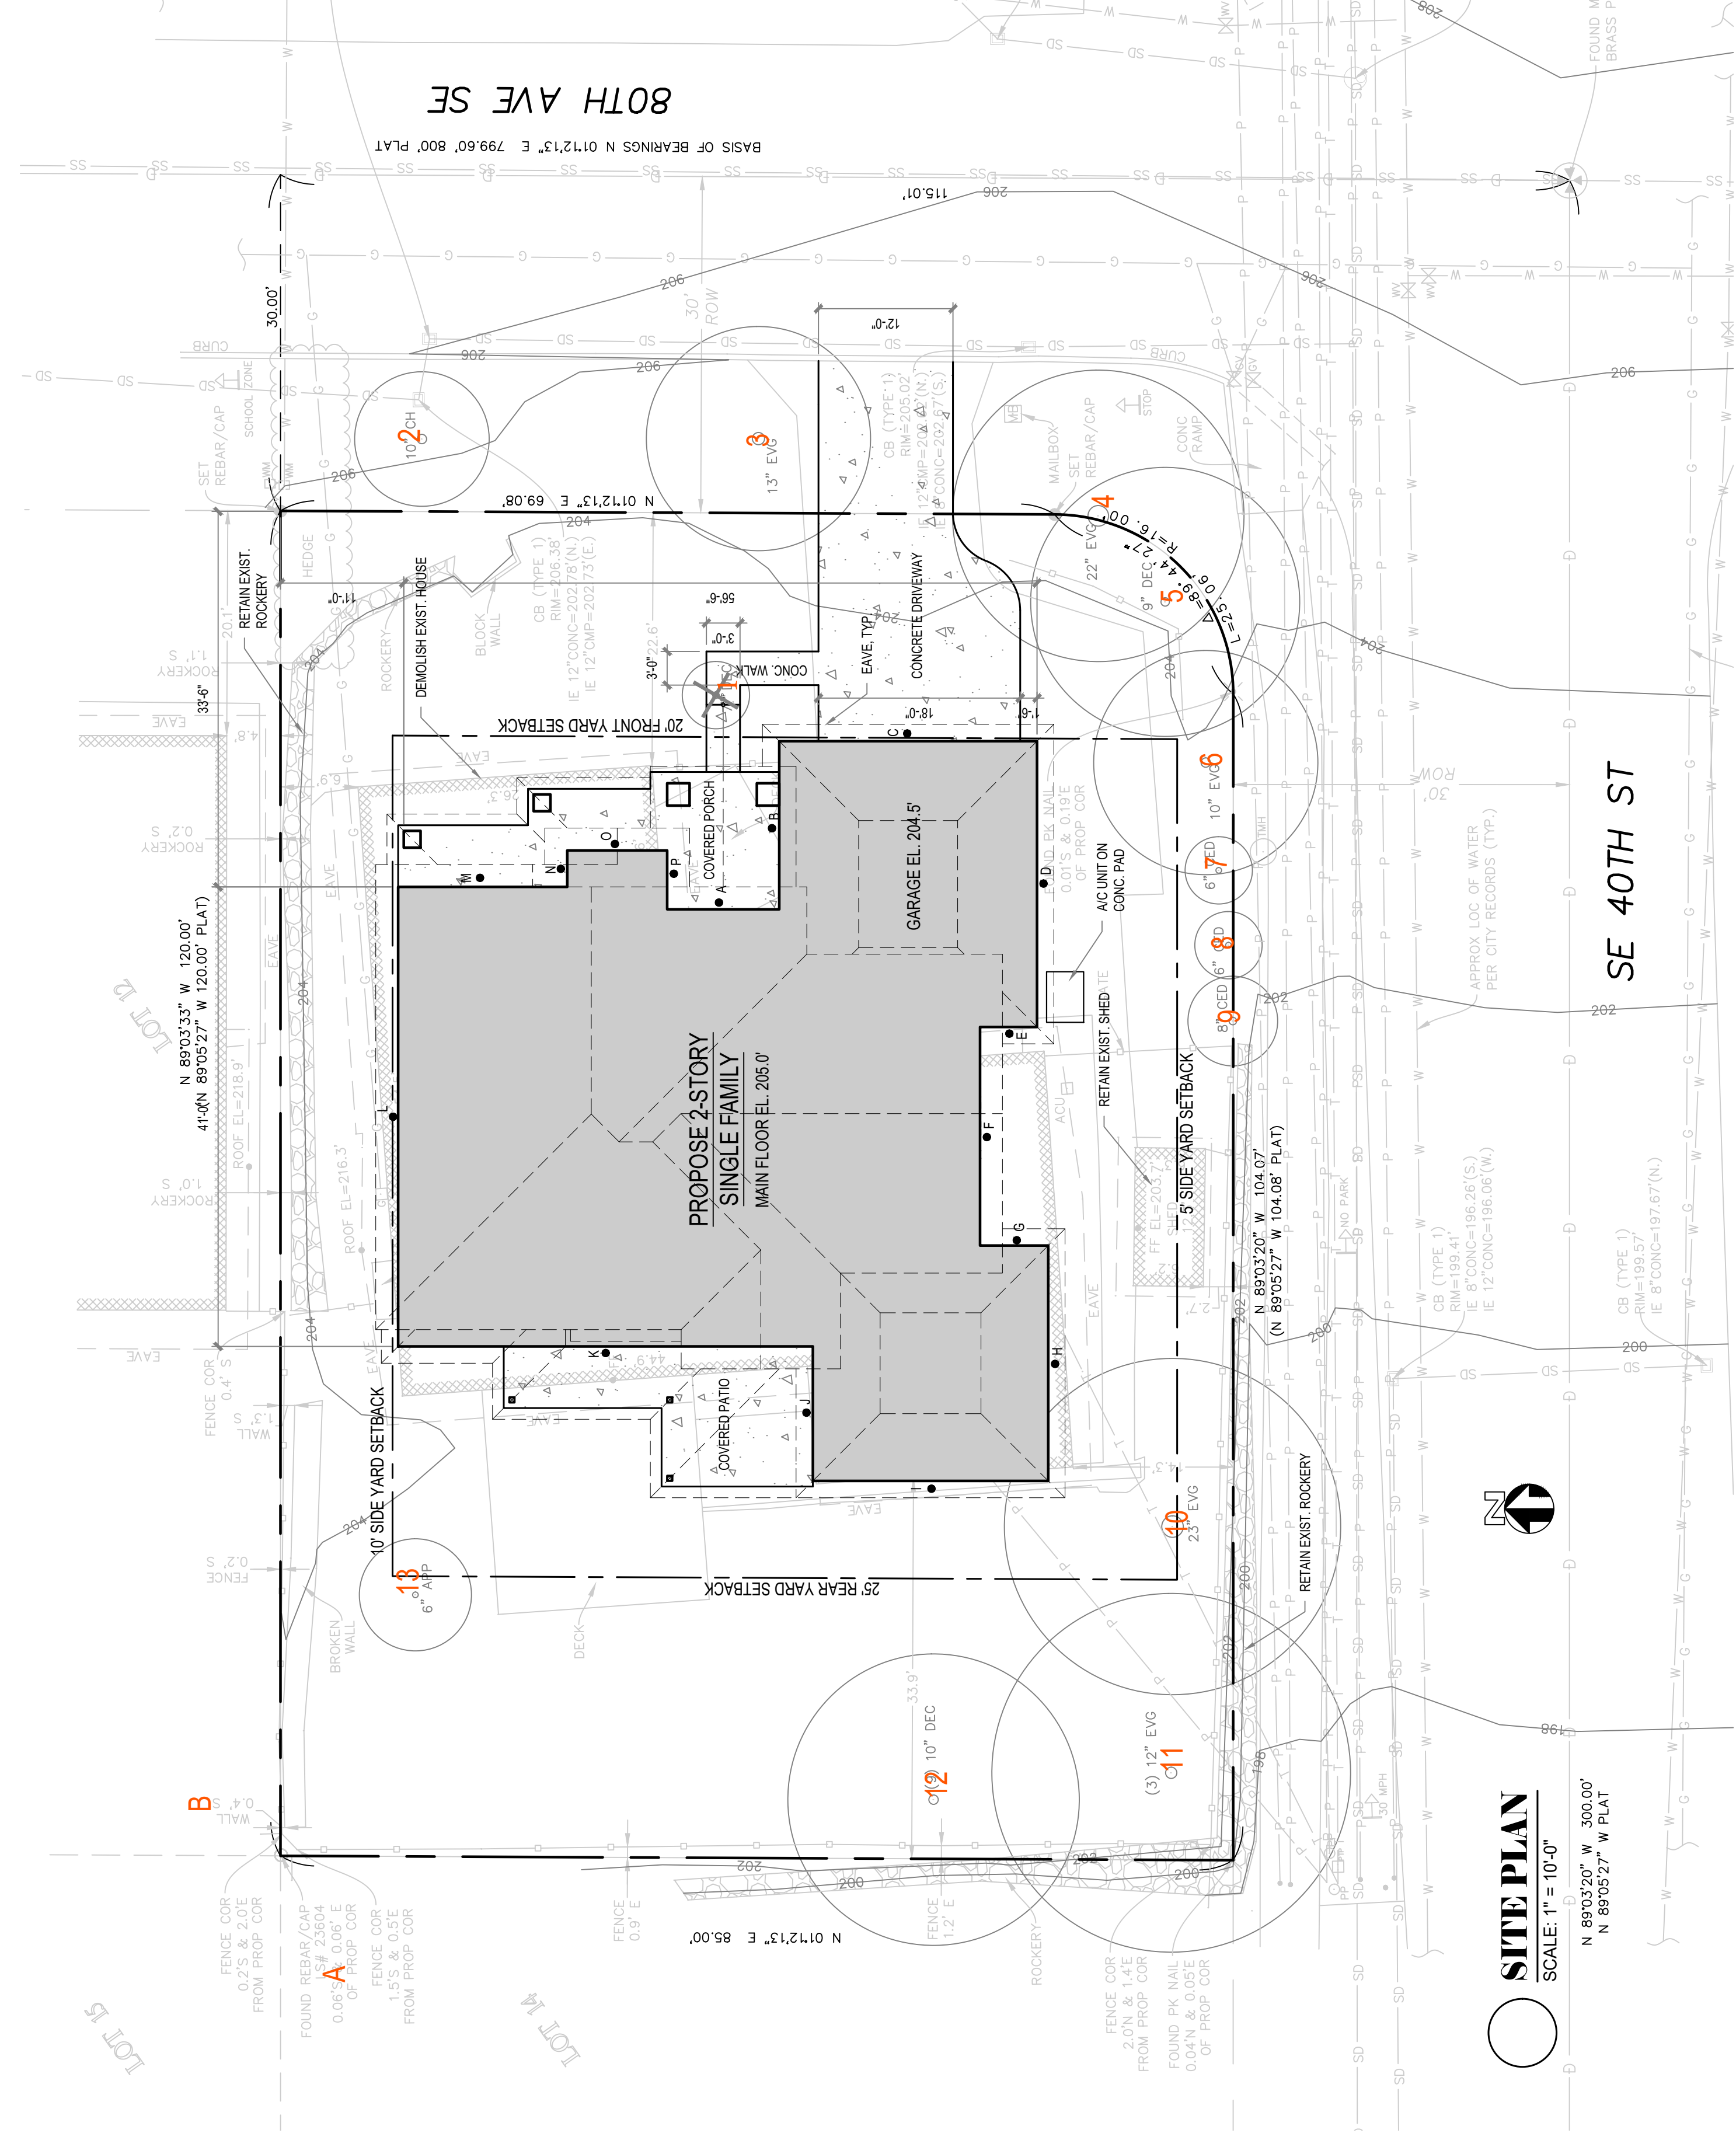
A0

It is assumed herein that the subject trees 1-13, referenced on the attached site map and tree assessment form stand on the subject property. Trees A and B are assumed to be offsite. A site plan indicating a proposed development plan was provided and is included in the Addenda with tree locations noted.

Refer to the attached Tree Assessment Summary Form. A total of thirteen on-site trees and two off-site over 6-inches in diameter were found and located on the attached Tree Location Map. All trees are defined as “large trees” by the City of Mercer Island.
