May 12, 2020

TO: Andrew Park, Managing Partner - Viewcrest Capital
SUBJECT: Post-construction Arborist Report
4703 – 88th Avenue SE
Mercer Island, Washington 98040

FROM: Arbutus Design LLC

PREPARED BY: M. Eliza Davidson, Certified Arborist PN-5767A

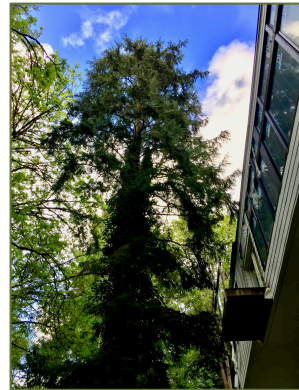
Tree 7 (from south)

In the lone case of Tree 7, I recommend removal. Any causal connection with construction is very limited, since the area of root disturbance was minimal. At most I would consider it a minor stressor to a tree of a species vulnerable to fatal attack by insects, disease and increasing drought. In 2015, this 25-inch dbh (diameter at breast height) *Tsuga heterophylla* just below the future house was in good condition. My removal determination is driven both by Tree 7's decline in condition from its pre-construction status, and by the previously un-noted discovery of a major trunk defect high in the canopy at very close range to the house.

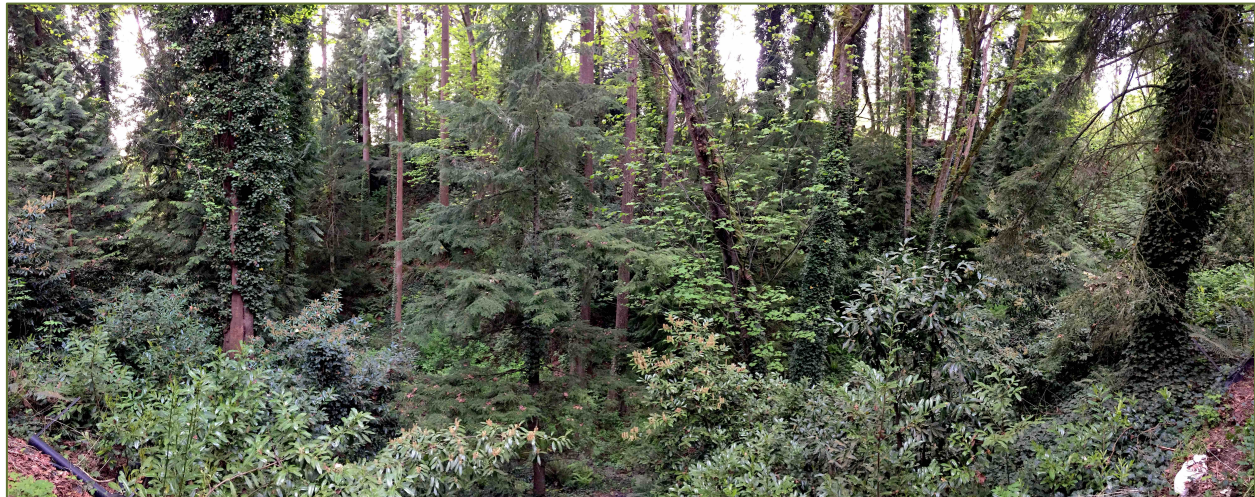
View from house into ivy & laurel infested slope along W side - Tree 12 slightly left of center, Tree 7 at right edge

The steep forested slope west of the house can accommodate additional trees but not the full remaining 12. This slope is heavily infested with English laurel shrubs and ivy aggressively climbing trees. To create space to plant additional trees, several large laurels need to be removed. I recommend that all laurels between Trees #7 and #10 upslope of Tree #12 be cut to the ground, stumps treated with herbicide and debris hauled out for disposal offsite. Treatment by a State-certified pesticide applicator would provide enhanced control. Removing large quantities of invasive laurel will significantly improve conditions for regeneration of native understory.

In addition, I recommend controlling all tree-climbing ivy to protect the property's existing large trees from destruction. To do so, ivy should be severed at 4 feet above ground and removed

from the trunk below, and cleared away from tree's base to create a six-foot "survival ring." For safety, ivy above four feet should not be removed, but instead left to die naturally. Cleared ivy can be left on site if rolled up and piled on large sheets of cardboard to discourage re-rooting. Ivy piles contribute to wildlife habitat. Approximate restoration area is indicated in yellow below. On-site trees that require ivy control are marked in yellow as well.

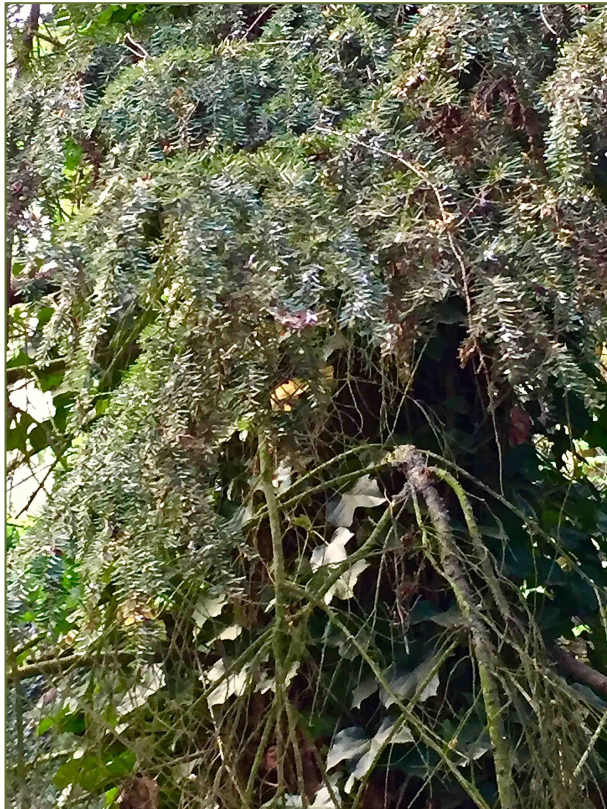
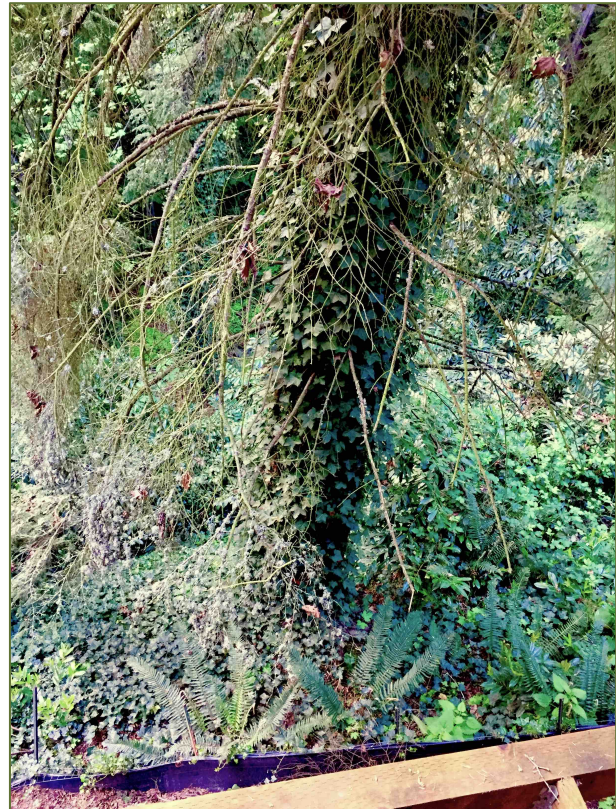
As illustrated below, many lower limbs are dead or dying, typical of the bottom-up progression of damage from feeding hemlock woolly adelgid -*Adelges tsugae* that heavily infests needles of this tree. Hemlocks can die from this pest within four years. Unfortunately the adelgid by now is widespread in our region, including other trees on site. The presence of root or trunk decay also cannot be ruled out. Invisible internal rot is a common cause of trunk failure, but impossible to detect without invasive resistance drilling. A dead tree is a dangerous tree.

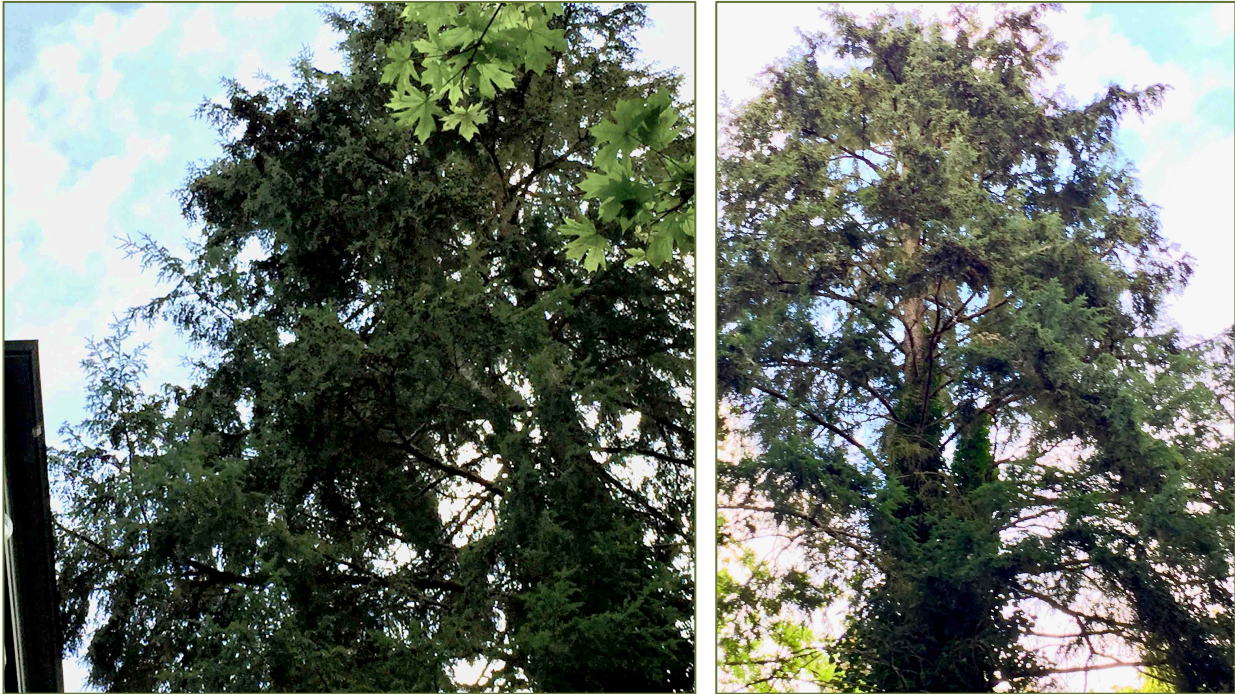
Compounding this issue is the presence of tight co-dominant leaders originating high on the ivy-swathed trunk. The secondary leader leans toward the new house's deck and roof. The owner has experienced limb drop onto the roof in windy weather, but the much greater concern is breakout of this entire leader. The house and its occupants will be highly vulnerable to a potentially fatal failure. The extra weight of the mantle of ivy that grows to

60 feet or more is a compounding factor, as is the fact that thick trunk ivy traps moisture and creates conditions conducive to decay.

Tree 7's high, overhanging co-dominant leader seen from south on left, north on right
