Memorandum

To: Edson Gallaudet, Build Urban
From: Benjamin Mark, American Forest Management
Date: 9/9/2020
Re: Tree Assessment at 8720 SE 52nd Place, Mercer island

On August 26th 2020 at your request, I evaluated the condition of three trees located at 8720 SE 52nd Place in Mercer Island. The trees were to be retained and protected from impacts associated with construction of the new house. An arborist report prepared by American Forest Management on August 7th, 2018 detailed development activity near these trees. Each were rated 'Moderate Risk' due to the possibility of failure and high likelihood of striking the new building causing severe damage. The report recommended a re-evaluation of their condition after two years.

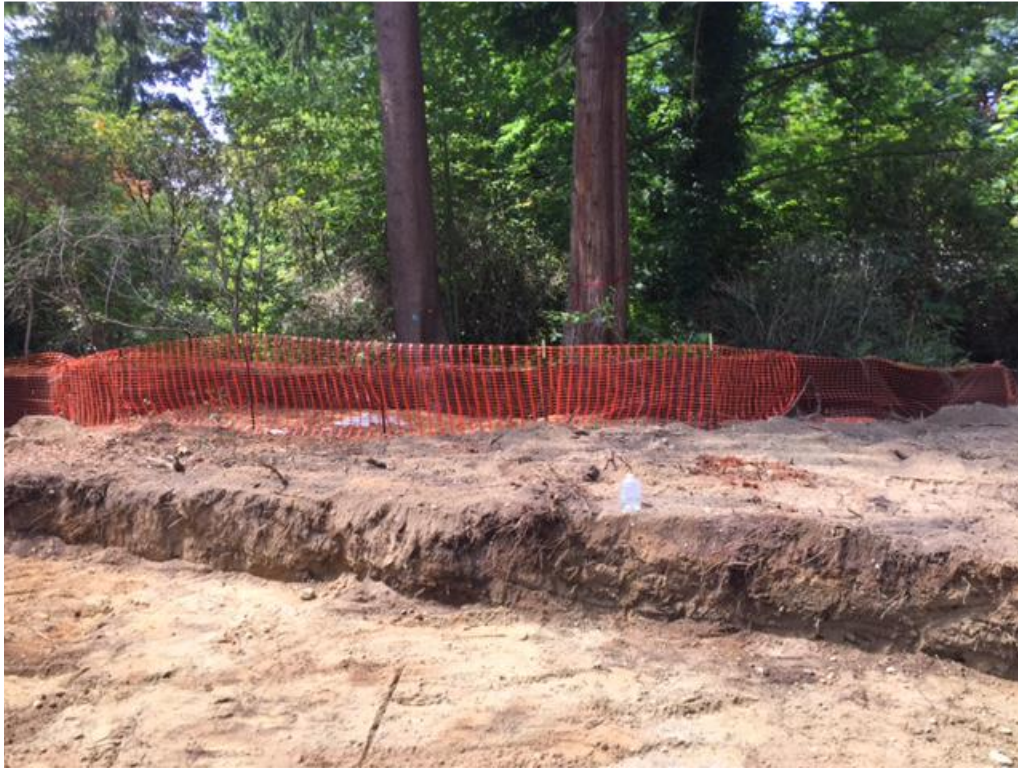
Tree #8409 is a western red cedar with a DBH (trunk diameter at 4.5 feet above grade) of 43.5 inches and an overall height of 104 feet. It shows good foliage color and a full crown. Tree protection fencing is in place 15 feet north of the trunk. The arborist report from 2018 describes excavation and minor root disturbance 22 feet to the east of this tree and adjacent tree #8410.

Image from 2018 showing trench east of trees #8409 and #8410

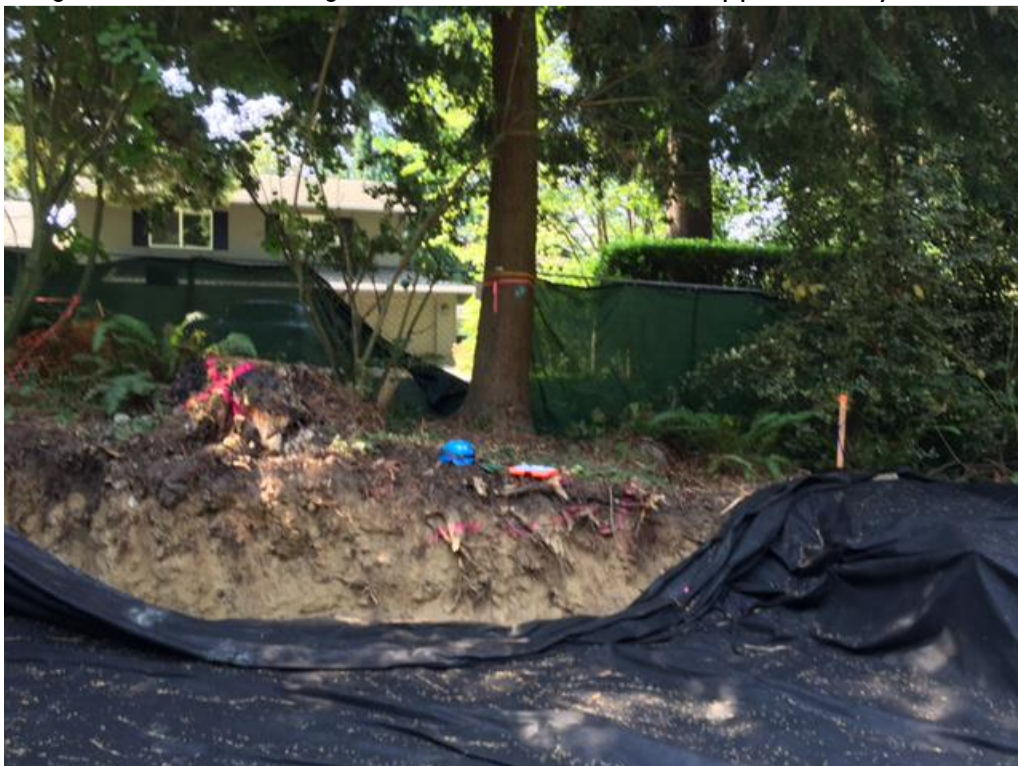
Tree #8251 is a western hemlock with a DBH of 21.2 inches and a height of 84 feet. This tree shows good vigor with a high live crown ratio and a slight lean to south. An infiltration drainage system is installed to the north, and a natural gas line will be installed just outside the dripline 17 feet to the west. The arborist report from 2018 described approximately eight 2-4 inch diameter roots damaged by an excavator eight feet north of its trunk. Some yard waste debris is piled at the base, and some construction materials are piled to the north just outside of the dripline. There is no tree protection fencing between this tree and the construction zone. There is potential for decay originating from the root cuts in 2018 to enter the trunk of the tree. It is possible that this tree could become structurally unstable in the future due to this root disturbance.

Image from 2018 showing Tree #8251 with roots torn approximately 8' north of the trunk.

Further excavation is necessary to install the gas line north of tree #8251. This excavation should not encroach within 15 feet of the trunk. If it is not possible to maintain at least a 15 foot area of undisturbed soil in each direction of the trunk the tree is likely to be severely impacted. Violating this limit of disturbance would likely create a structurally unstable tree that would not have a long useful life expectancy in that location.

- Follow all tree protection measures outlined in the arborist report from 2018.
- Tree protection fencing should be installed at the dripline of tree #8251. No further excavation or storage of materials should take place within the fenced area.
- Trees on the property should be reassessed if changes in condition or structure occur.

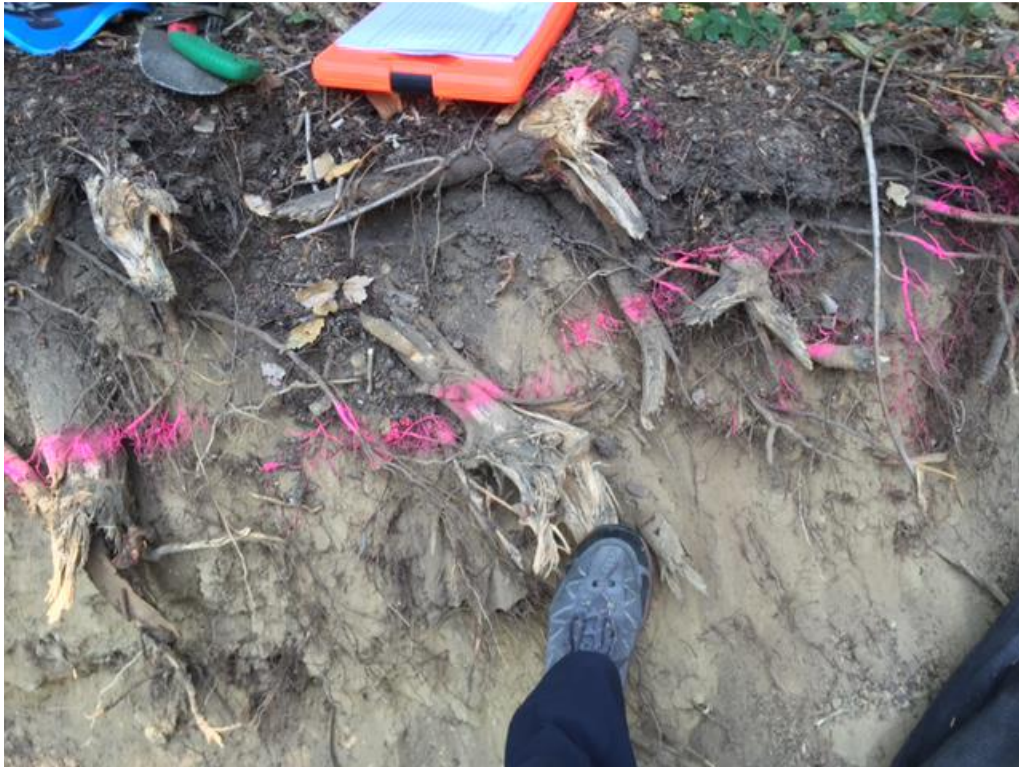
Closer view of torn roots of Tree #8251 in 2018

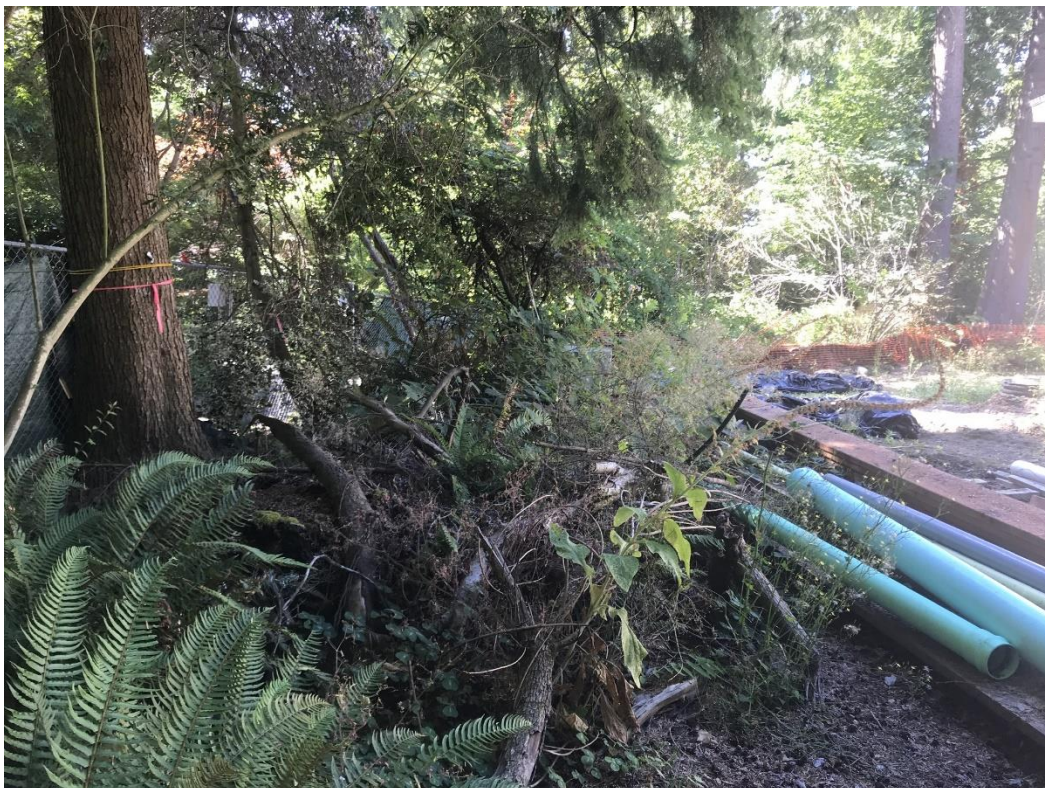
Trunk of Tree #8251 viewed from the east in 2020

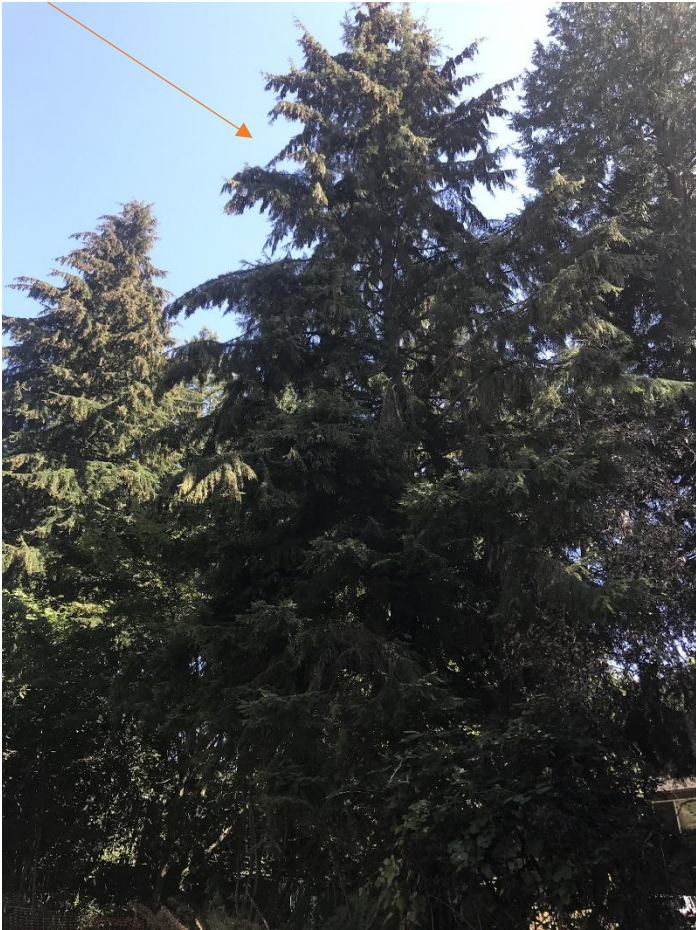
Crown of Tree #8251 viewed from the north in 2020

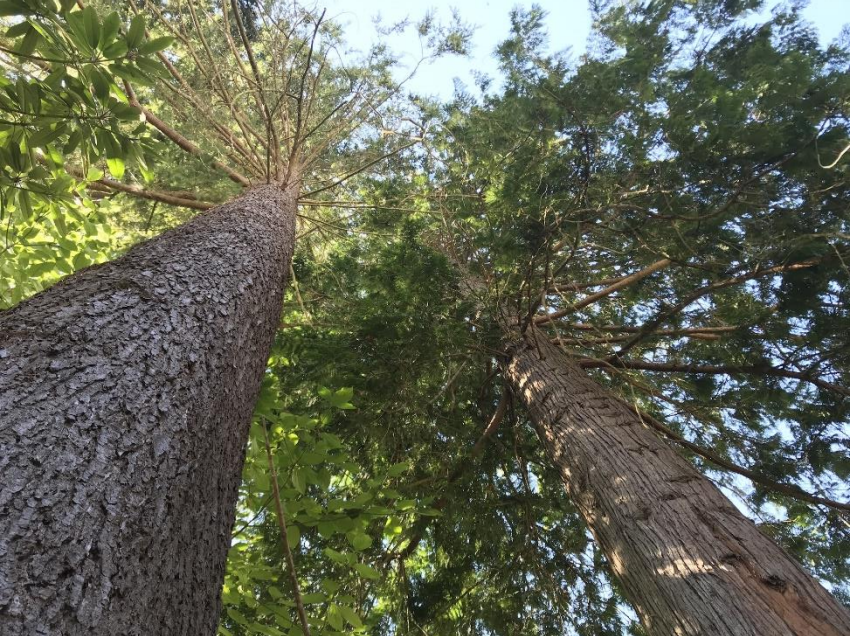
Tree #8410 is a western hemlock with a 35 inch DBH and an overall height of 100 feet. Tree protection fencing is in place 13 feet to the east of its trunk. It shows healthy vigor with good foliage color and a full crown.

Shared canopy of #8409 (right) and #8410 (left)

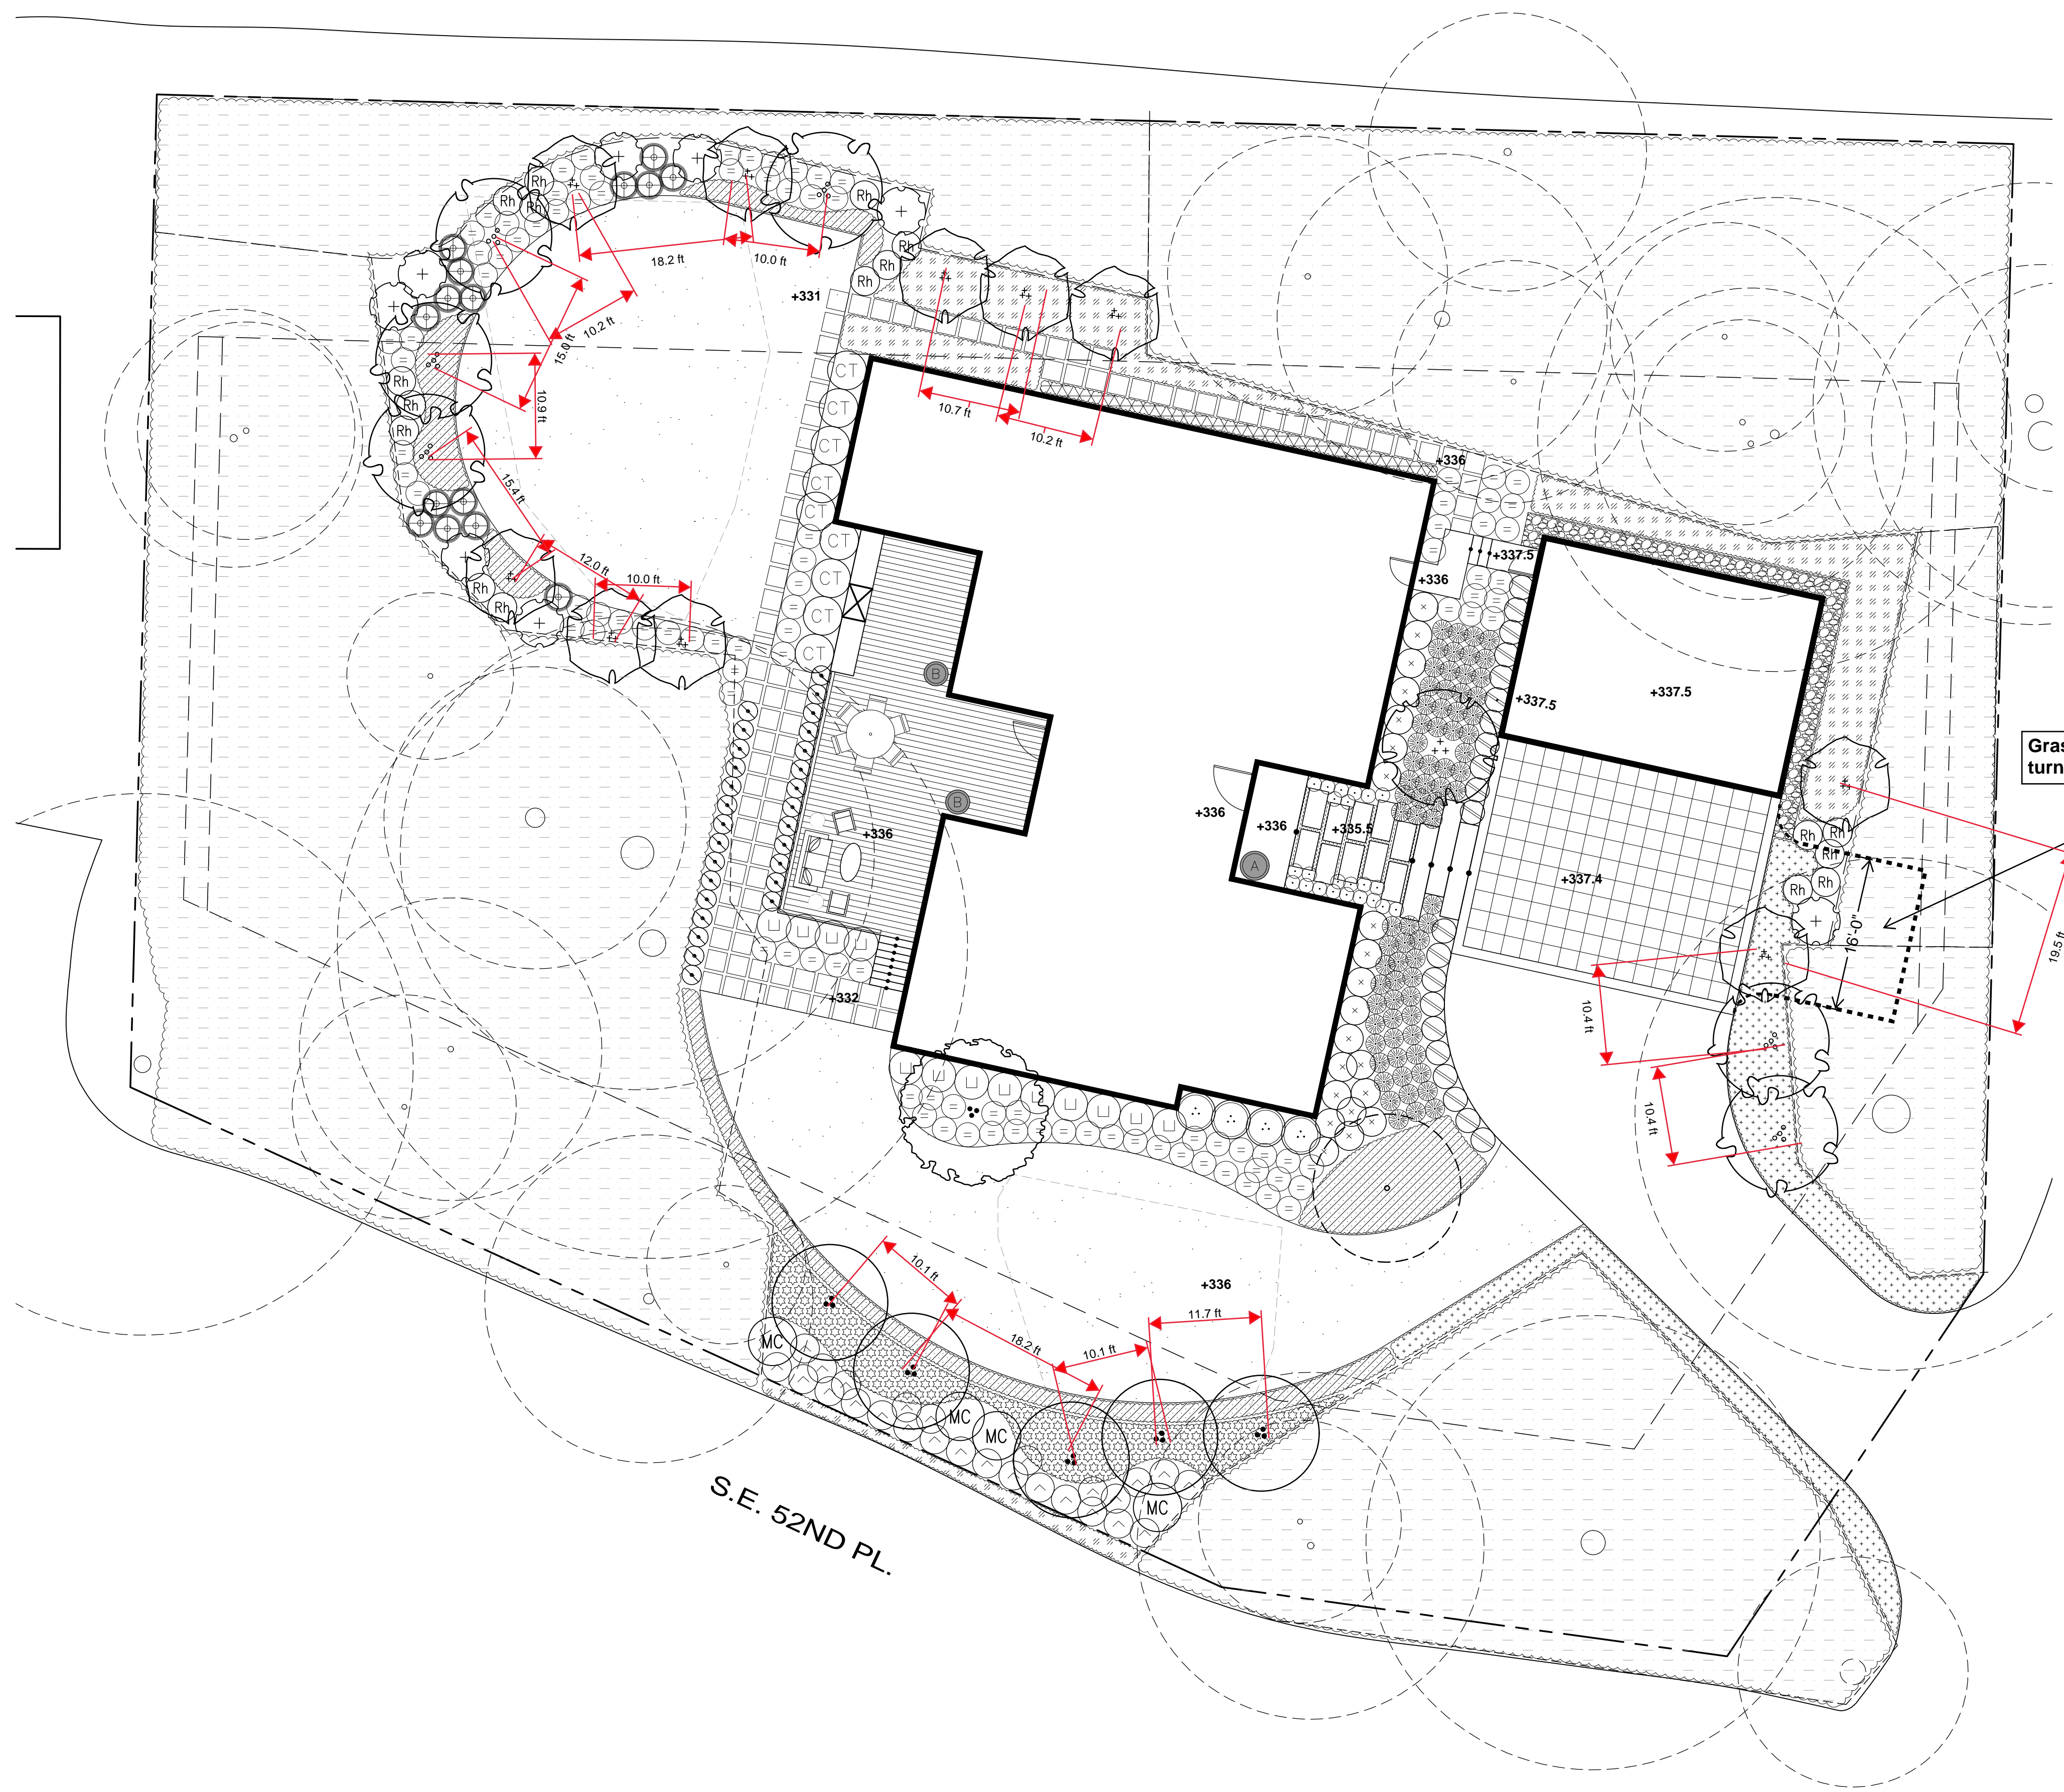
1 PLANTING PLAN
SCALE: 1"=10'-0"

I evaluated the planting plan to determine if it met the requirements of MICC 19.10.070 Tree Replacement obligation of 22 native trees. The plan specifies eight vine maple, six Amelanchier and five hybrid dogwoods all at least 1.5 inch caliper spaced at least 10 feet on center. The planting plan also includes 65 native shrubs which replace trees at a 6:1 ratio and 115 native groundcover ferns which replace trees at a 12:1 ratio. This planting specification is equivalent to 39 replacement trees.
