**PRUNING AND MANAGEMENT PLAN
FOR
TWO HORNBEAMS**

**At:
9224 SE 60th Street
Mercer Island, WA 98040**

June 9, 2020

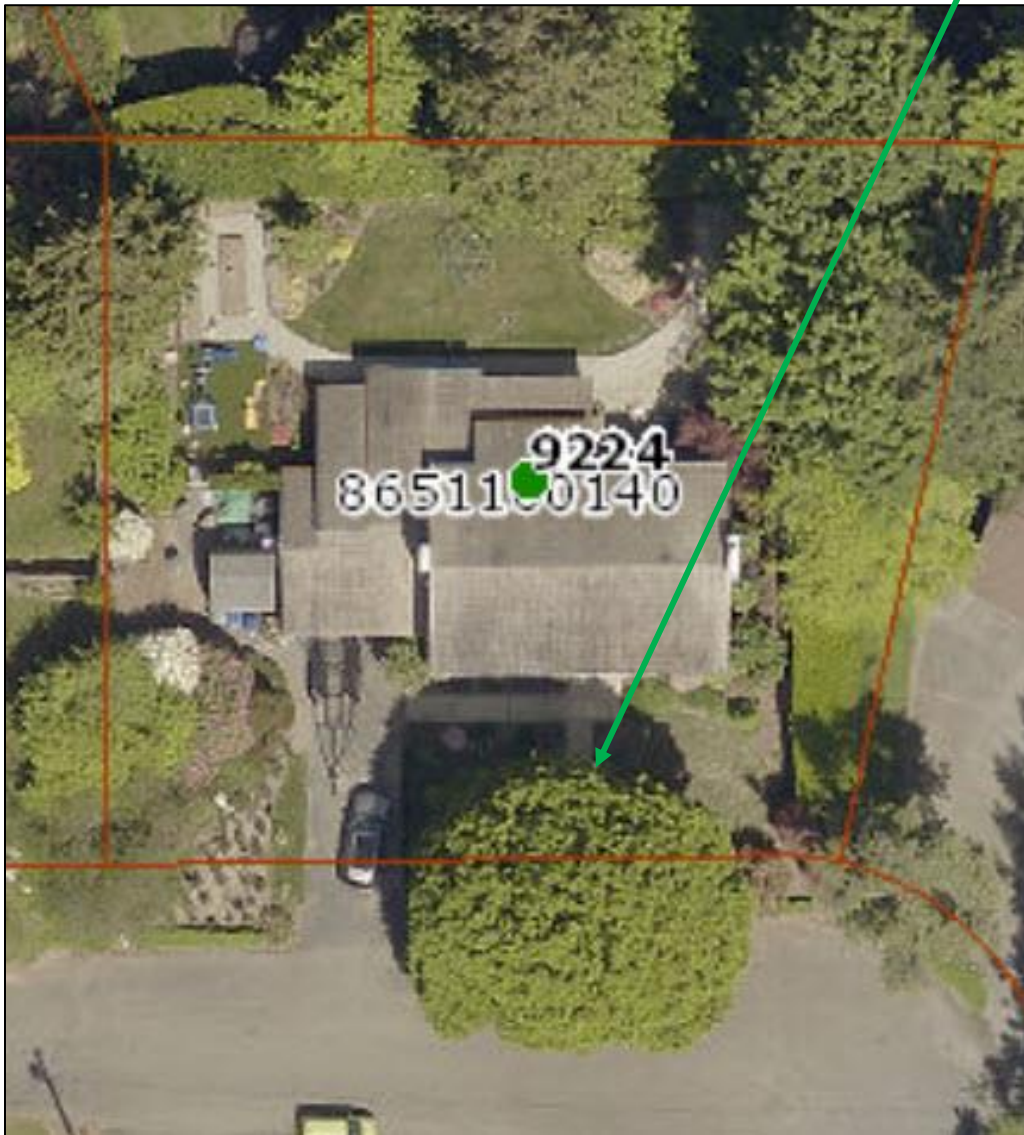
Photo # 1: A 2019 aerial photo taken from the King County Assessor's website. The two trees are these. Note how the canopies look like one tree. They also act as a single unit.

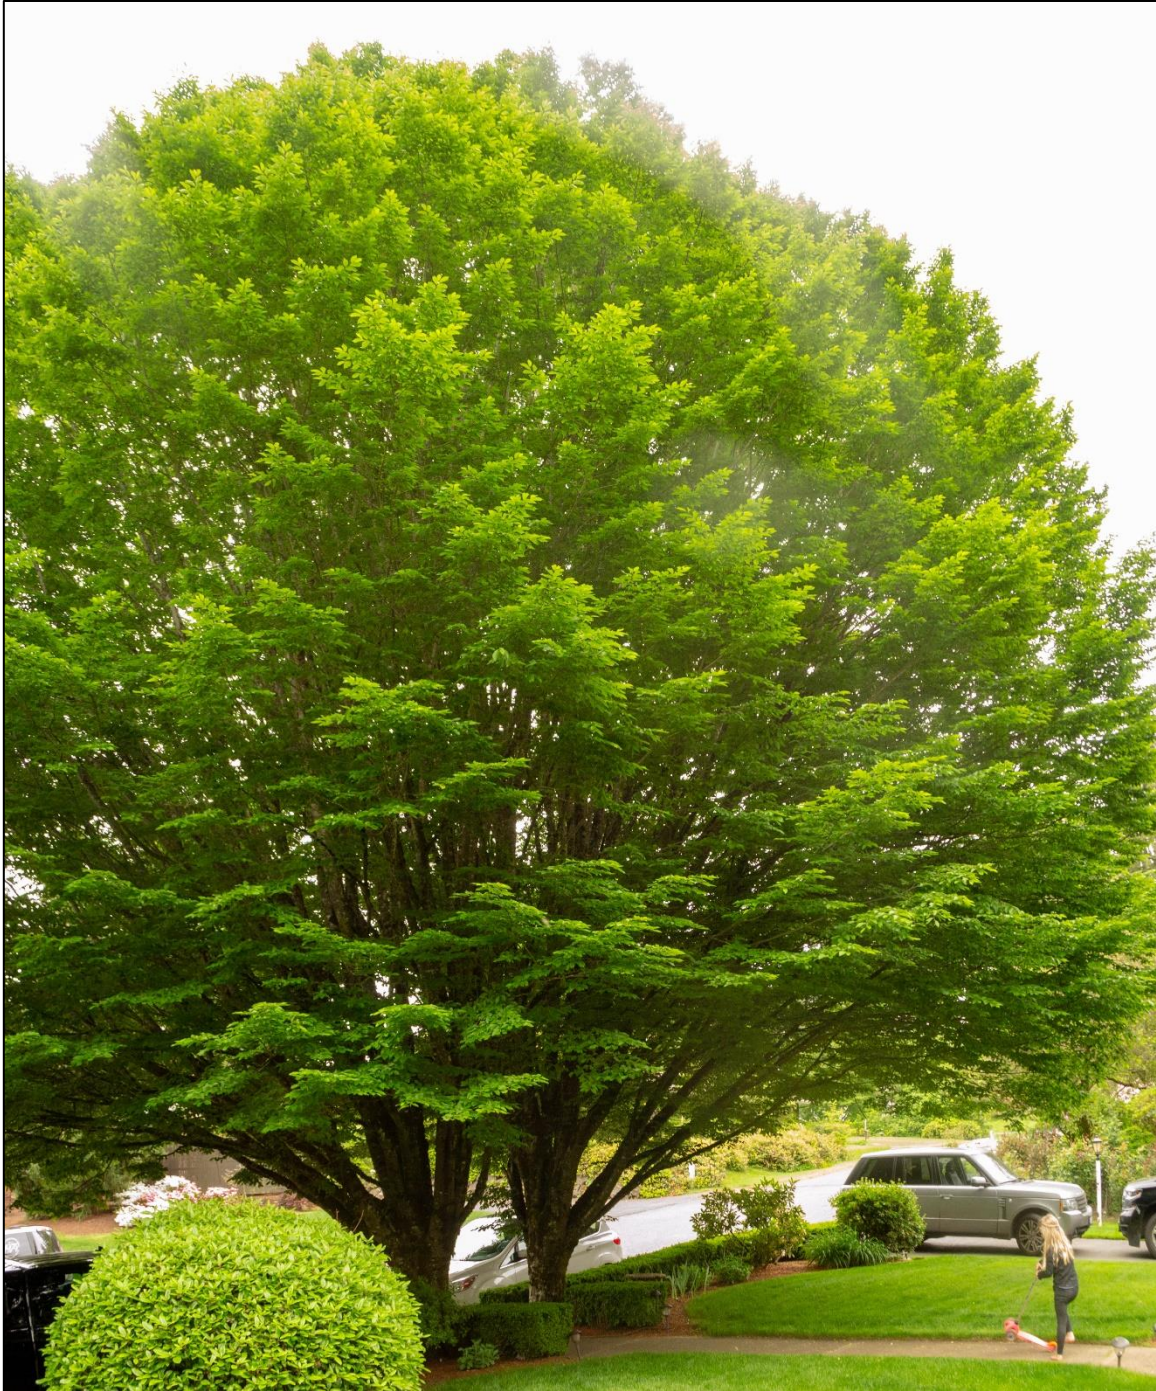
Photo # 2: A panoramic photo of the two trees from the front yard looking to the southwest.

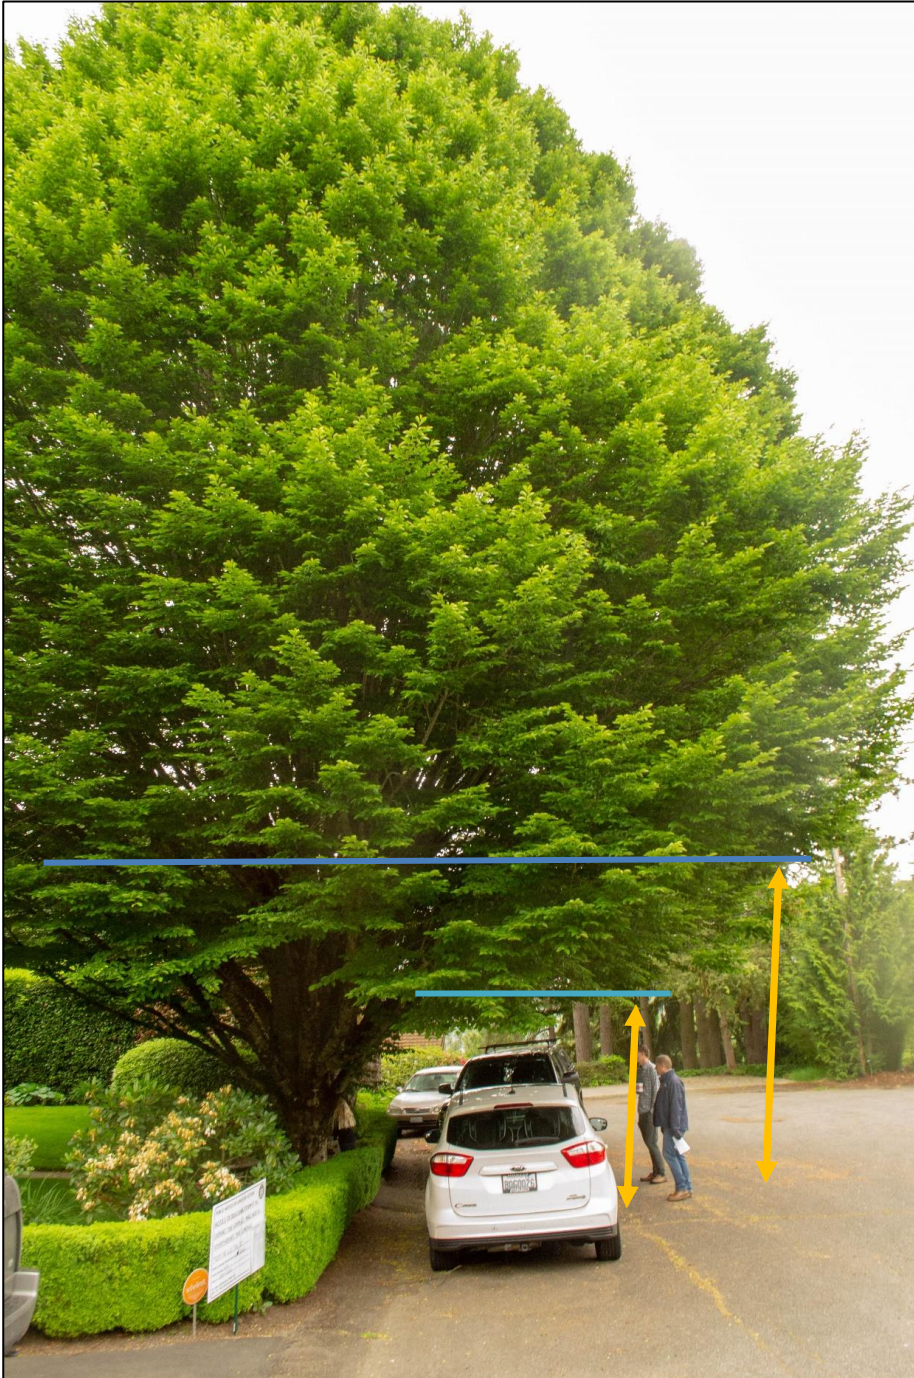
Photo # 3: Looking east from the road at the two trees. The canopy is currently 8 feet above the roadway. It should be properly pruned to be 12 to 14 feet above the driveway.

Currently 8'

- e. The canopies should be pruned up to 12 feet above the road surface.
 - i. If proper pruning techniques mean the pruning cuts would raise the canopy to 14 feet above the road surface, this is acceptable based upon the decision of the Certified Arborist.

Prune to 12' – 14'
