ARBOR INFO LLC

**Tree Assessment
For
Medved Residence
At
4752 89th Ave SE
Mercer Island, Washington**

**Date
8/21//2020**

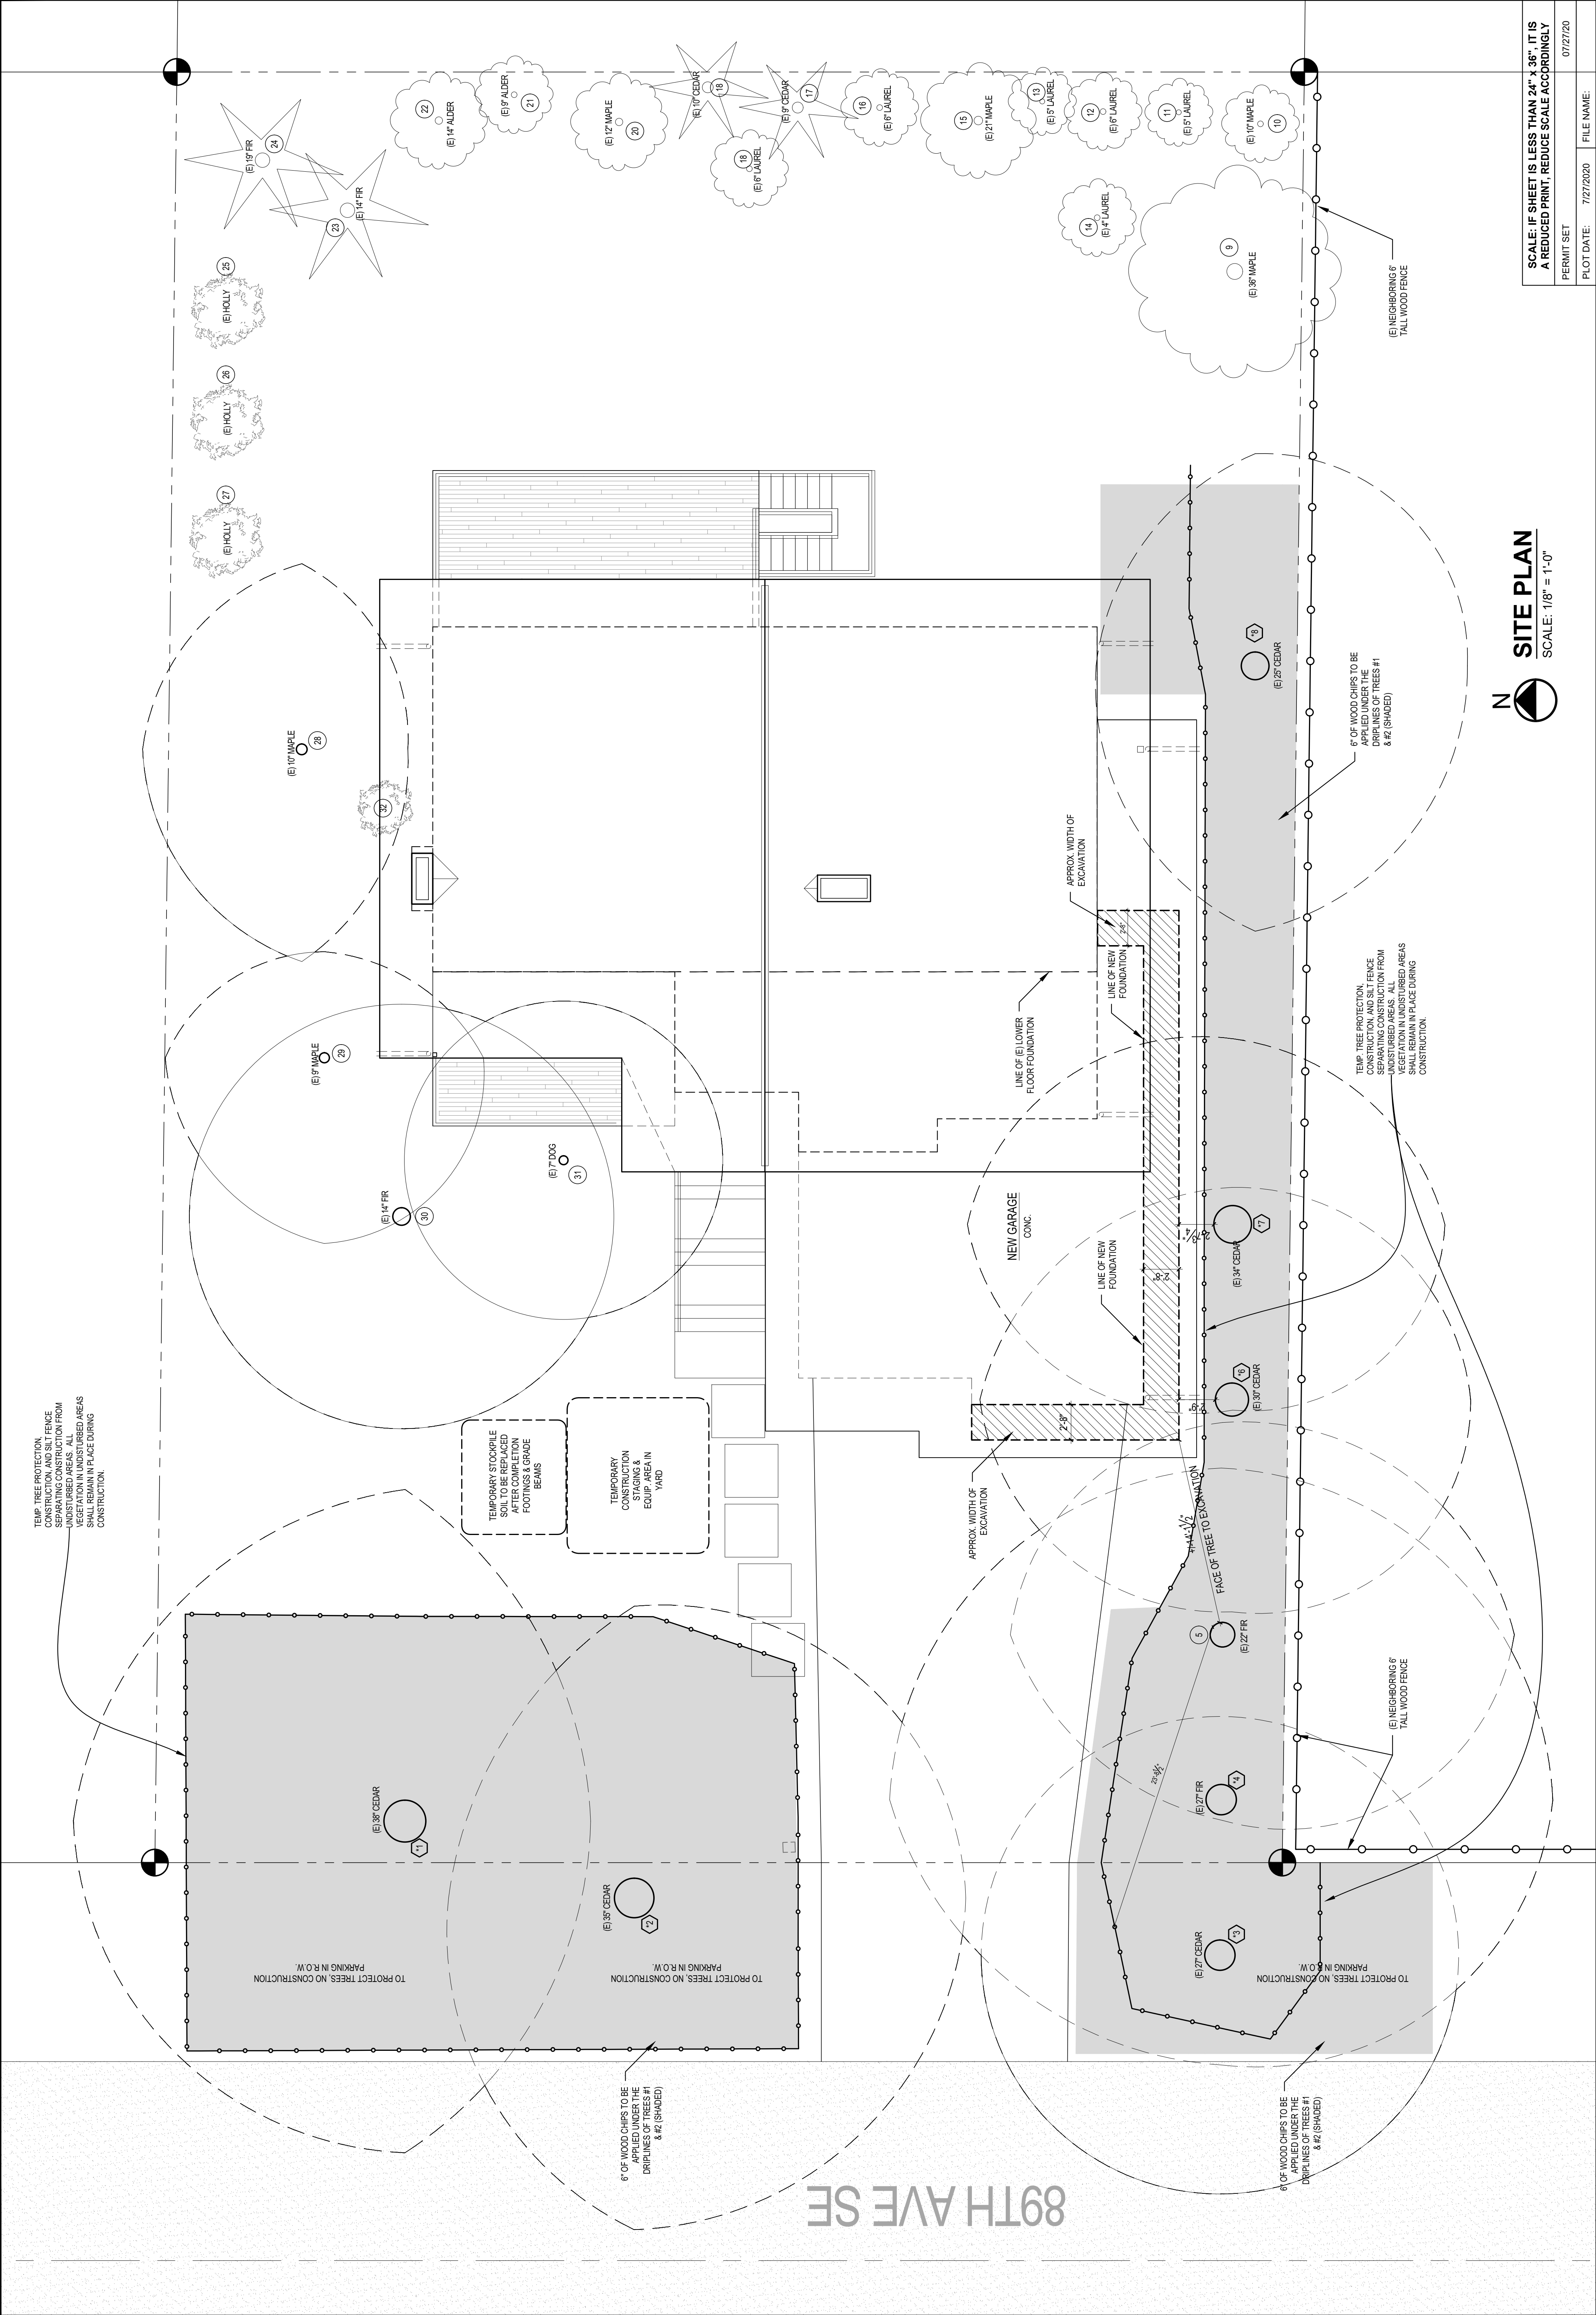
Trees 6,7 and 31 will be removed. Tree 31 is a non-exceptional tree and is not required to be replaced. (MICC19.10.070). Trees potentially affected by construction are Nos. 5 and 8.

The limits of disturbance are determined on a case by case basis for each tree in consideration of the tree size, estimate of the extent of the root zone and consideration of the planned root zone disturbance. Distances from the face of each tree to the excavation limit were provided by the client. There appears to be little or not impact to the retained trees.

<u>Diameter</u>	<u>Facing Dripline</u>	<u>Measured Distance to Excavation Limit</u>	<u>Excavation Type</u>	<u>Root Zone impact</u>
5	Douglas-fir	22.3	16,	15'	Footing	None
8	W. red cedar	25.1	12'	4'	Footing	~20%

Mercer Island Code does not specify root zone protection areas. The encroachments projected for trees 5 and 8 are within the general tolerances for trees and it can be expected that these will remain viable.

- Certified Arborist on site during excavation activities within the defined root zone of all trees.
- All trees to be retained are to be fenced at the edge of the recommended tree protection zone with 6-foot high cyclone type fencing.

- Utility lines should be bored. Bore access pits to be developed with 18” buckets or hand dug.
- Retaining wall footings to be minimally deep, no more than 12-inches.

- Tree roots over 1-1/2 inches in diameter encountered in all excavations are to be cut cleanly to the trench wall with clean sharp tools. Roots to be covered with soil or wetted burlap if they must remain exposed.

- Supplemental irrigation is to be provided during summer months (generally June-September) for all trees in the construction zones.
- Recommended protected tree root zones are to be covered with 4-inches of hog fuel at all times. Where machinery access is needed, the root zones should be covered with 12-inches of hog fuel, plywood or steel sheets.
