Title: Rudolf Property Development
ISA Level 2 Basic Tree Risk Assessment
8253 West Mercer Way
Mercer Island, Washington

Prepared by: Urban Forestry Service, Inc.
Anna Heckman
ISA Board Certified Master Arborist® #PN-6153B
ISA Tree Risk Assessment Qualified

Date: September 18, 2018

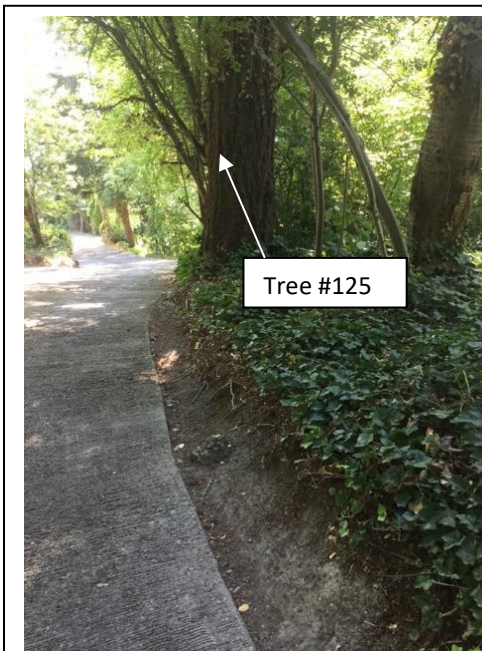
Photo 3. This is the neighboring Driveway to the south and graded cut slope potentially impacting roots.

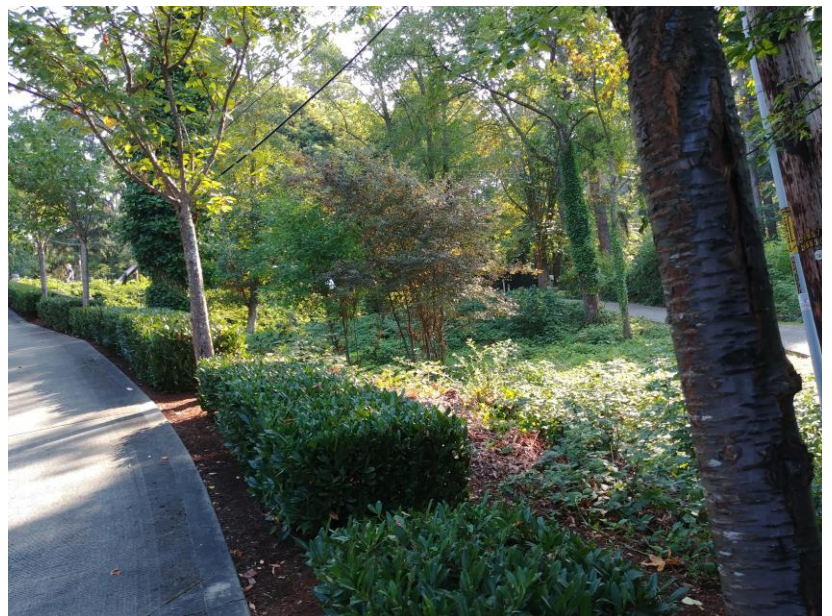
Photo 4. These are flowering cherry trees along the North property edge. Trees on top the wall only require branch protection, others will require root protection as well.

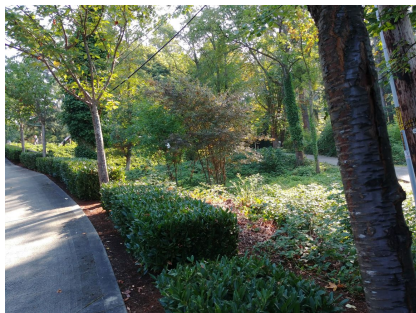
Tree	Species	DBH (in)	Dripline (ft)	CRZ (ft)	Vigor	Structure	Risk	Prot.Cat./Pres.Val.	Recommendations
130	Kwanzan cherry <i>Prunus serrulata</i> 'Kwanzan'	6, (6)	4.0	6.0	Fair	Fair to Good	Low	Medium	Crown Reduction Prune Install Tree Protection Fencing Monitor Tree, Construction Impacts
Notes / Defects	4 cherries on adjacent property west of wall and tree # 104. 3 have canopy and root systems overhanging property to be developed. 4.5, 5.5, 6.0" DBH Trees may be removed and replaced due to size. Laurel hedge will also have root impacts.

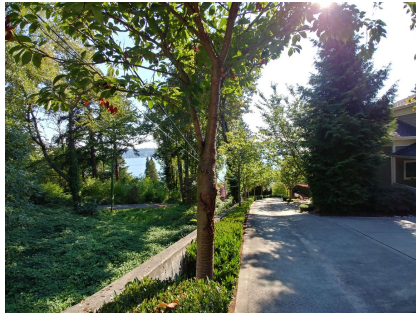
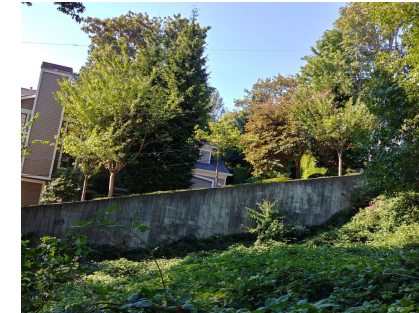
Tree	Species	DBH (in)	Dripline (ft)	CRZ (ft)	Vigor	Structure	Risk	Prot.Cat./Pres.Val.	Recommendations
131	Kwanzan cherry <i>Prunus serrulata</i> 'Kwanzan'	6, (6)		6.0	Fair	Fair	Low	Medium	Crown Reduction Prune Install Tree Protection Fencing Monitor Tree, Construction Impacts
Notes / Defects	3 trees on top of wall, canopy overhang. can be replaced if needed due to small size

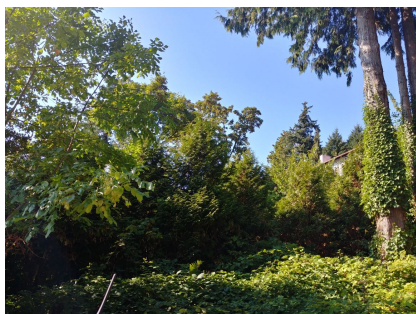
Tree	Species	DBH (in)	Dripline (ft)	CRZ (ft)	Vigor	Structure	Risk	Prot.Cat./Pres.Val.	Recommendations
132	Arborvitae <i>Thuja occidentalis</i>	4, (4)	4.0	4.0	Fair	Fair	Low	Low	Install Tree Protection Fencing Monitor Tree, Construction Impacts
Notes / Defects	20 tightly spaced arborvitae along property edge. Many on adjacent property. The north east end of row begins at tree 110. Hedge is overgrown. Trees can be thinned and protected or Hedge can be removed and replace.
