Background and History

Lucia Pirzio-Biroli of Studio Ectypos Architecture contacted me and asked that I prepare an arborists report for the trees located at 4207 West Mercer Way, Mercer Island WA. She was representing her client Rahul Shinde, the owner of the subject property.

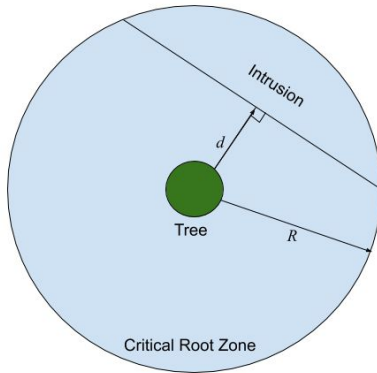
Tree Protection Zone intrusions were based on a one sided reduction in the size of the overall TPZ. % TPZ intrusion is shown as a percentage of the whole. These calculations are based on the chart in **Appendix 2: TPZ Intrusion Measurements**. The minimum distance to disturbance measurements listed correspond to the d value in the image to the right. R corresponds to the TPZ radius.
