Re: 4207 W. Mercer Way New Single Family Residence - removal of ROW trees

Background and History

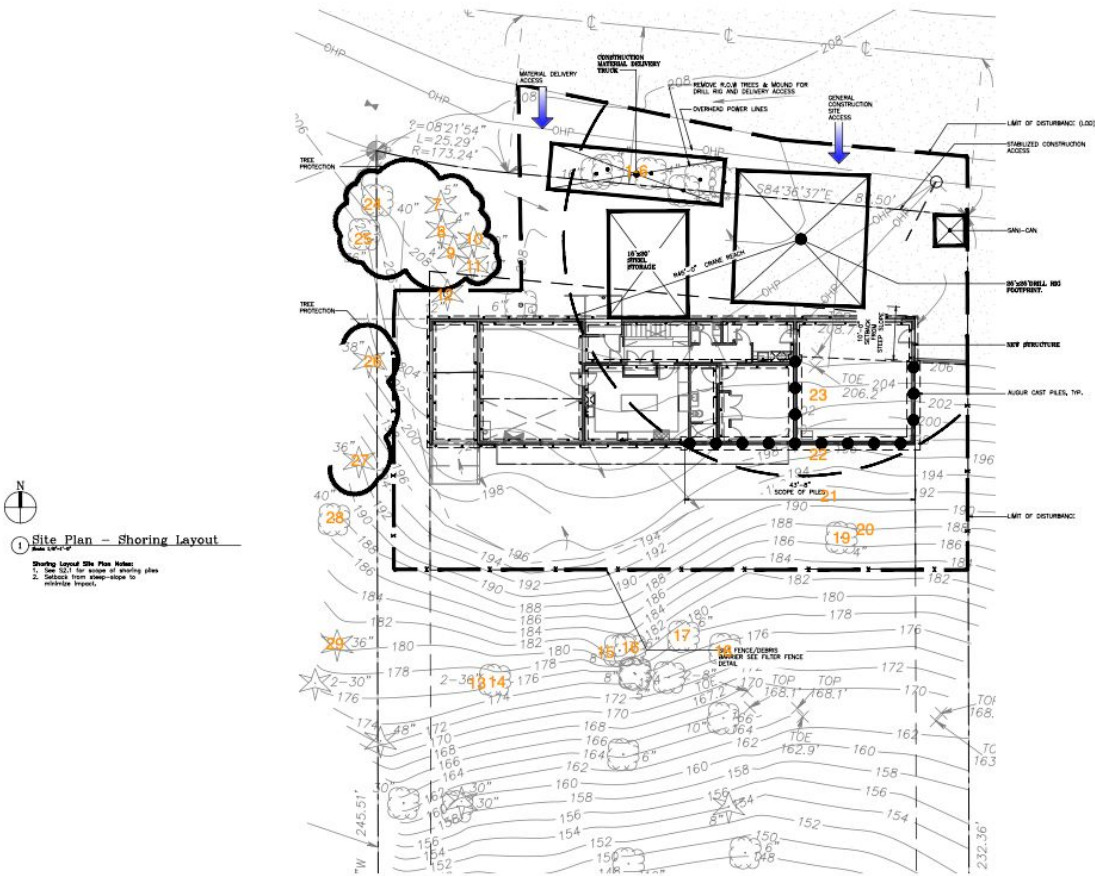
Appendix 1: Site Map with tree numbers (please note TPZs have been modified on final plans, this map is only for tree locations)

I am recommending removal of the city owned European birch trees (*Betula pendula*, #1-6) for several reasons. The first is that this is an inappropriate species to be located under utility lines. Several of the trees have been severely topped and are showing poor structure and vigor because of repeated utility clearance pruning. The larger trees have been forced to grow exclusively over the client's property with a significant lean. Additionally I noted the symptoms of bronze birch borer infestation in several of the taller trees. This insect has been causing widespread damage to the species and has led to doubts about the long term viability of the species in the region. Based on their inappropriate location as well as the insect infestation I recommend that this entire group of trees be removed and replaced with a species more appropriate to growth under utility wires. I do not anticipate a significant impact to the remaining trees from the removal of this group.

I recommend that four replacement trees be located on the critical slope downhill of the house and two be located on the public right of way. The trees located on the critical slope are to be native trees reflecting the makeup of the surrounding stand. This includes **two bigleaf maple (*Acer macrophyllum*)** and **two Douglas fir (*Pseudotsuga menziesii*)** meeting the size criteria listed above. I recommend a low-growing tree for the area under the utility lines on the ROW. **Two pacific yew (*Taxus brevifolia*)** are recommended, additional yew specimens may be planted in the ROW to create a privacy screen. These recommendations are meant only to reflect the minimum requirements, additional planting on the critical slope or within the ROW may also be performed.
