# Earth Solutions NW LLC

## DAILY FIELD REPORT

| Project Name<br>Foo SFR | Job Location<br>3453 74 <sup>th</sup> Ave SE, Mercer Island | Client/Owner<br>JayMarc Homes, LLC | |

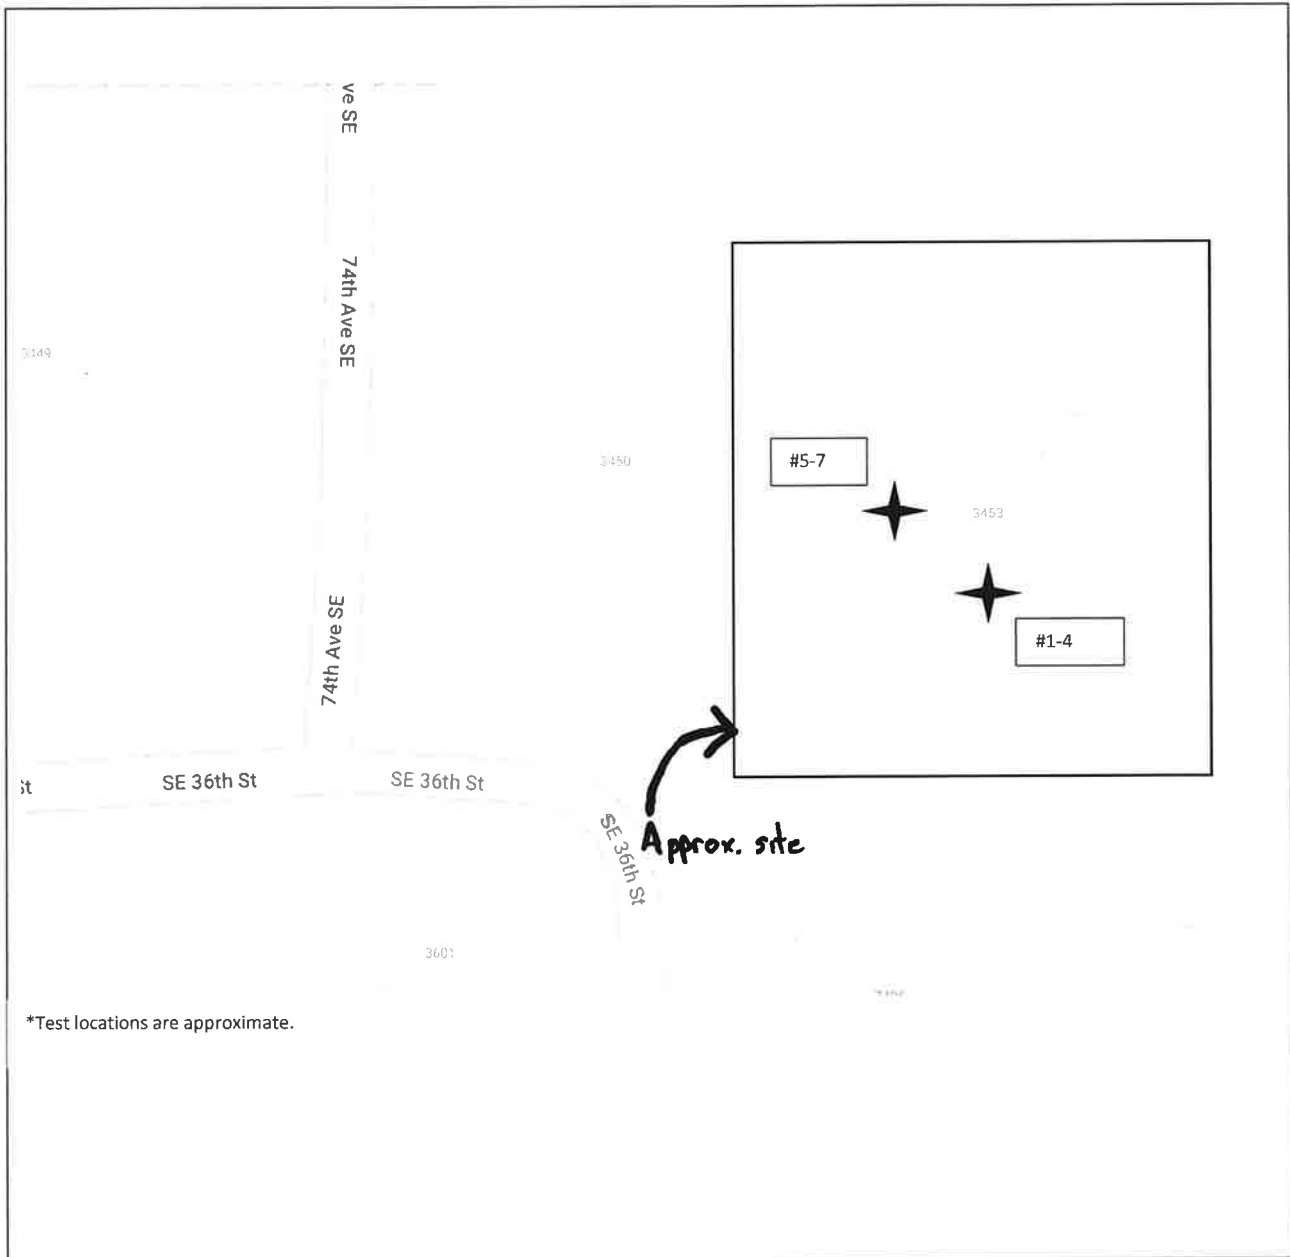
| Test Number | Test Location (See Map) | Elevation | Reference Compaction Curve | Maximum Dry Density (pcf) | Fill Moisture (%) | Test Dry Density (pcf) | % of Maximum Dry Density |
|---|---|---|---|---|---|---|---|
| 1 | Removed tank Backfill (pg. 2) | -3' | 1 | 134.2 | 9.2 | 126.8 | 95 |
| 5 | Removed Pool Backfill (pg. 2) | -2' | 1 | 134.2 | 9.6 | 127.3 | 95 |

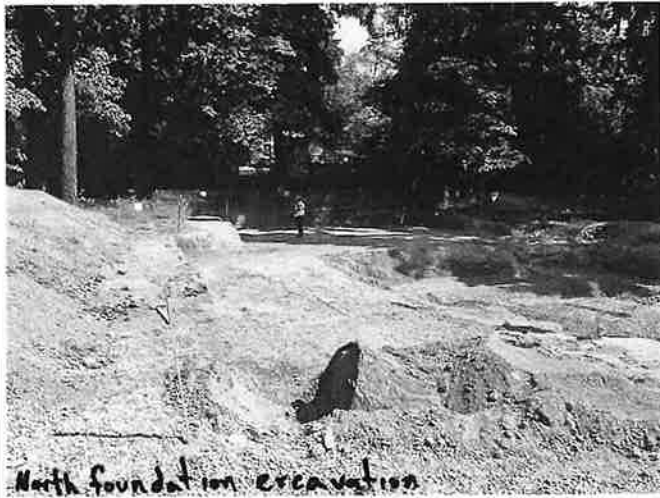
ESNW rep observed the contractor had partially excavated to soil subgrade for a single-family residence foundation. ESNW rep used a half-inch diameter steel T-probe to probe locations of the foundation. ESNW rep observed dense soil conditions, considered suitable for the allowable soil bearing of 3,000 psf.

North foundation excavation

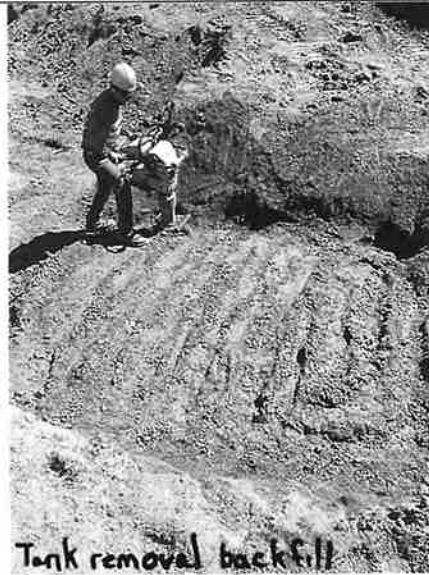
While onsite, ESNW rep observed the contractor had removed a tank and a buried swimming pool uncovered during foundation excavation. The contractor backfilled the excavations with native silty gravel with sand. The contractor placed the material in approximate 6-8-inch loose lifts and compacted each lift with a jumping jack to a firm and unyielding state. Compaction tests indicate adequate compaction of 95% at tested locations.

Tank removal backfill

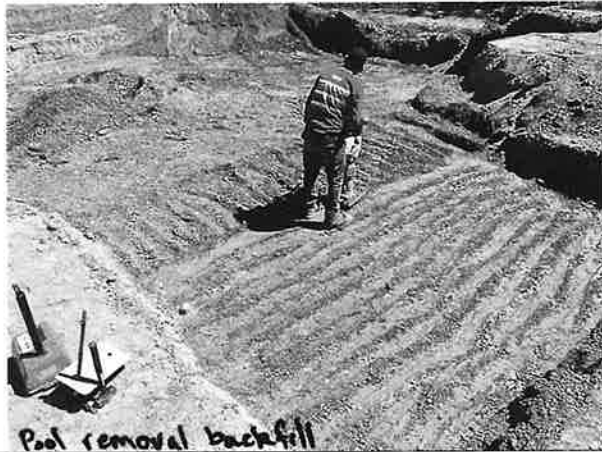
Pool removal backfill

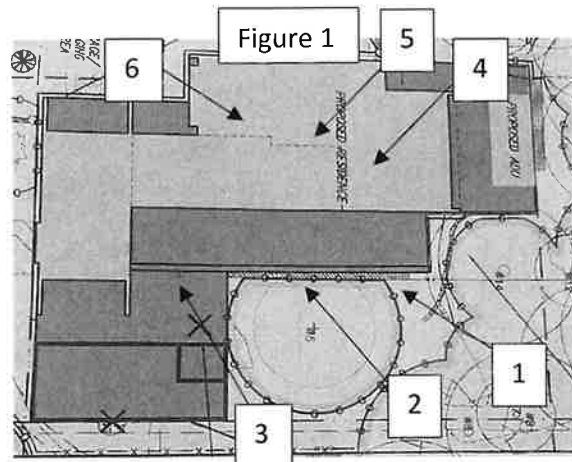
Upon arrival, ESNW rep observed that the contractor placing fill along the exterior of the south footing stem wall and interior footing fill on the north side of the proposed residence. ESNW rep observed the fill being moisture treated and compacted using medium track hoe pack. ESNW rep took compaction tests at the -8' elevations. Density test results indicate adequate compaction of at least 95% at the tested locations. The locations of these tests are approximately shown in Figure 1 below.

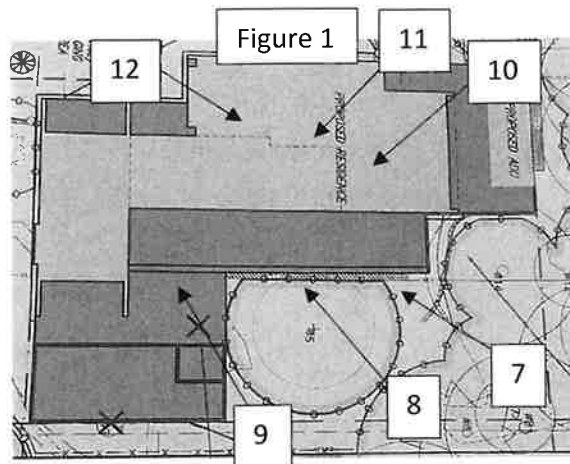
Upon arrival, ESNW rep observed that the contractor placing fill along the exterior of the south footing stem wall and interior footing fill on the north side of the proposed residence. ESNW rep observed the fill being moisture treated and compacted using medium track hoe pack. ESNW rep took compaction tests at the -6' elevations. Density test results indicate adequate compaction of at least 95% at the tested locations. The locations of these tests are approximately shown in Figure 1 below.

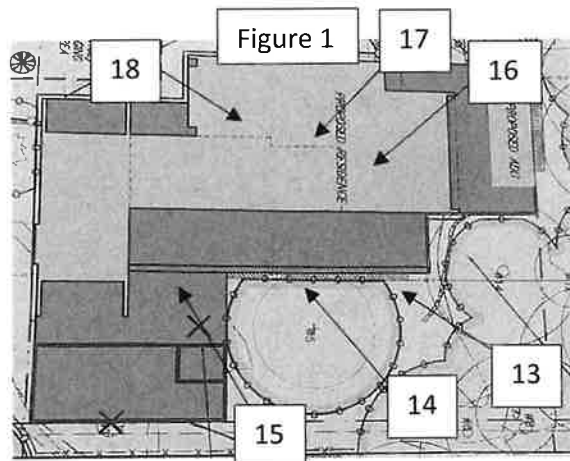
Upon arrival, ESNW rep observed that the contractor placing fill along the exterior of the south footing stem wall and interior footing fill on the north side of the proposed residence. ESNW rep observed the fill being moisture treated and compacted using medium track hoe pack. ESNW rep took compaction tests at the -4' elevations. Density test results indicate adequate compaction of at least 95% at the tested locations. The locations of these tests are approximately shown in Figure 1 below.

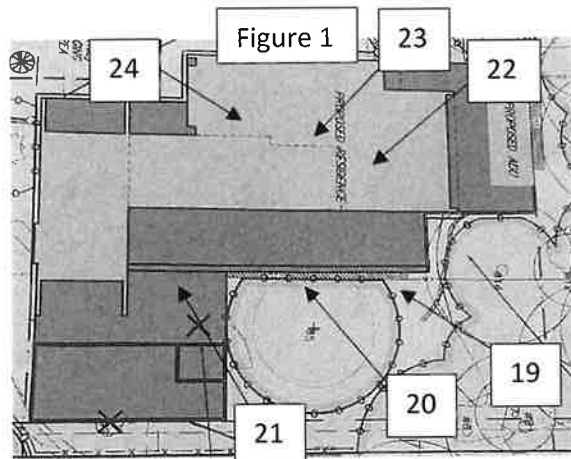
Upon arrival, ESNW rep observed that the contractor placing fill along the exterior of the south footing stem wall and interior footing fill on the north side of the proposed residence. ESNW rep observed the fill being moisture treated and compacted using medium track hoe pack. ESNW rep took compaction tests at the -4' elevations. Density test results indicate adequate compaction of at least 95% at the tested locations. The locations of these tests are approximately shown in Figure 1 below.

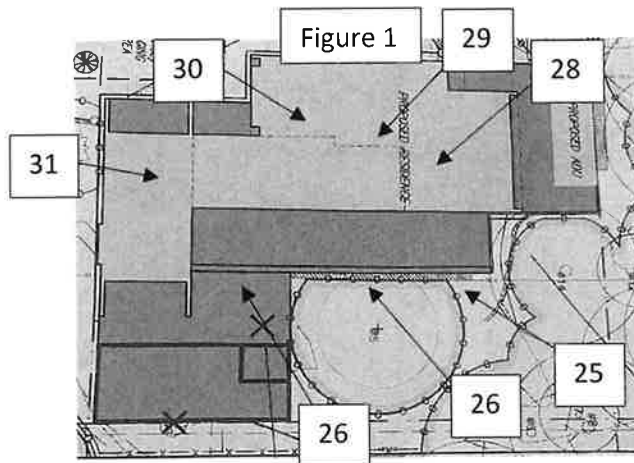
Upon arrival, ESNW rep observed that the contractor placing fill along the exterior of the south footing stem wall, interior footing fills on the north side of the proposed residence, and slab subgrade fill along the west side of the residence. ESNW rep observed the fill being moisture treated and compacted using medium track hoe pack. ESNW rep took compaction tests at the SG elevations. Density test results indicate adequate compaction of at least 95% at the tested locations. The locations of these tests are approximately shown in Figure 1 below. ESNW rep will return when requested.

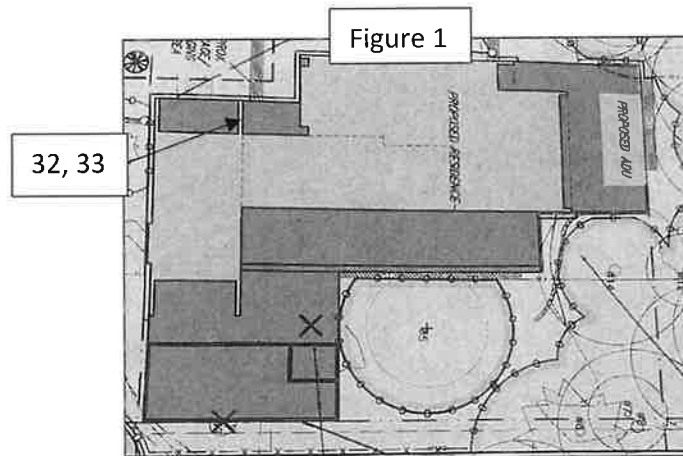
Upon arrival, ESNW rep observed that the contractor placing fill under the secondary pour footing subgrade on the northwest corner of the structure. ESNW rep observed the fill being moisture treated and placed in 1' lifts. ESNW rep observed the fill being compacted using medium track hoe pack. ESNW rep took compaction tests at the -2' and -4' elevations. Density test results indicate adequate compaction of at least 95% at the tested locations. The locations of these tests are approximately shown in Figure 1 below.

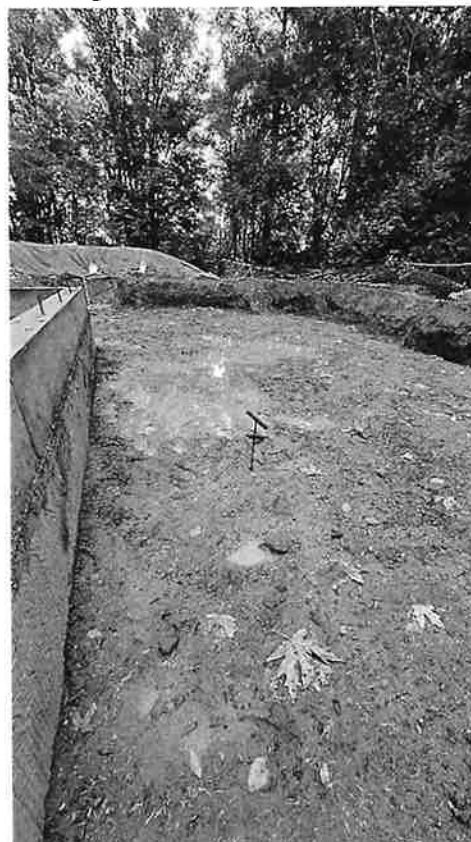
***ESNW rep utilized a 1/2" diameter steel footing probe to probe the newly excavated south footing subgrade(s) and observed moisture rich and loose soils conditions along the entirety of the south perimeter footing subgrades. ESNW rep recommends that the contractor perform the following:***

ESNW rep marked the following locations of recommended over-excavation for the contractor with orange marking paint. Please refer to the attached photo documentation provided below.

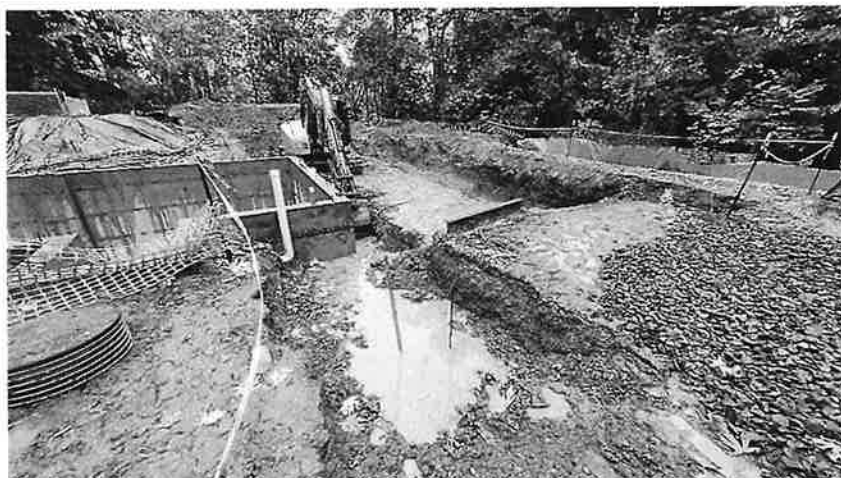
**South Footing Perimeter Subgrade Over-Excavation Observations:**  
 Per client request, ESNW rep arrived onsite within Foo SFR development to observe and document over-excavated footing subgrade along the south footing perimeter. Upon arrival, ESNW rep met with the onsite contractor (Builders Supply) and client rep (Gabe, JayMarc) and observed the contractor had begun the recommended over-excavation of the footing subgrade and stockpiling of clean 2-4" crushed rock backfill material. ESNW rep showed the client rep the areas of soft probing conditions encountered, and recommended that the contractor continue the following over-excavation recommendations:

Following discussion with the client and contractor about loose soils conditions along the existing footing wall (pictured), ESNW rep was informed that following compaction testing of the footing wall backfill along the south footings (please refer to DFR 12, August 2021), the contractor had later removed the footing wall backfill to install footing drains with unknown comp active effort. Due to the present moisture rich and loose soils conditions in addition to the lack of compaction observation, ESNW PM (RAC) recommended that the contractor remove this area of backfill and replace with a minimum of 2' of clean 2-4" crushed rock.

The contractor and client agreed to these recommendations and requested ESNW rep return tomorrow for over-excavation and backfill observation. Please refer to the attached photo documentation provided below.

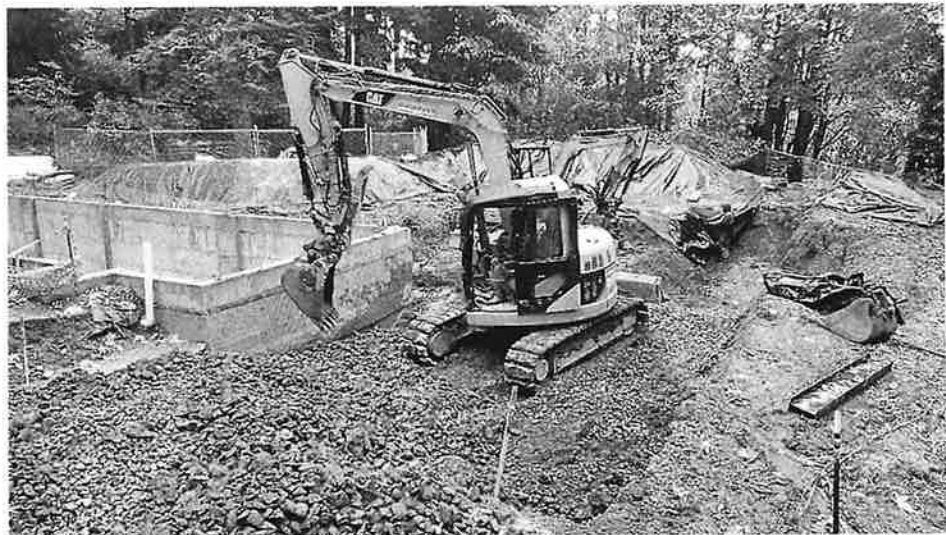
Per client request, ESNW rep arrived onsite within Foo SFR development to observe and document over-excavated footing subgrade along the south footing perimeter. Upon arrival, ESNW rep met with the onsite contractor (Builders Supply) and client rep (Gabe, JayMarc) and observed the contractor was onsite and commencing the previously recommended over-excavation within the footing subgrade. ESNW rep observed the contractor had over-excavated the slab subgrade by approximately 1' and was actively over-excavating the remainder of the footing wall subgrade by a minimum of 2' per recommendation and removing the loose backfill along the existing south footing wall. The contractor was additionally observed to have stockpiled clean 2-4" rock as material for backfill and informed ESNW rep that backfill would be completed by tomorrow afternoon.

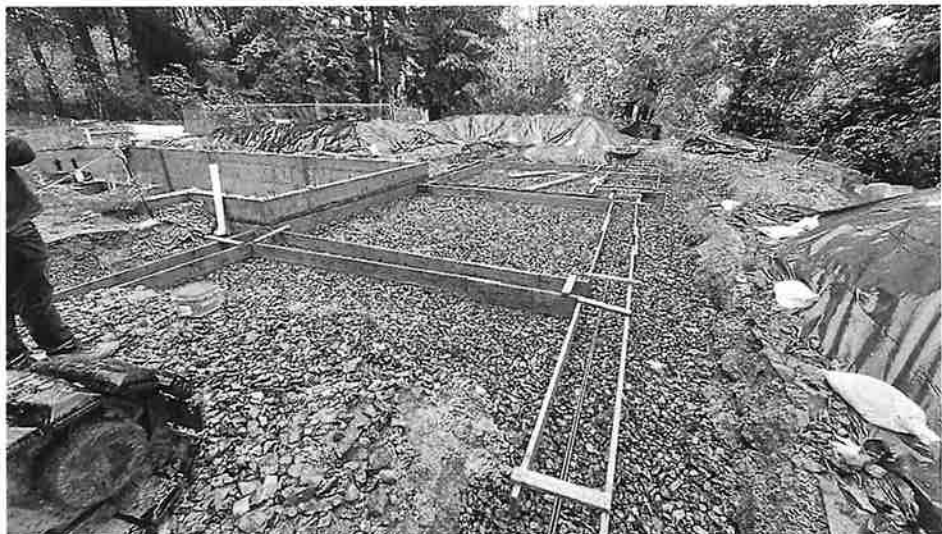
Per client request, ESNW rep arrived onsite within Foo SFR development to observe and document over-excavated footing subgrade along the south footing perimeter. Upon arrival, ESNW rep met with the onsite client rep (Gabe, JayMarc) and observed the contractor had completed backfill of the footing and slab subgrade with the minimum recommended amount of clean 2-4" crushed rock (minimum of 1' below slab subgrade, minimum of 2' below spread footing subgrade). ***These conditions are considered suitable for the support of the proposed structure.***

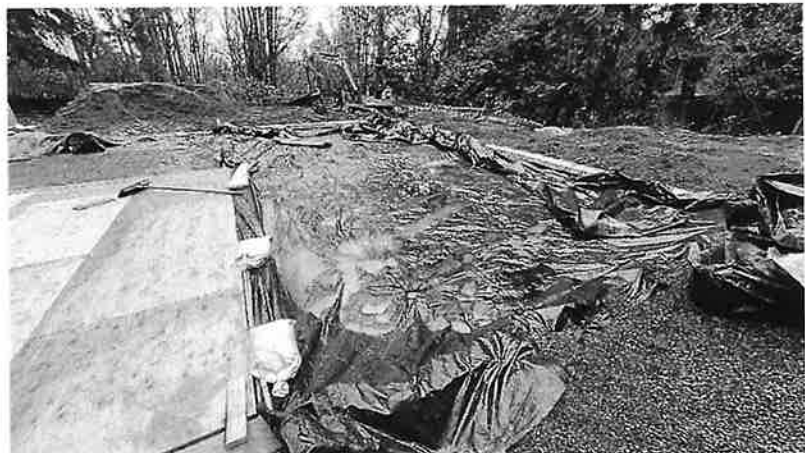
Per client request, ESNW rep arrived onsite within Foo SFR development to observe and probe the prepared subgrade for the interior slab located within the south area of the SFR structure. Upon arrival, ESNW rep met with the onsite contractor (Builders Supply), and observed that the slab subgrade consisted of onsite native soils fill material that had been placed following footing wall construction. ESNW rep utilized a 1/2" diameter steel footing probe to probe the interior slab subgrade and observed loose and over-optimum moisture conditions within the fill, which is not considered suitable for the structure.

ESNW rep recommended that the contractor over-excavate the top 12" of the slab subgrade and backfill with imported clean crushed rock (2-4") to original slab subgrade elevation. The contractor acknowledged this recommendation and agreed to contact ESNW rep once installation is complete for follow up observation.

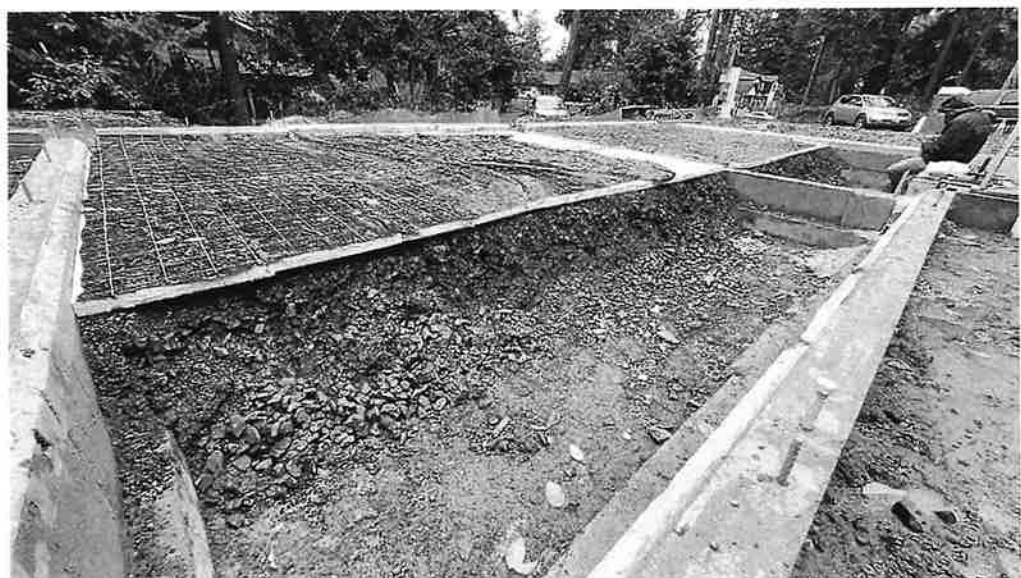
Per client request, ESNW rep arrived onsite within Foo SFR development to observe and document completed slab over-excavation and backfill. While onsite, ESNW rep observed the earthwork contractor was not onsite however had completed the previous subgrade recommendations.

***ESNW rep observed that the contractor had completed the previously recommended approximate 12" over-excavation of the interior slab subgrade and had placed the recommended backfill consisting of clean 2" crushed rock to original slab subgrade elevation. These conditions are considered suitable for the support of the proposed slab.***
