AMERICAN FOREST  
MANAGEMENT

**ARBORIST REPORT**  
**3453 74<sup>th</sup> Ave SE**  
**Mercer Island, WA**

**Updated 1/7/2021**

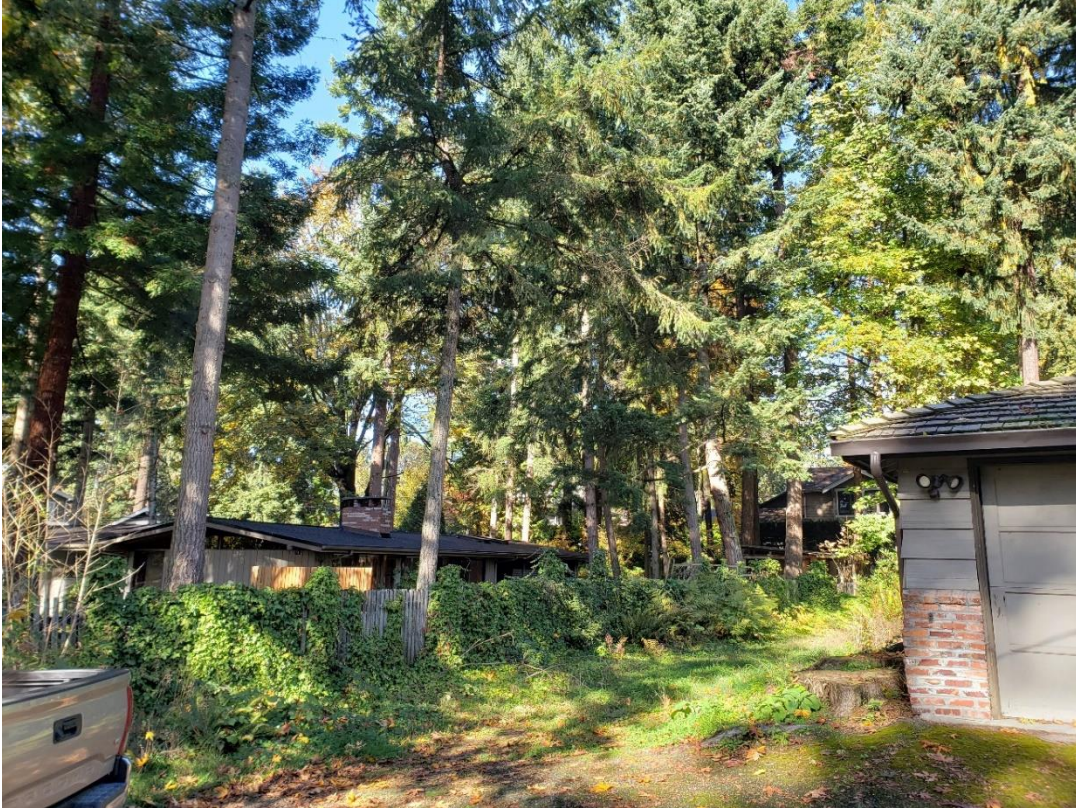
Neighboring trees 104 and 106 located on the parcel west of the subject property should be protected during the construction of the proposed driveway on the west side of the subject property.

Photo 1. Facing north, showing the west property line and neighboring trees. A driveway is proposed for this area.

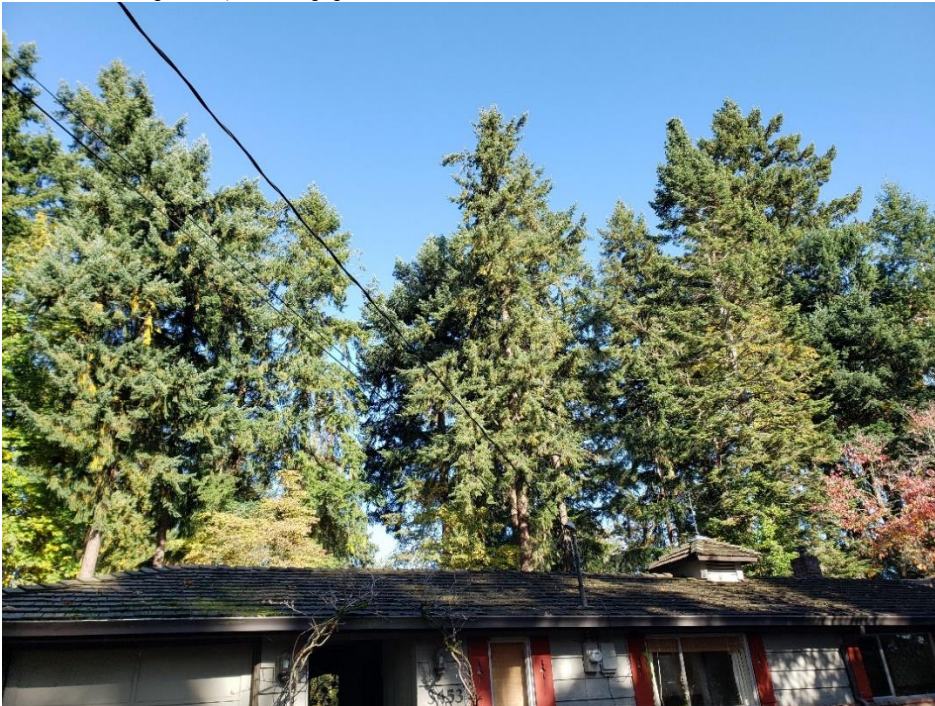
Photo 2. Facing north, showing grove trees located north of the residence.

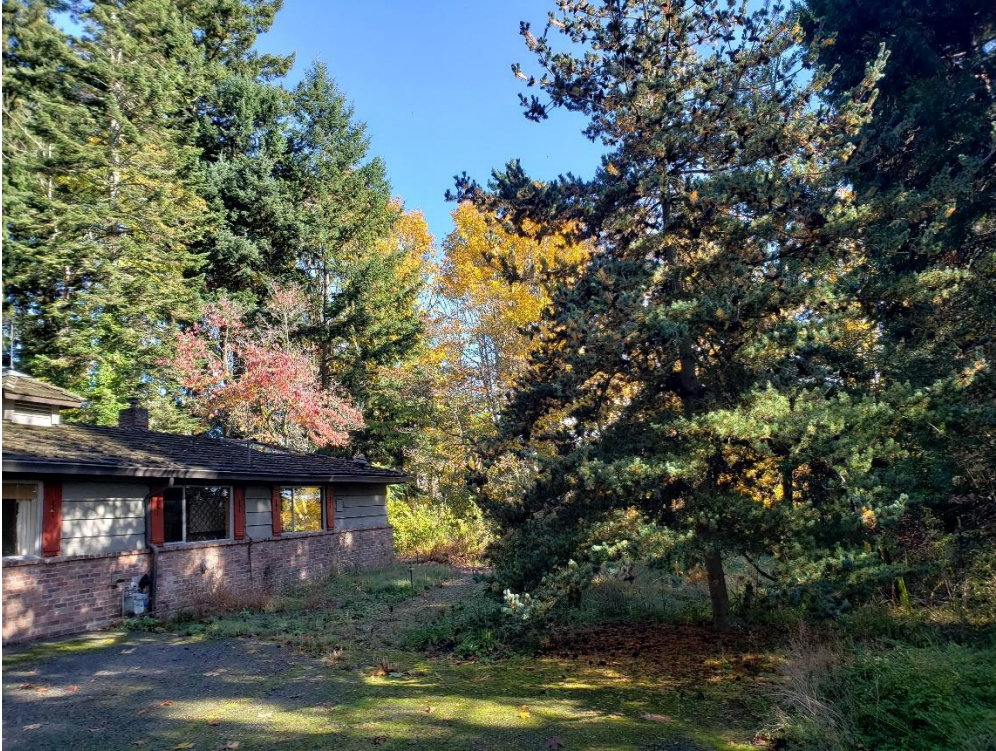
Photo 3. Facing east, showing tree number 1 located south of the residence and adjacent to the property line.

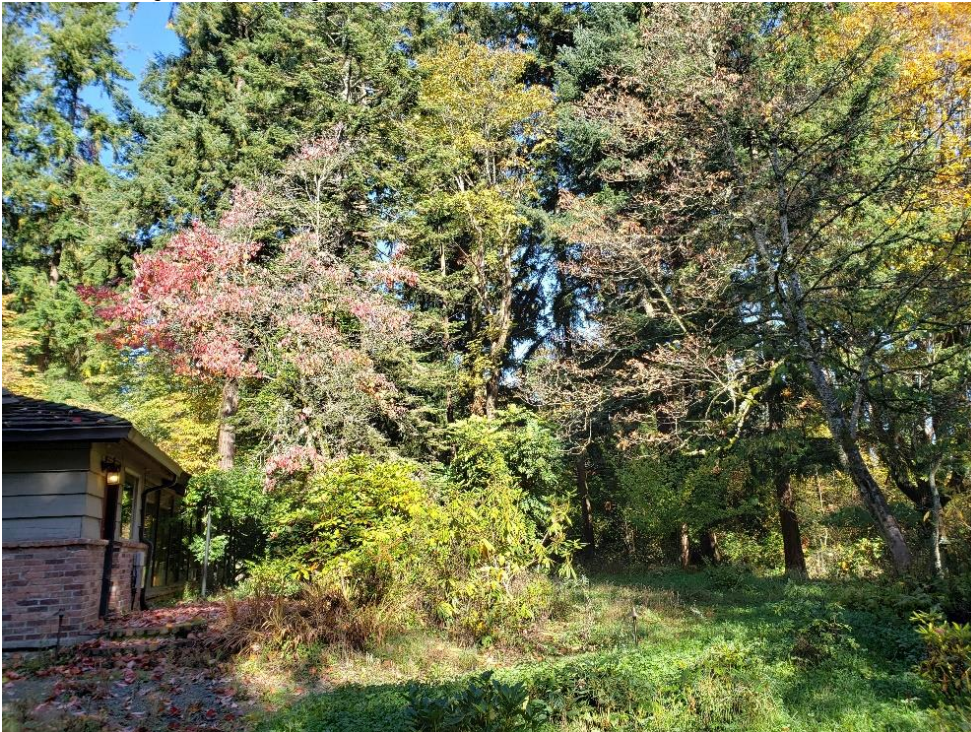
Photo 4. Facing north, showing the area east of the residence.

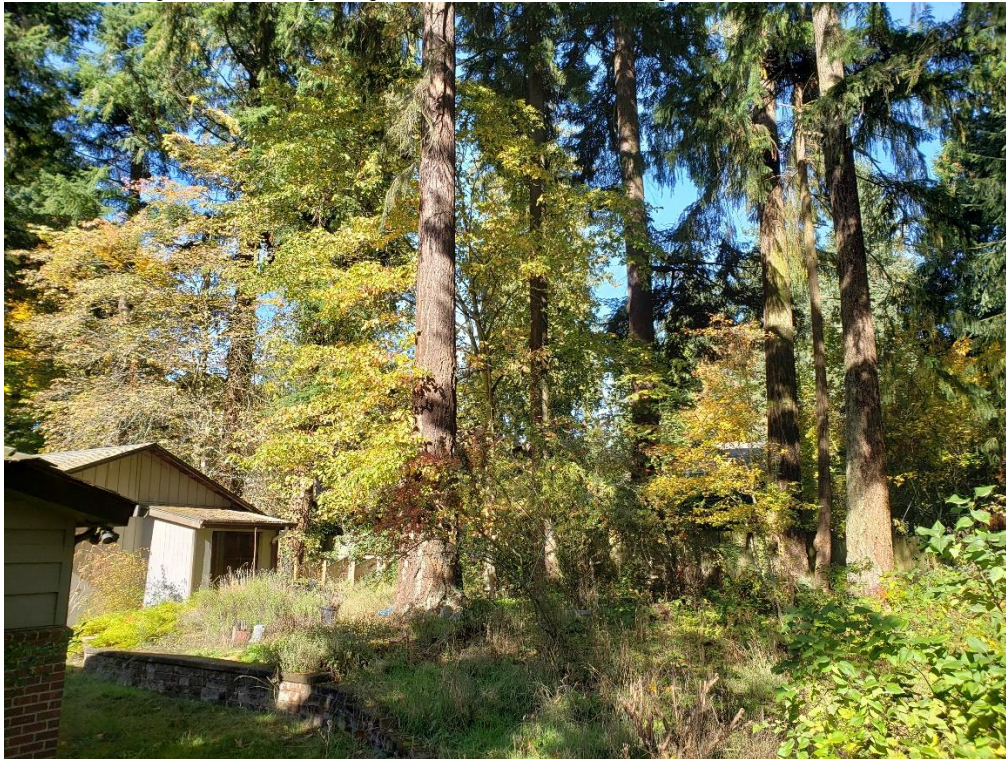
Photo 5. Facing west, showing the grove trees number 9 through 14 located north of the residence.

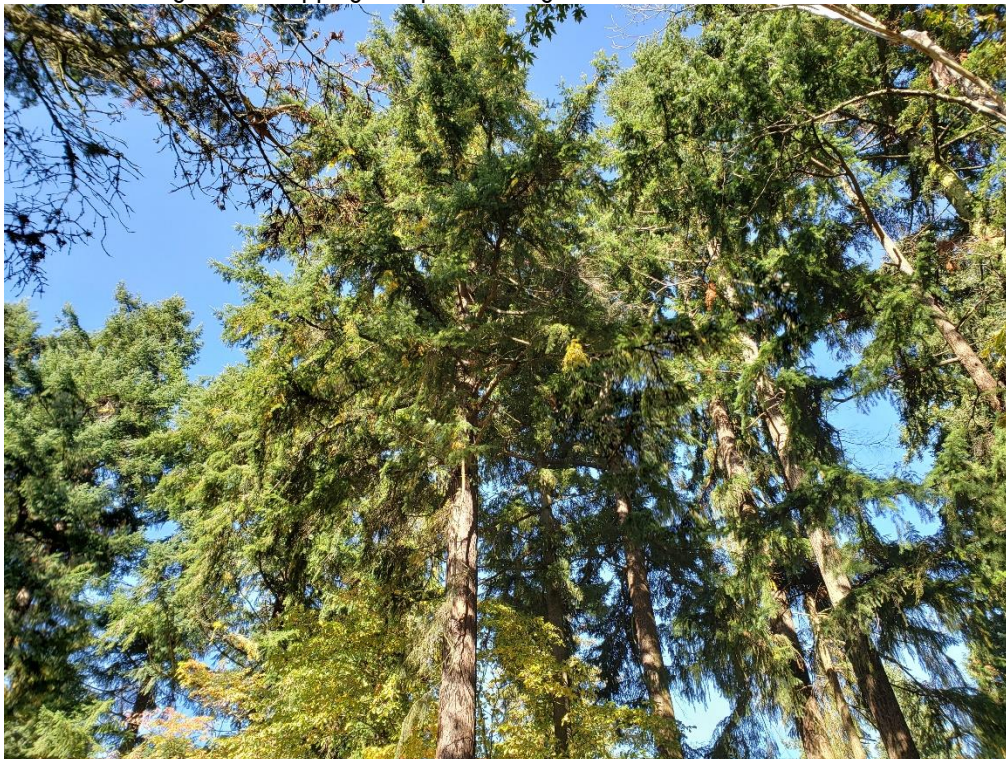
Photo 6. Showing the overlapping canopies of the grove trees.

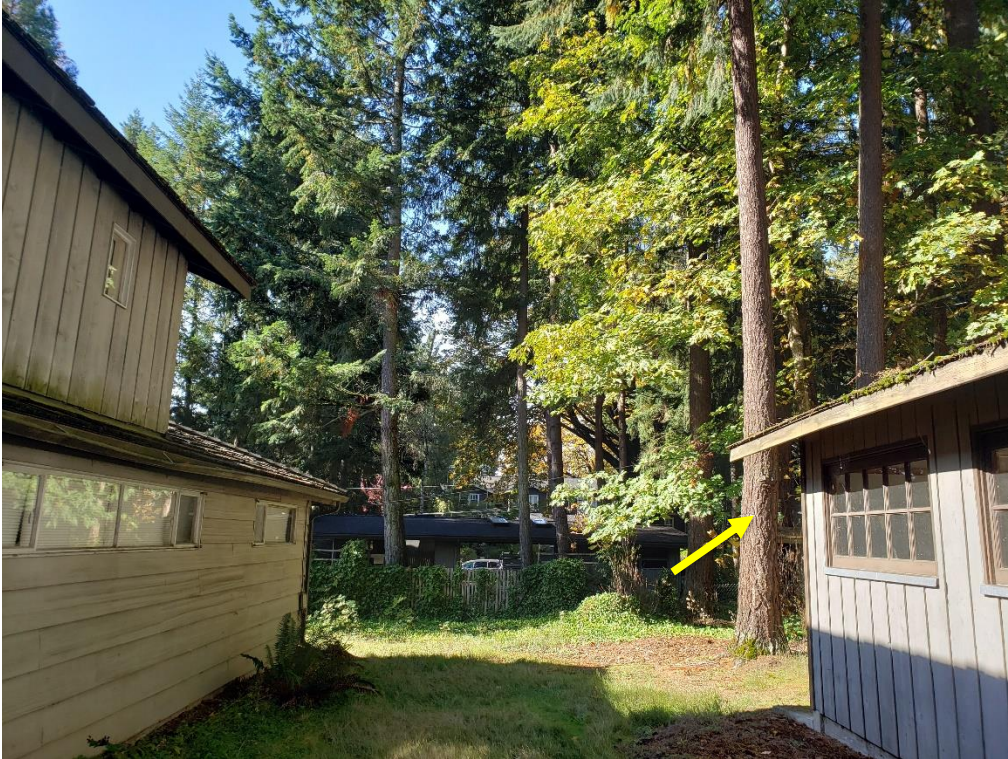
Photo 7. Facing west, showing grove tree number 23 located north of the residence.

22	Douglas fir	<i>Pseudotsuga menziesii</i>	yes	22	97	12	8	10	10	fair	Retain	Old broken top. Grove tree.
23	Douglas fir	<i>Pseudotsuga menziesii</i>	yes	24	90	8	13/12	14	10	fair	Retain	Old broken top. Grove tree.

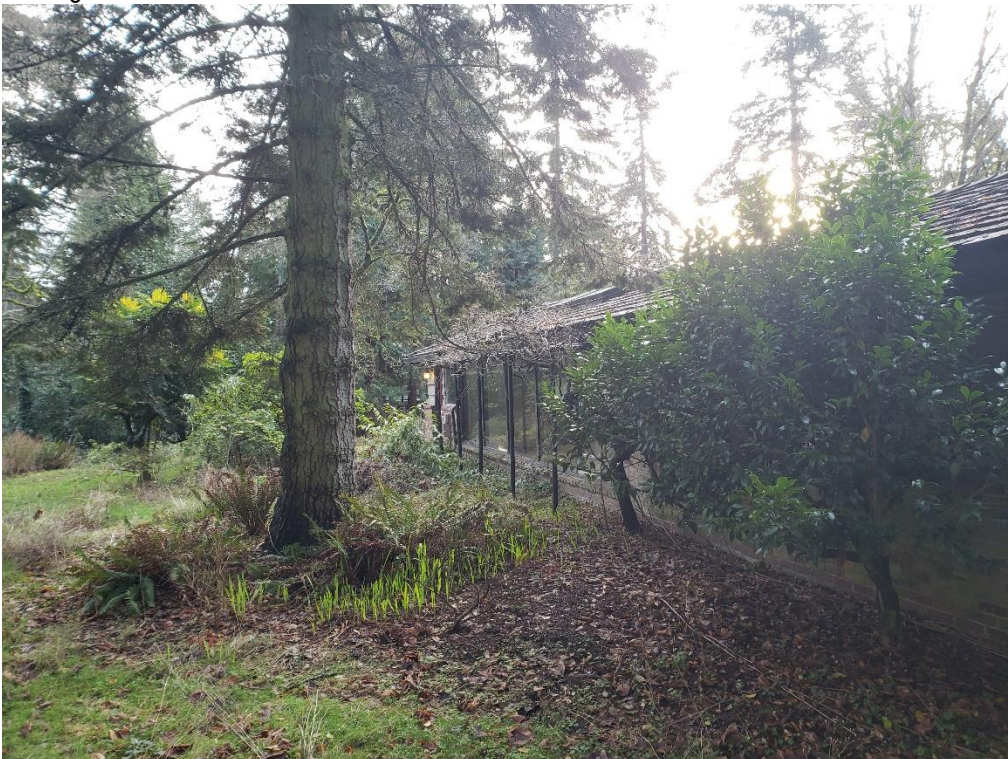
- **Comment 1 - The Latin binomial for tree 5 was determined to be *Abies grandis*, common name is grand fir. The previous version of the Arborist Report did not include a scientific name. In accordance with the City of Mercer Island Exceptional Tree List, this tree is exceptional due to size with an exceptional threshold of 24 inches. This tree is proposed for removal due to a conflict with the proposed improvements on the east side of the proposed residence.**

Trees 4 and 5 conflict with proposed improvements. Tree 5 is in good health condition and is exceptional due to size per MICC 19.16.010 Exceptional Tree Table. Exceptional trees may be prioritized for retention by the City. Removal of this tree will require permission from the City.

Photo 8. Taken on 1/7/2021. Facing south looking at the base of tree 5 approximately 10 feet east of the existing residence.

**If tree 4 and 5 are removed, they shall be replaced in accordance with MICC 19.10.070. Available space for planting replacement trees will likely be available on the southeast portion of the site. Native coniferous species appropriate for the site will provide long-term high-quality ecosystem services for the site. Tree planting should adhere to current ANSI Standards and occur in the fall or early spring.**

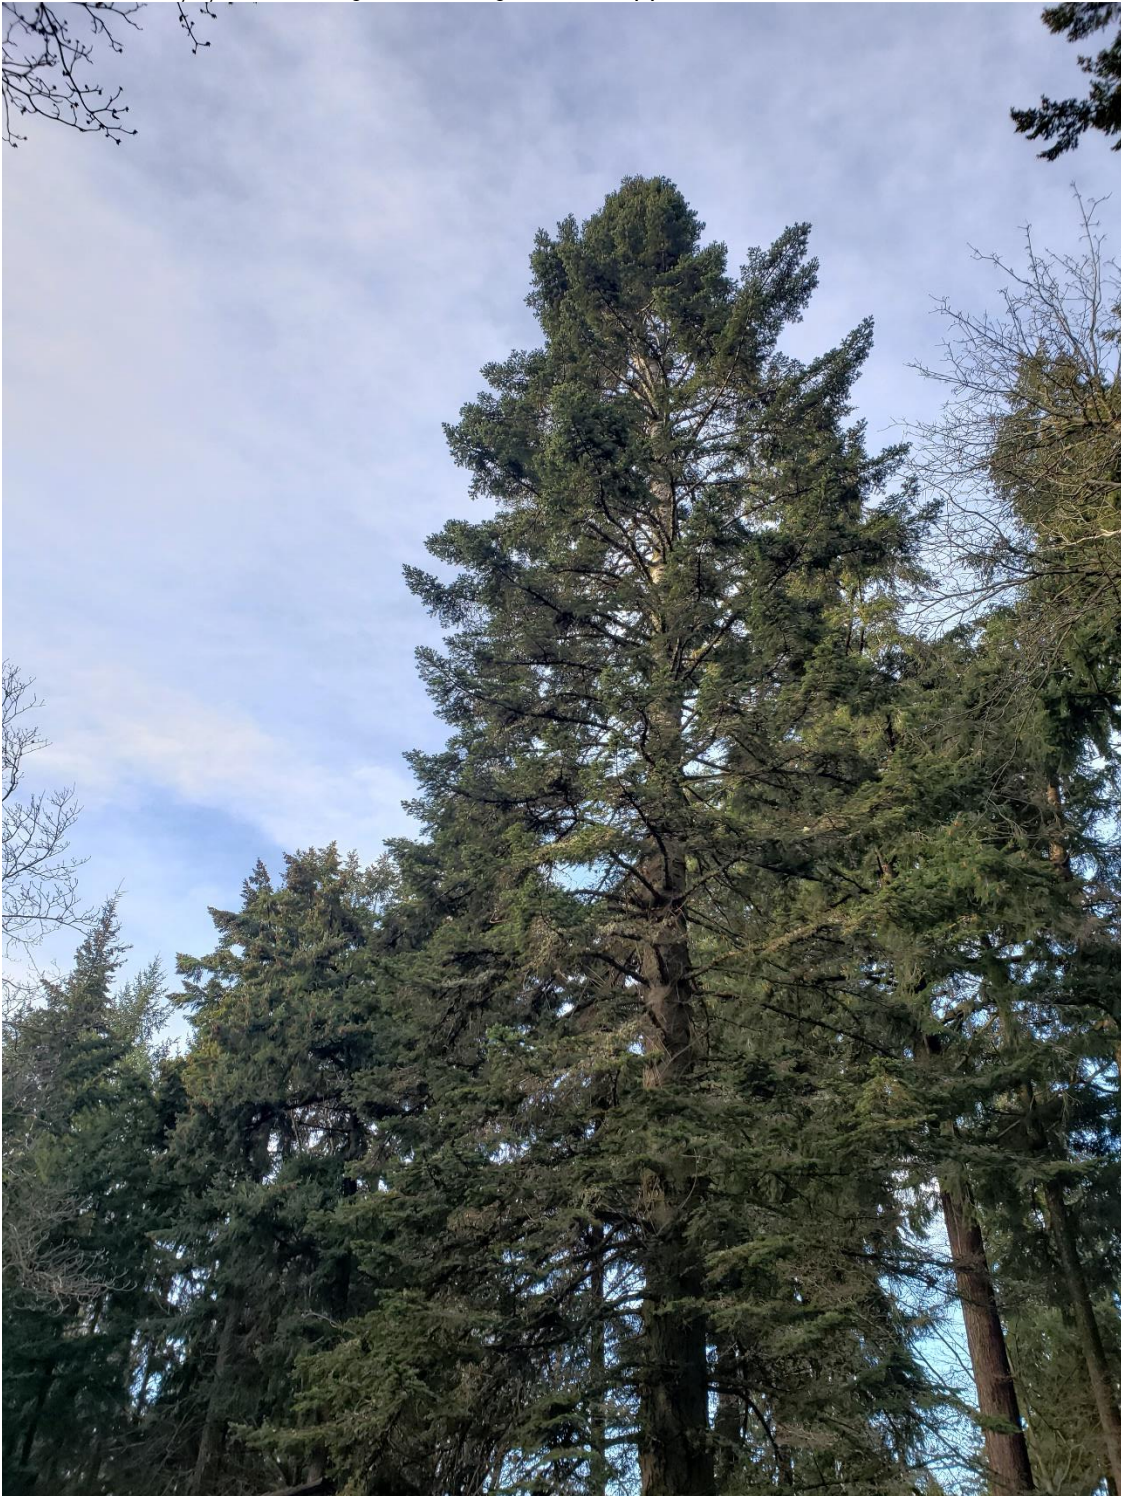
Photo 9. Taken 1/7/2021. Facing north looking at the canopy of tree 5.
