ARBORIST REPORT 3453 74th Ave SE Mercer Island, WA

October 31st, 2019

Updated 5/5/2020

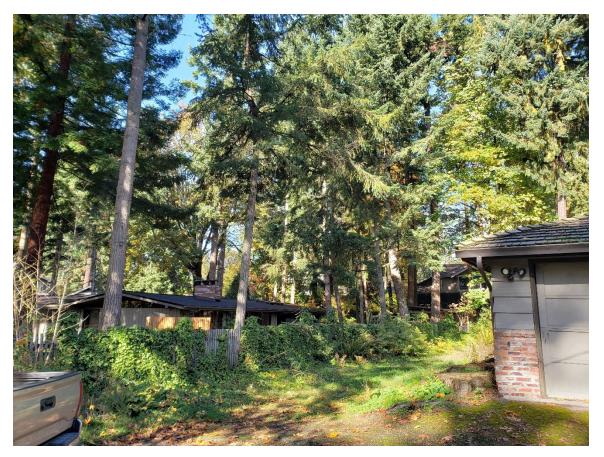
Photo 1. Facing north, showing the west property line.

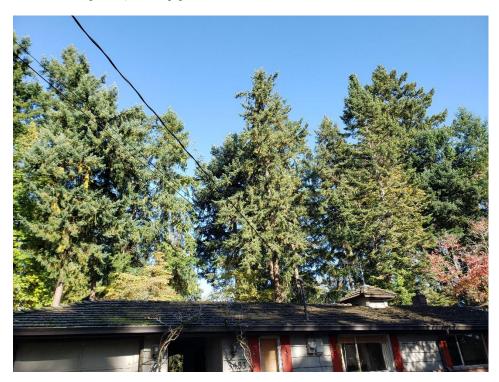
Photo 2. Facing north, showing grove trees located north of the residence.

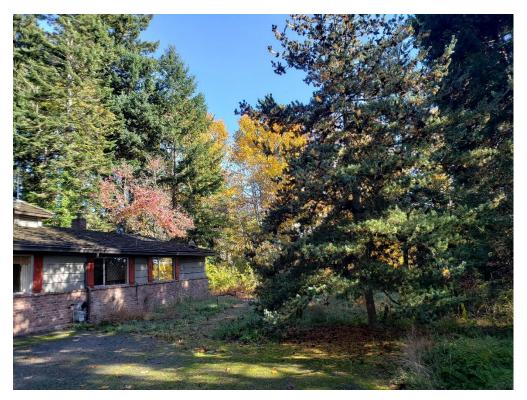
Photo 3. Facing east, showing tree number 1 located south of the residence and adjacent to the property line.

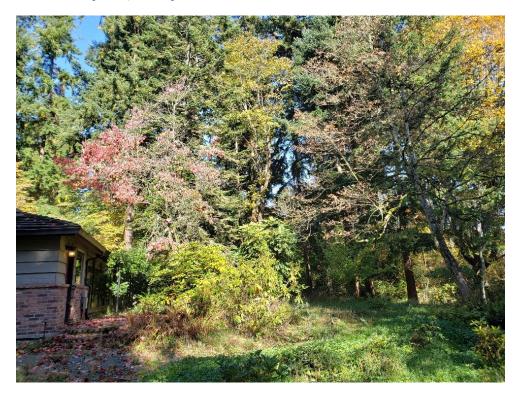
Photo 4. Facing north, showing the area east of the residence.

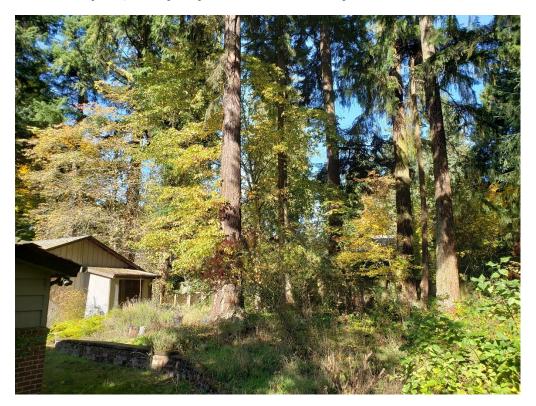
Photo 5. Facing west, showing the grove trees number 9 through 14 located north of the residence.

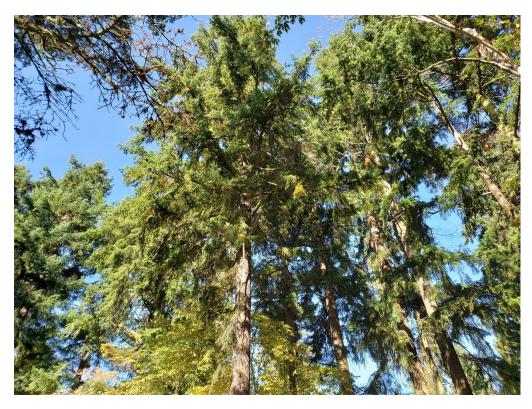
Photo 6. Showing the overlapping canopies of the grove trees.

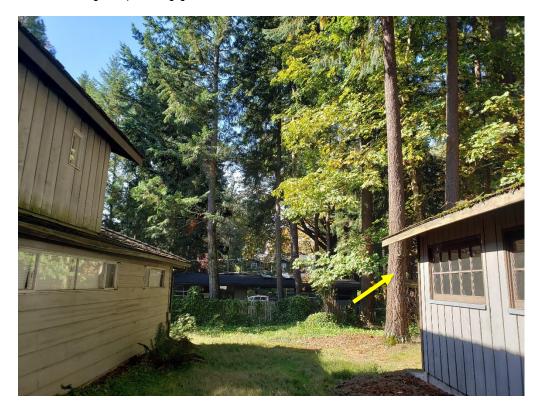
Photo 7. Facing west, showing grove tree number 23 located north of the residence.

Douglas fir	yes	22	97	12	8	10	10	fair	Retain	Old broken top. Grove tree.		
23	Douglas fir	yes	24	90	8	13/12	14	10	fair	Retain	Old broken top. Grove tree.

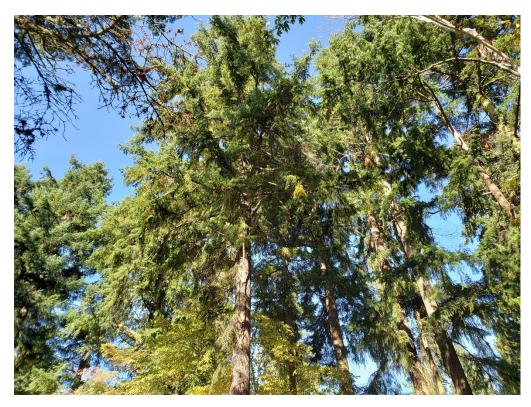
Photo 8. Showing the overlapping canopies of the grove trees.
