April 9, 2020
PanGEO Project No. 20-084

**Subject: Geotechnical Engineering Report
Proposed Residence
3453 74th Avenue Southeast
Mercer Island, Washington 98040**

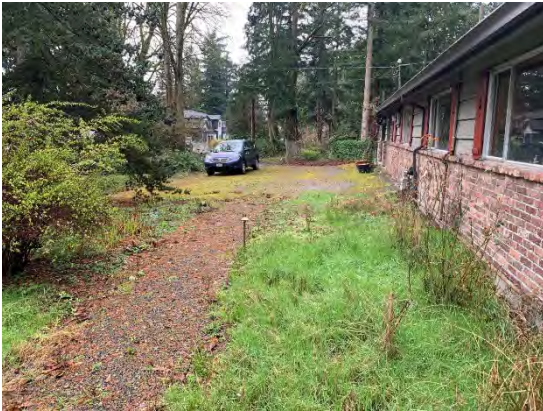
Plate 1: Existing building (south side), looking west

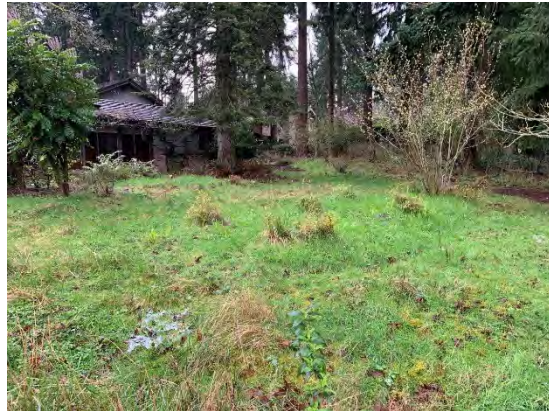
Plate 2: SE corner of the property, looking NW

Based on the site topographic survey, the overall site grades are practically level. The southeast corner of the subject property slightly descends to the south and east property lines with an elevation relief of about 4 feet. The southeast portion of the property is mapped as a potential landslide area, a potential erosion hazard area, and a seismic hazard

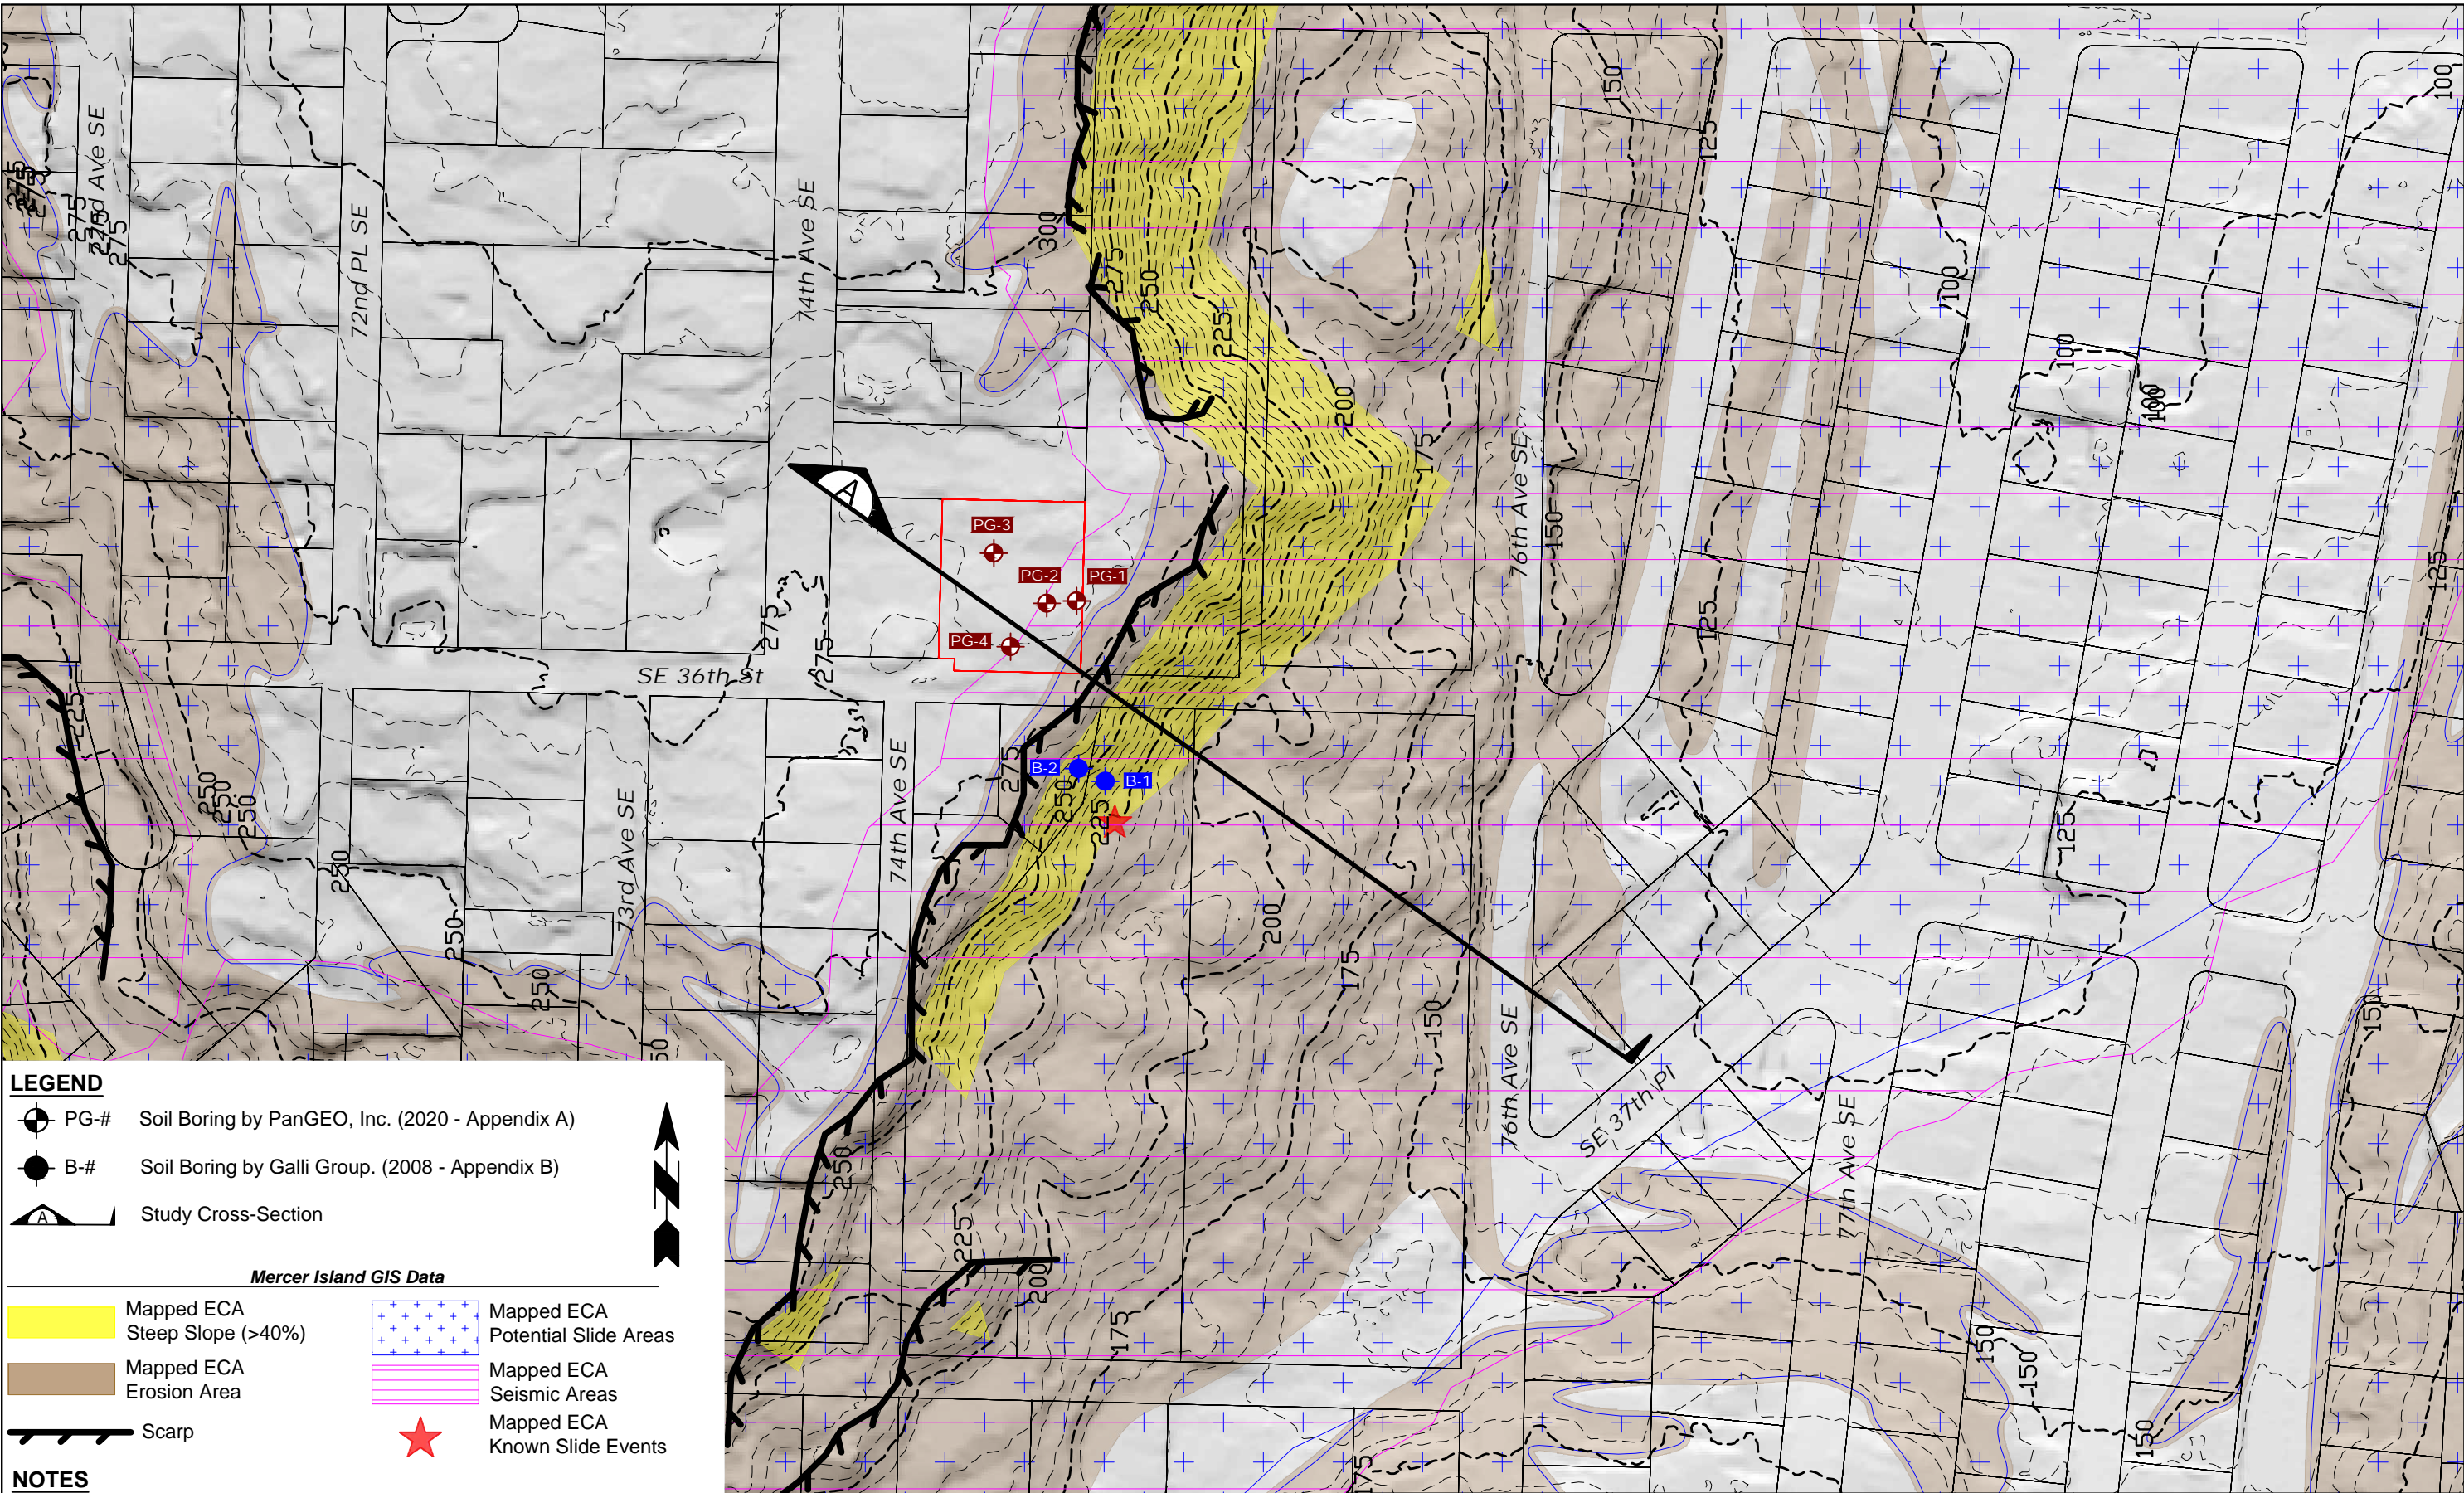
FIGURE NO.
3

potential landslide hazards (see mapped areas in the attached Figure 3). The following sections discuss each of the mapped hazard areas.

A small area in the southeast corner of the site and the eastern slope (i.e. Mercerdale Hillside Park) are mapped by the City within a potential landslide hazard area (see attached Figure 3). The City's landslide hazard area map also shows head scarps and a known slide within the eastern slope.

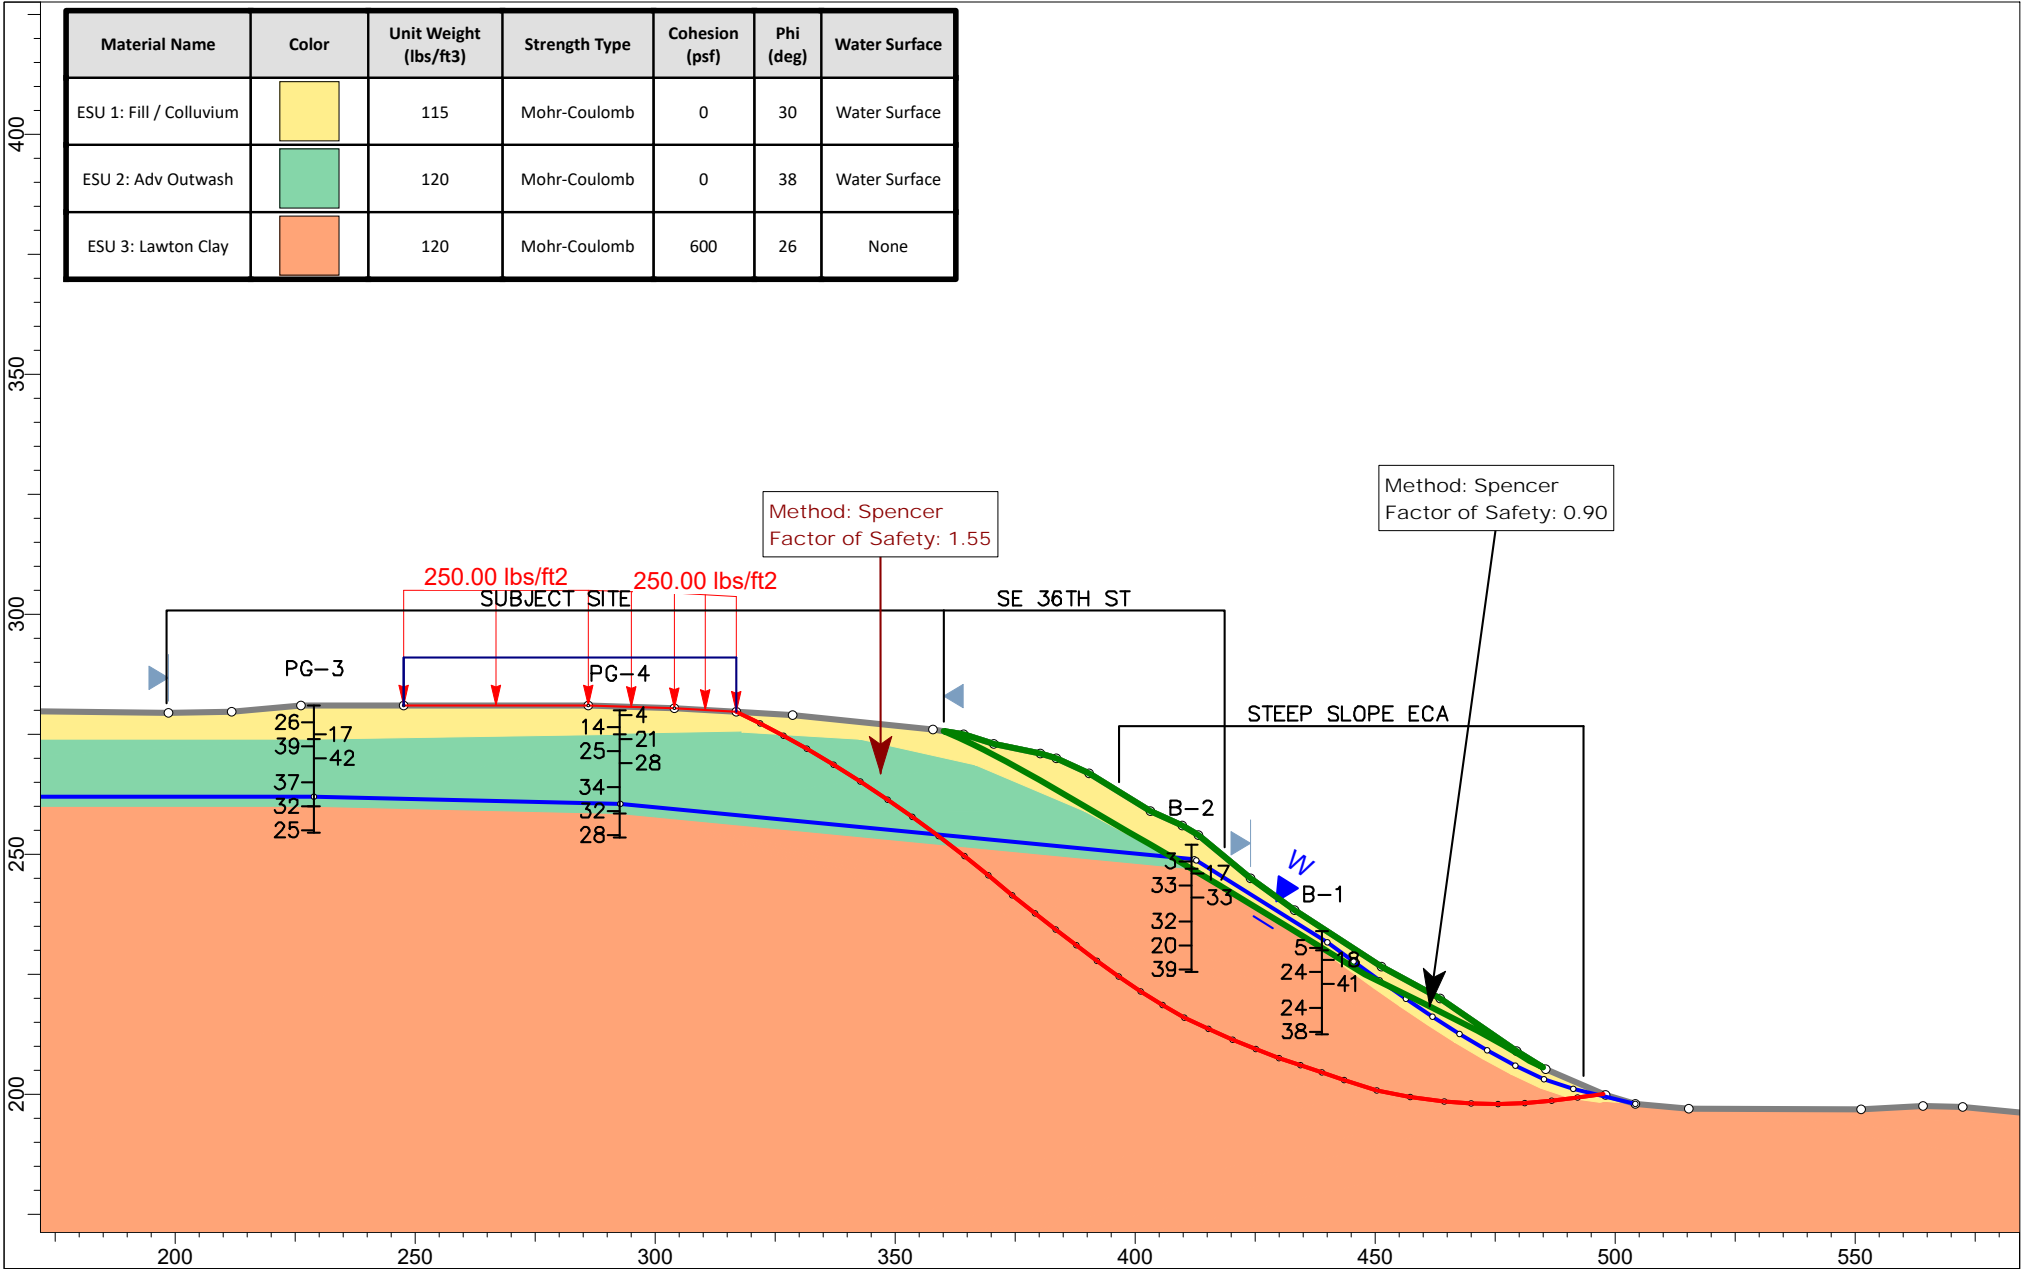
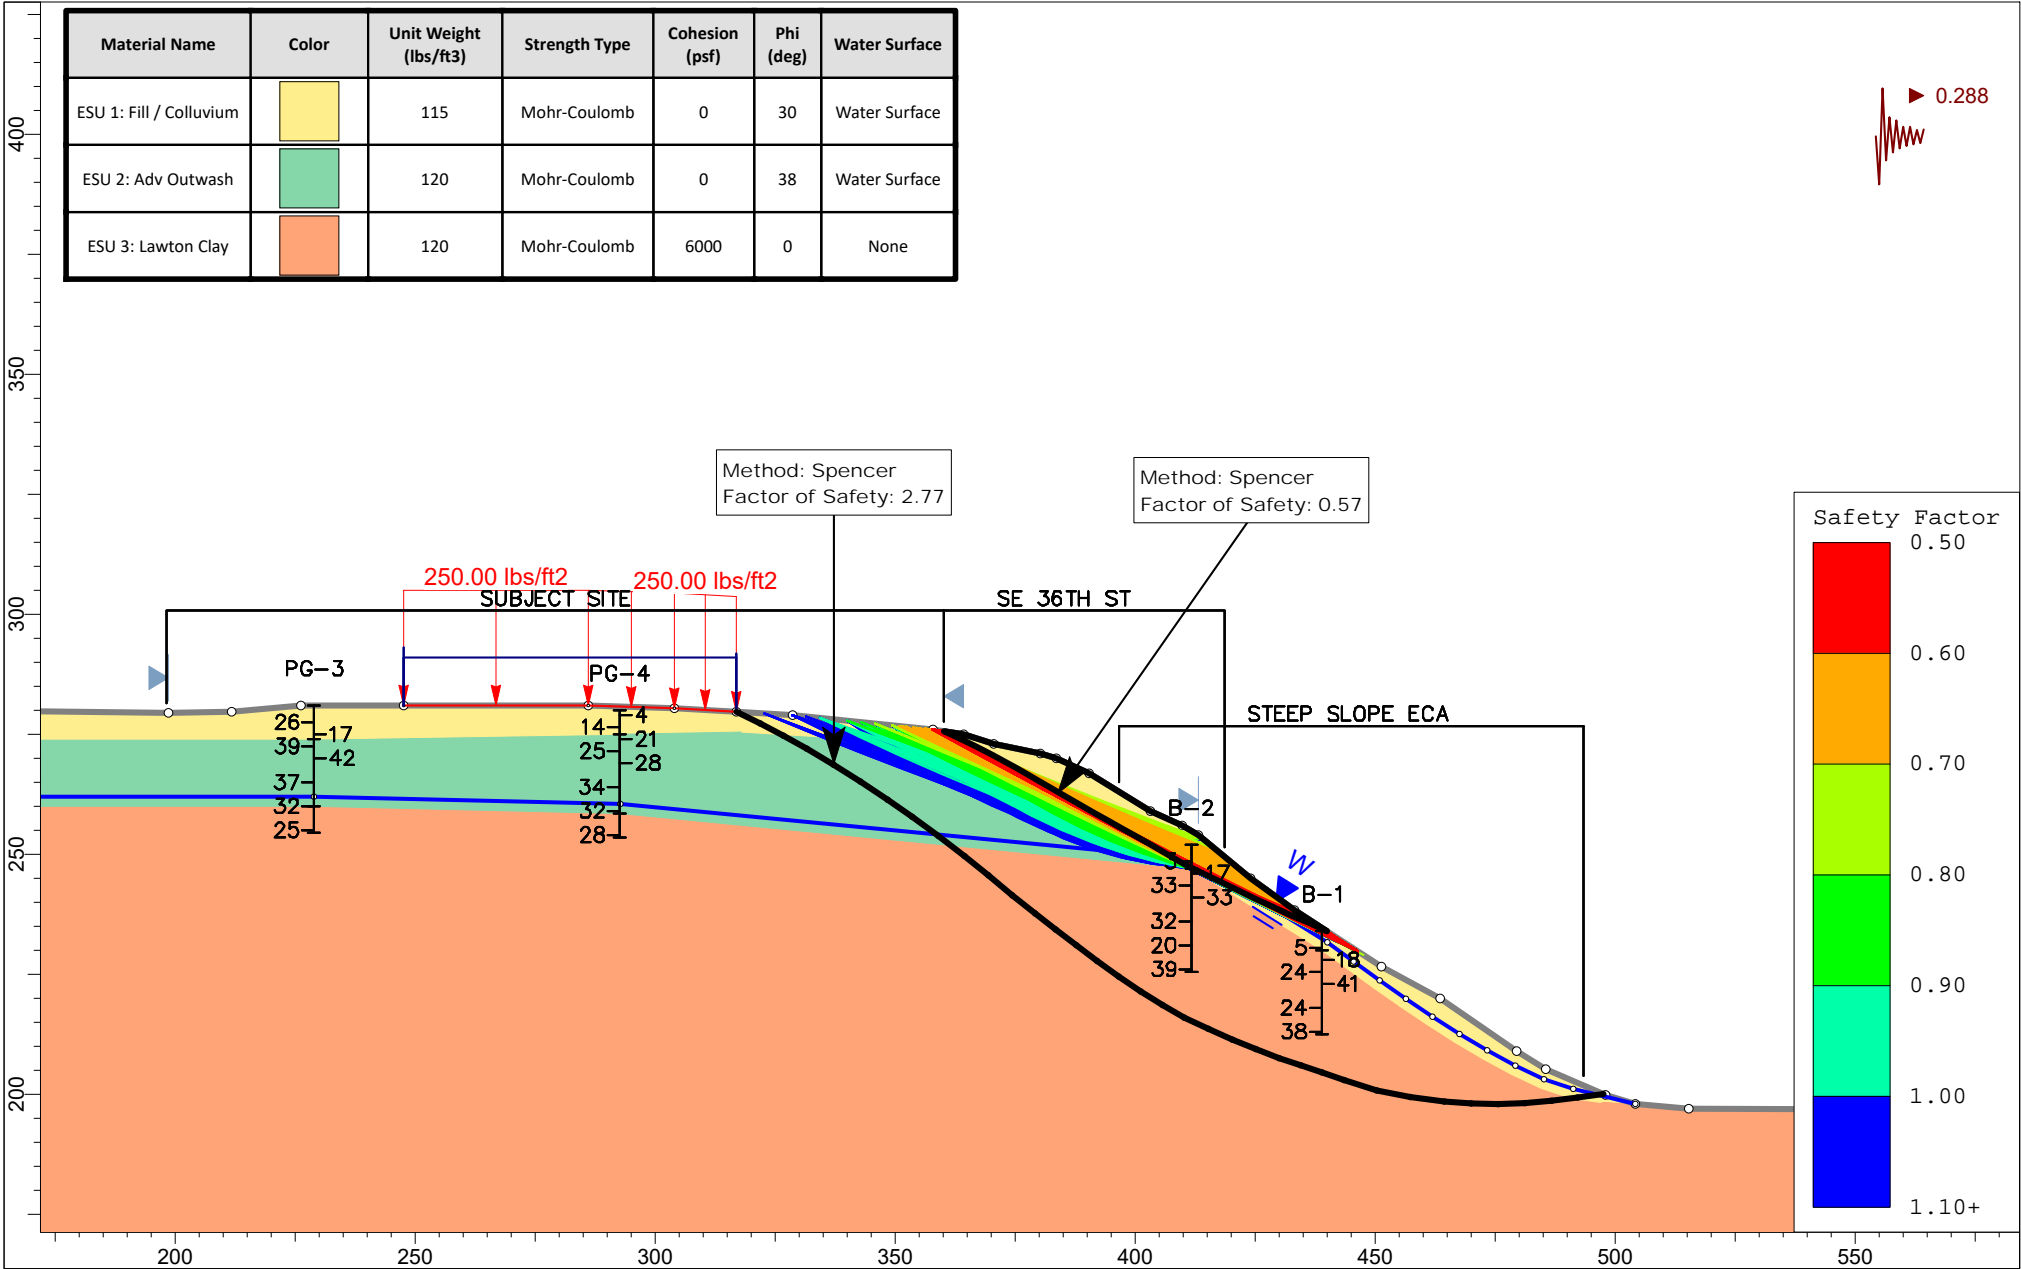
We developed a generalized subsurface profile along Section A-A' (see Figure 3 for location of A-A'). The subsurface profiles are shown in Figures 4 and 5. The subsurface profile A-A' consists of three generalized soil units. The uppermost soil unit consisting of about 4½ to 7 feet of loose to medium sand (i.e. fill and weathered advance outwash deposits). The second soil unit consists of medium dense to dense sand (advance outwash deposits). The lowest soil unit consists of very stiff to hard, silt and clay (Lawton clay). The soil strength parameters modeled in the analyses are also shown in Figures 4 and 5.

Potential Failure Planes: We analyzed the most critical failure planes that occur under static and seismic loading. The failure planes were analyzed, and the corresponding factors of safety are shown in Figures 4 and 5.

Estimated Factor of Safety – As shown in Figures 4 and 5, the estimated factors of safety are at least 1.5 under static loading and 1.1 under seismic loading, for potential slide planes that extend to the proposed building location. Based on the results of our slope stability analyses, it is our opinion that the risk of a large, deep-seated type of slope failure in the proximity of the proposed building is low. Shallow, surficial slide may occur near the east property line of the subject property and within the eastern slope. However, we do not anticipate these potential shallow, surficial slide to adversely affect the proposed building.
