# TREE RISK ASSESSMENT

Noriko Inoguchi  
2723 72nd Ave SE  
Mercer Island, WA

Chris Welch  
ISA Certified Arborist® #RM-1057  
ISA Tree Risk Assessment Qualified  
425-654-4745

On Wednesday, November 27, 2019 I evaluated four trees at 2723 72nd Ave SE Mercer Island, WA. The purpose of the inspection was to perform a basic assessment of the subject trees and to make appropriate recommendations to reduce hazard risk where warranted.

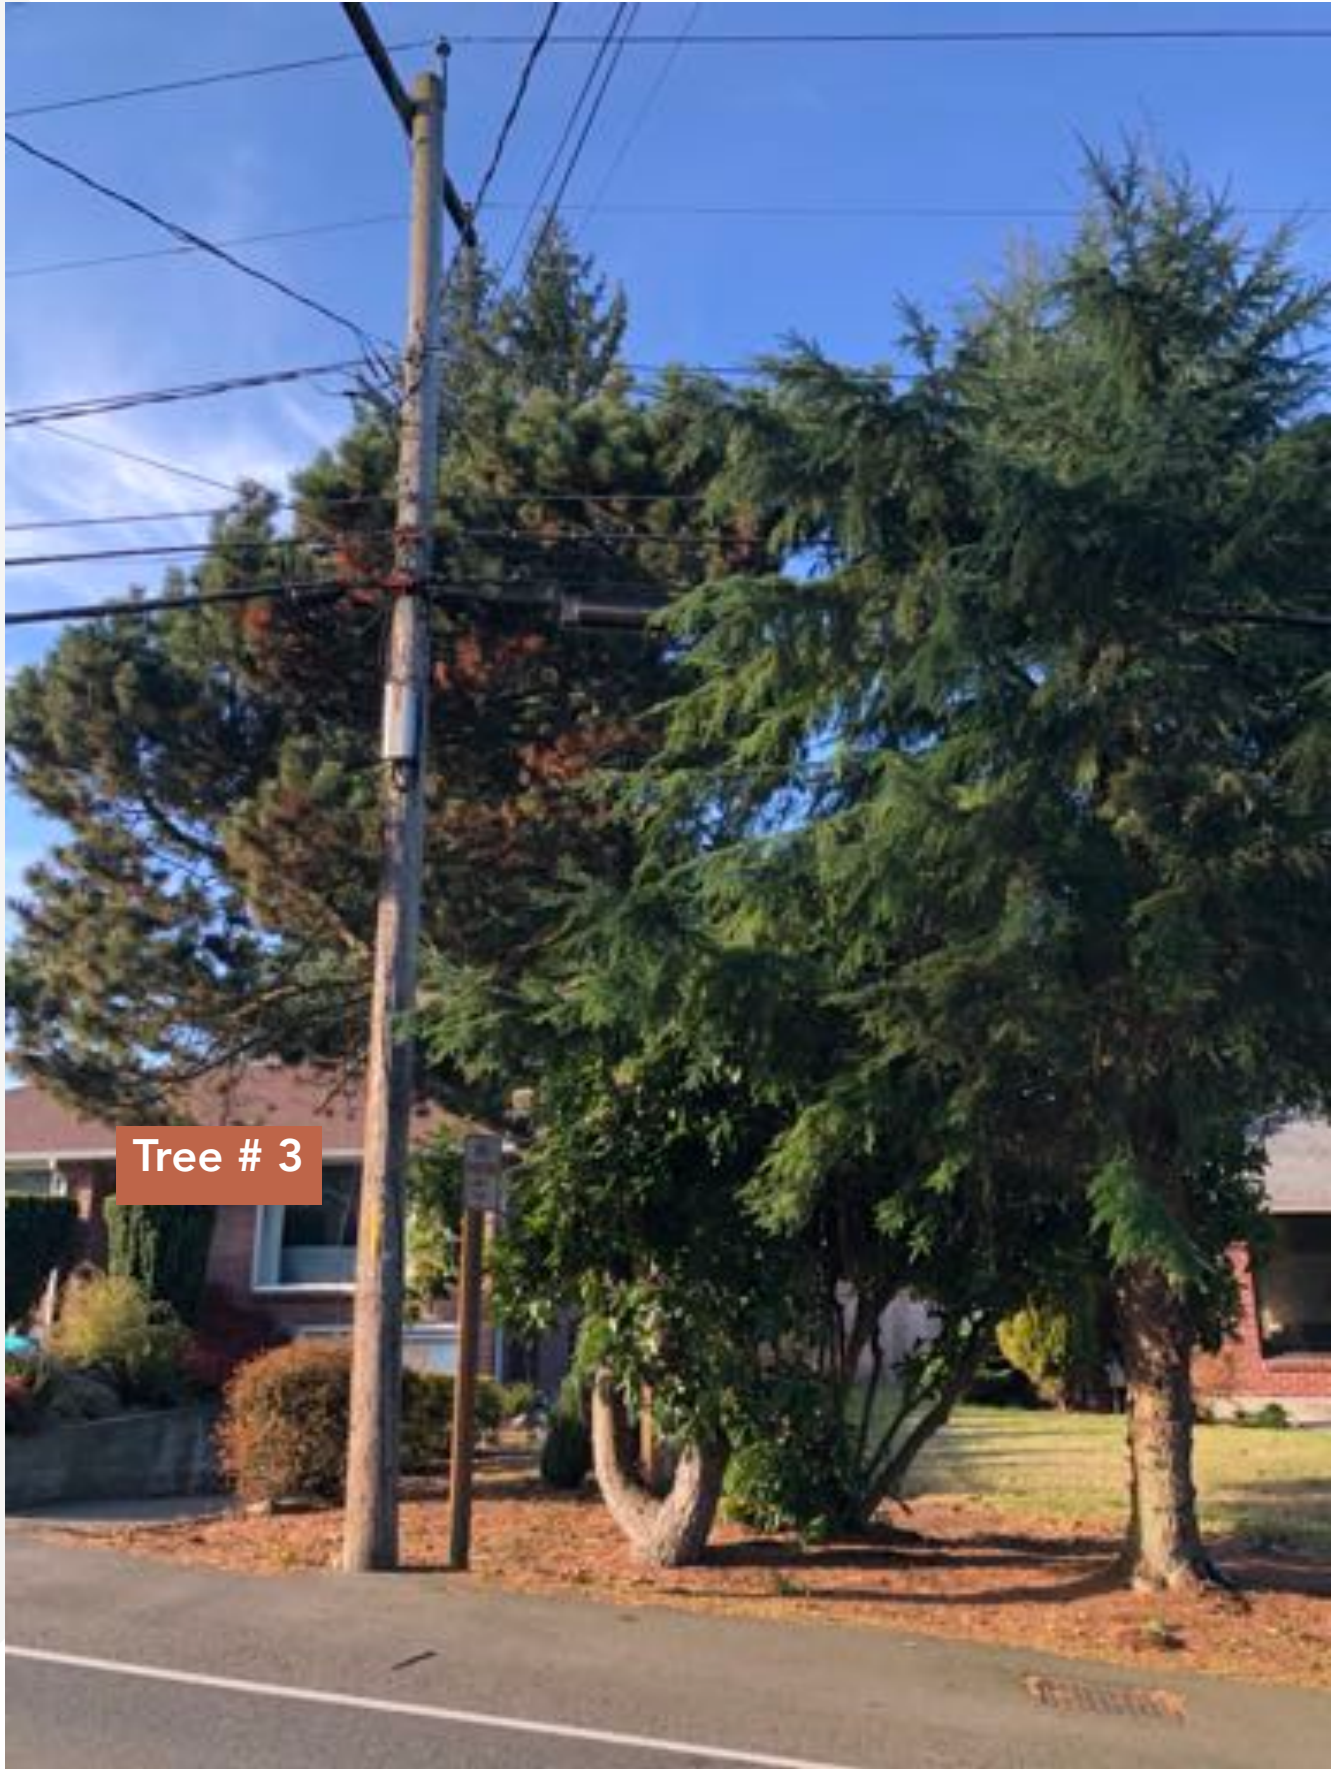
Tree # 3

As with the two adjacent trees, this canopy is also in contact with the utility. Line and has been pruned for clearance. The effect has not been as significant here because of the species. One large stem is overextended towards the neighboring driveway. There are a few dead branches.

A low branched tree, with significant secondary stems, suitable attachments.

No significant concerns with this tree, it will continue to conflict with the utility lines, but I don't believe the pruning is contributing to structural stability. The overall risk rating is low. I would recommend pruning out the few dead branches.

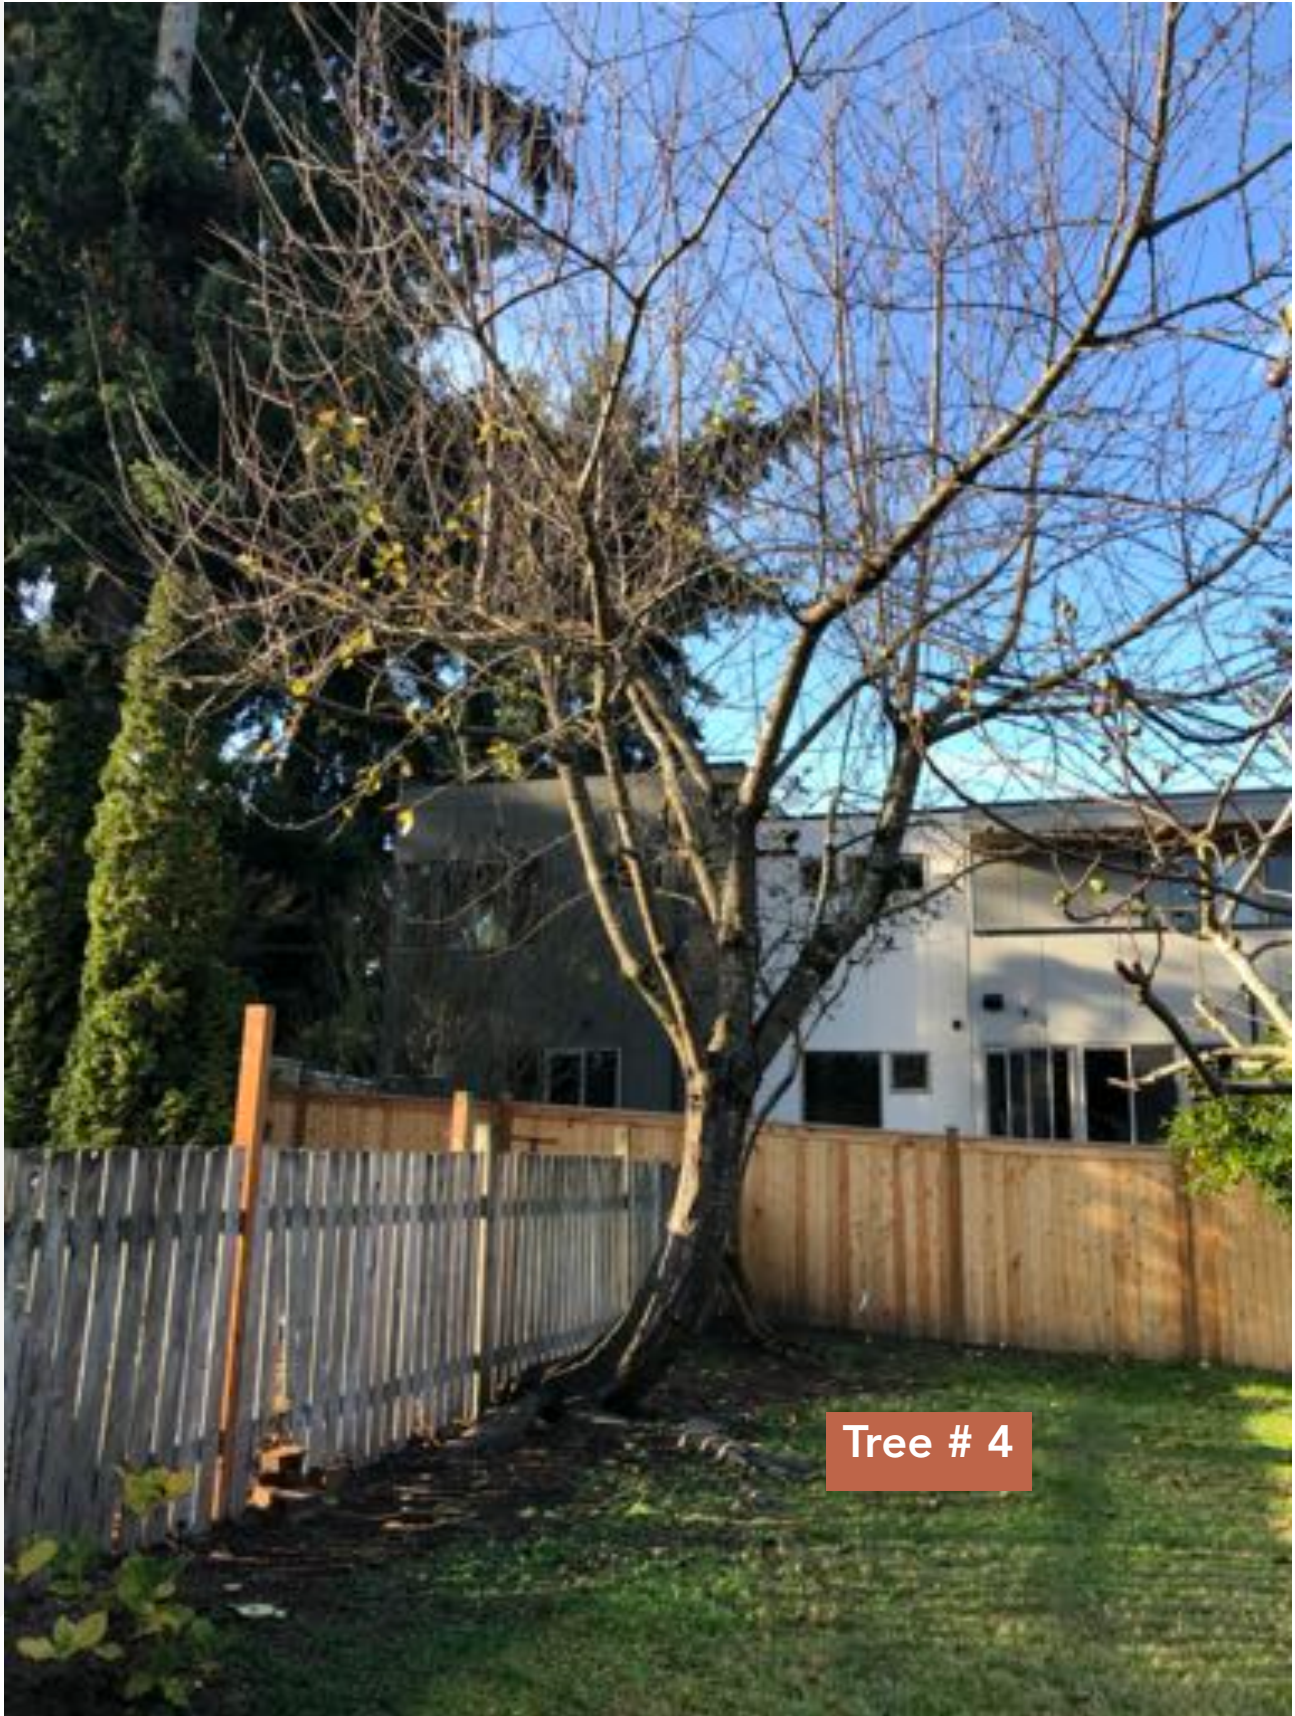
Tree # 4

This tree was topped at some point; the regrowth has relatively weak attachments. There are a few branches that have some early decay at pruning points. The overall load on these defects are minor as the canopy is relatively small.

The trunk emerges from the base with a rather large swooping lean to the north and then has corrected.

There are a significant number of surface roots exposed, and there is some mechanical damage in places. The neighbor has removed a couple of roots that were above ground at the fence line.

The overall risk rating for this tree is low. I would recommend regular pruning of the regrowth from the topping events to encourage suitable attachments.
