BAZE-INOGUCHI RESIDENCE

2723 72nd Avenue SE

Downstream Analysis

Mercer Island, Washington
June 11, 2020

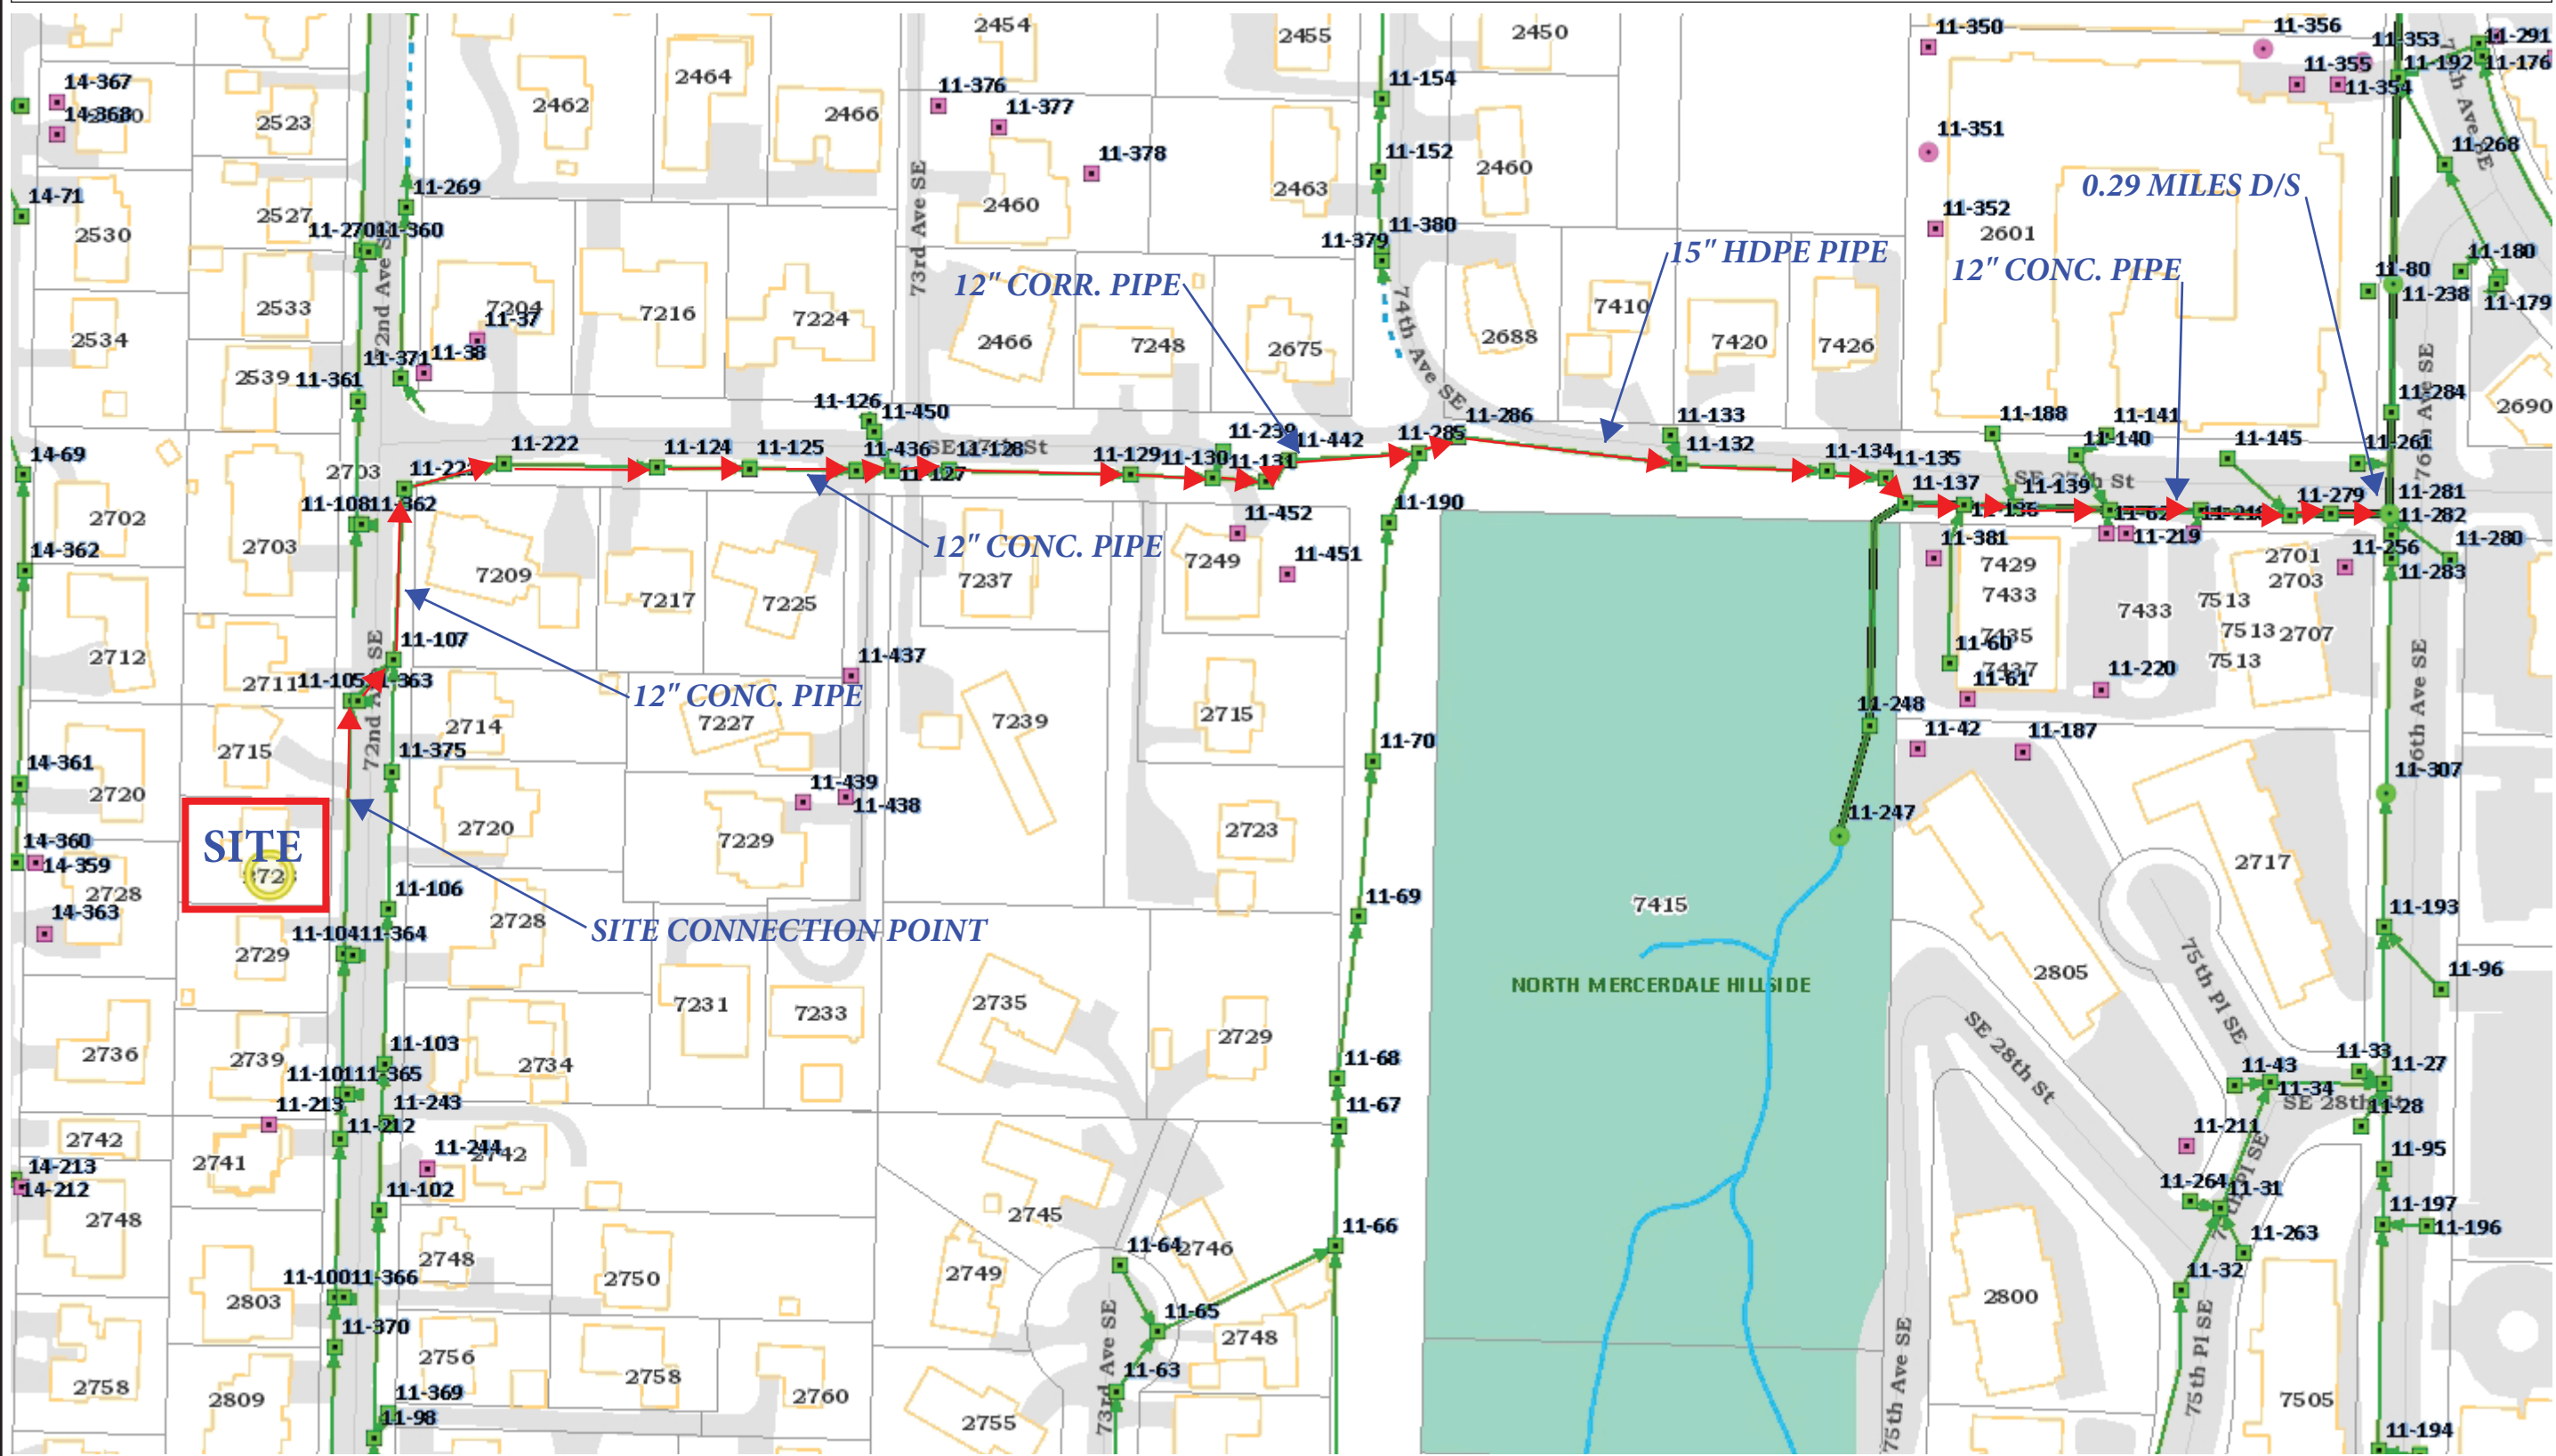
Off-Site Drainage System

The proposed site drainage system will connect to the existing City storm drainage system in 72nd Avenue SE. The connection point will be near the northeast property corner. A new catchbasin will be constructed on an existing 12-inch diameter concrete pipe that flows north near the west edge of the road pavement.

The 12-inch diameter concrete pipe flows north for 75 feet and into a Type 1 catchbasin. This catchbasin connects to another catchbasin located a few feet to the east, collecting runoff at the pavement flowline. Exiting the catchbasin a 12-inch diameter concrete pipe flows north beneath the road pavement to another Type 1 catchbasin located on the east side of the road. Flow continues in a 12-inch diameter concrete pipe about 120 feet north to a catchbasin located at the southeast corner of the 72nd Avenue SE and SE 27th Street intersection. Exiting the catchbasin is a 12-inch diameter concrete pipe that flows east.

The drainage system continues east inside a 12-inch diameter concrete pipe connecting a series of Type 1 catchbasins located in the south gravel shoulder of SE 27th Street. Eventually the system connects to a catchbasin located at the edge of some stairs that descend a steep portion of unimproved right-of-way. The catchbasin is drained by a 12-inch diameter corrugated pipe that flows east beneath and down the slope, passing through two catchbasins then entering a drainage system near 74th Avenue SE and SE 27th Street. The drainage system consists of 15-inch diameter HDPE pipe that connects a series of catchbasins at the south edge of SE 27th Street, eventually connecting to a 12-inch diameter concrete system opposite the east edge of Hillside Park. The 12-inch diameter pipe flows east under the south curb of SE 27th Street eventually discharging into a manhole in the road pavement at the southwest corner of the intersection of SE 27th Street and 76th Avenue SE. According to the City GIS the manhole is drained by a 24-inch diameter pipe that flows north under the west edge of 76th Avenue SE. The manhole is about 1,550 feet (0.29 miles) downstream of the site connection point.

There were no problems observed during the site inspection. No evidence of flooding, erosion, lack of capacity or capacity constriction were observed along the route. The conveyance system from the site to the quarter-mile point downstream is a constructed system consisting entirely of pipes and catchbasins. The structural condition of catchbasins and of pipes, where they appear in the catchbasins, appears to be good. No unusual siltation in pipes or catchbasins was observed. Due to the apparent adequacy of the downstream drainage system, no onsite or offsite mitigations are proposed.
