Greenforest Incorporated

REFERENCE: Arborist Report
Permit Application 2007-015

SITE ADDRESS: 2928 72nd PL SE, Mercer Island, WA 98040

DATE: September 23, 2020

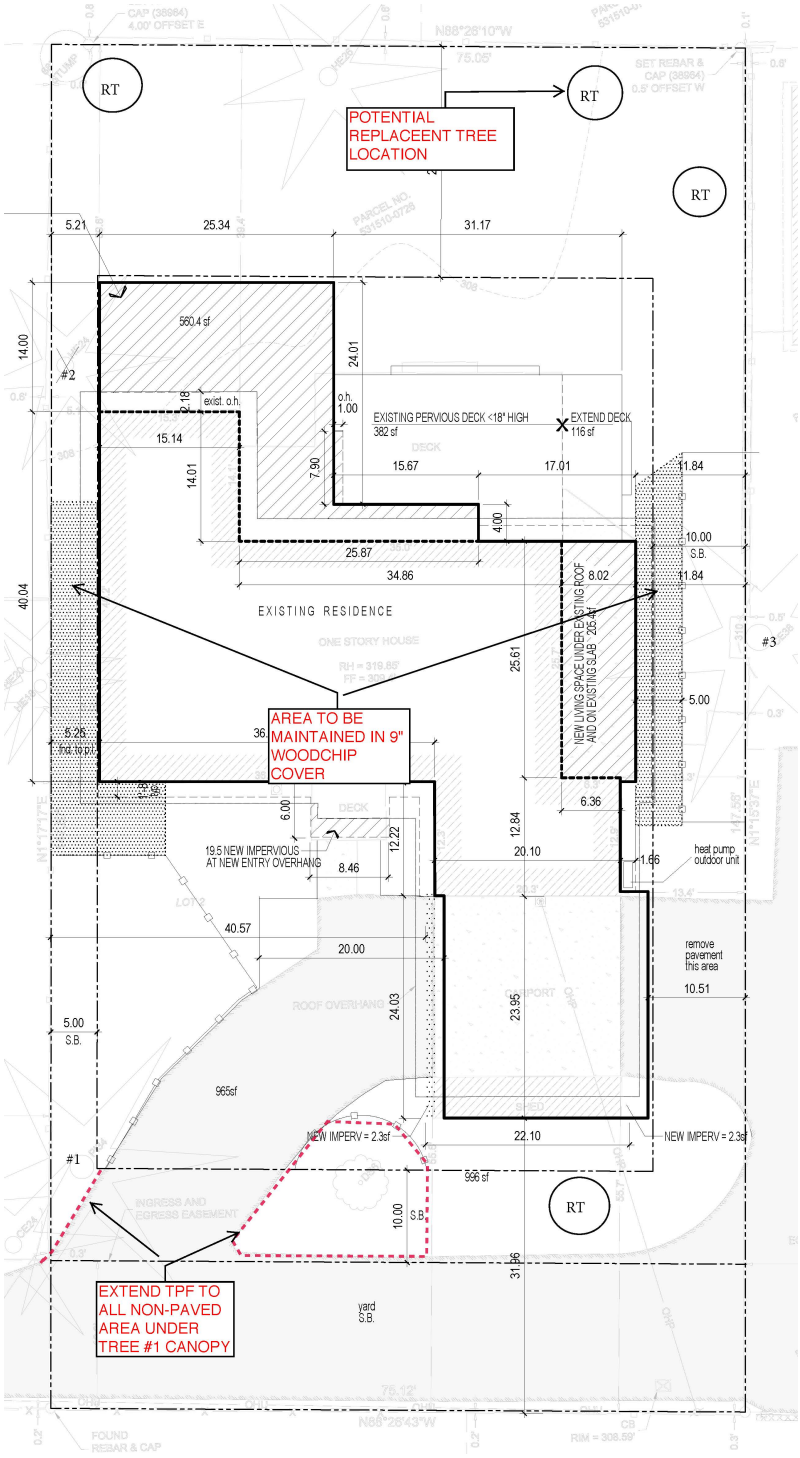
Tree Protection and Planting Exhibit

Minimum six (6) foot temporary chain-link fence shall be installed at the dripline of tree #1, except where covered in paving. This area includes non-paved area around small tree directly east and across the driveway. Fencing on the north side of tree #1 shall include protection for offsite tree #3. Install fence posts using pier block only. A City planner must approve any modifications to the fencing material and location. (See attached exhibit.)

Recommended planting sites are shown on the attached exhibit.

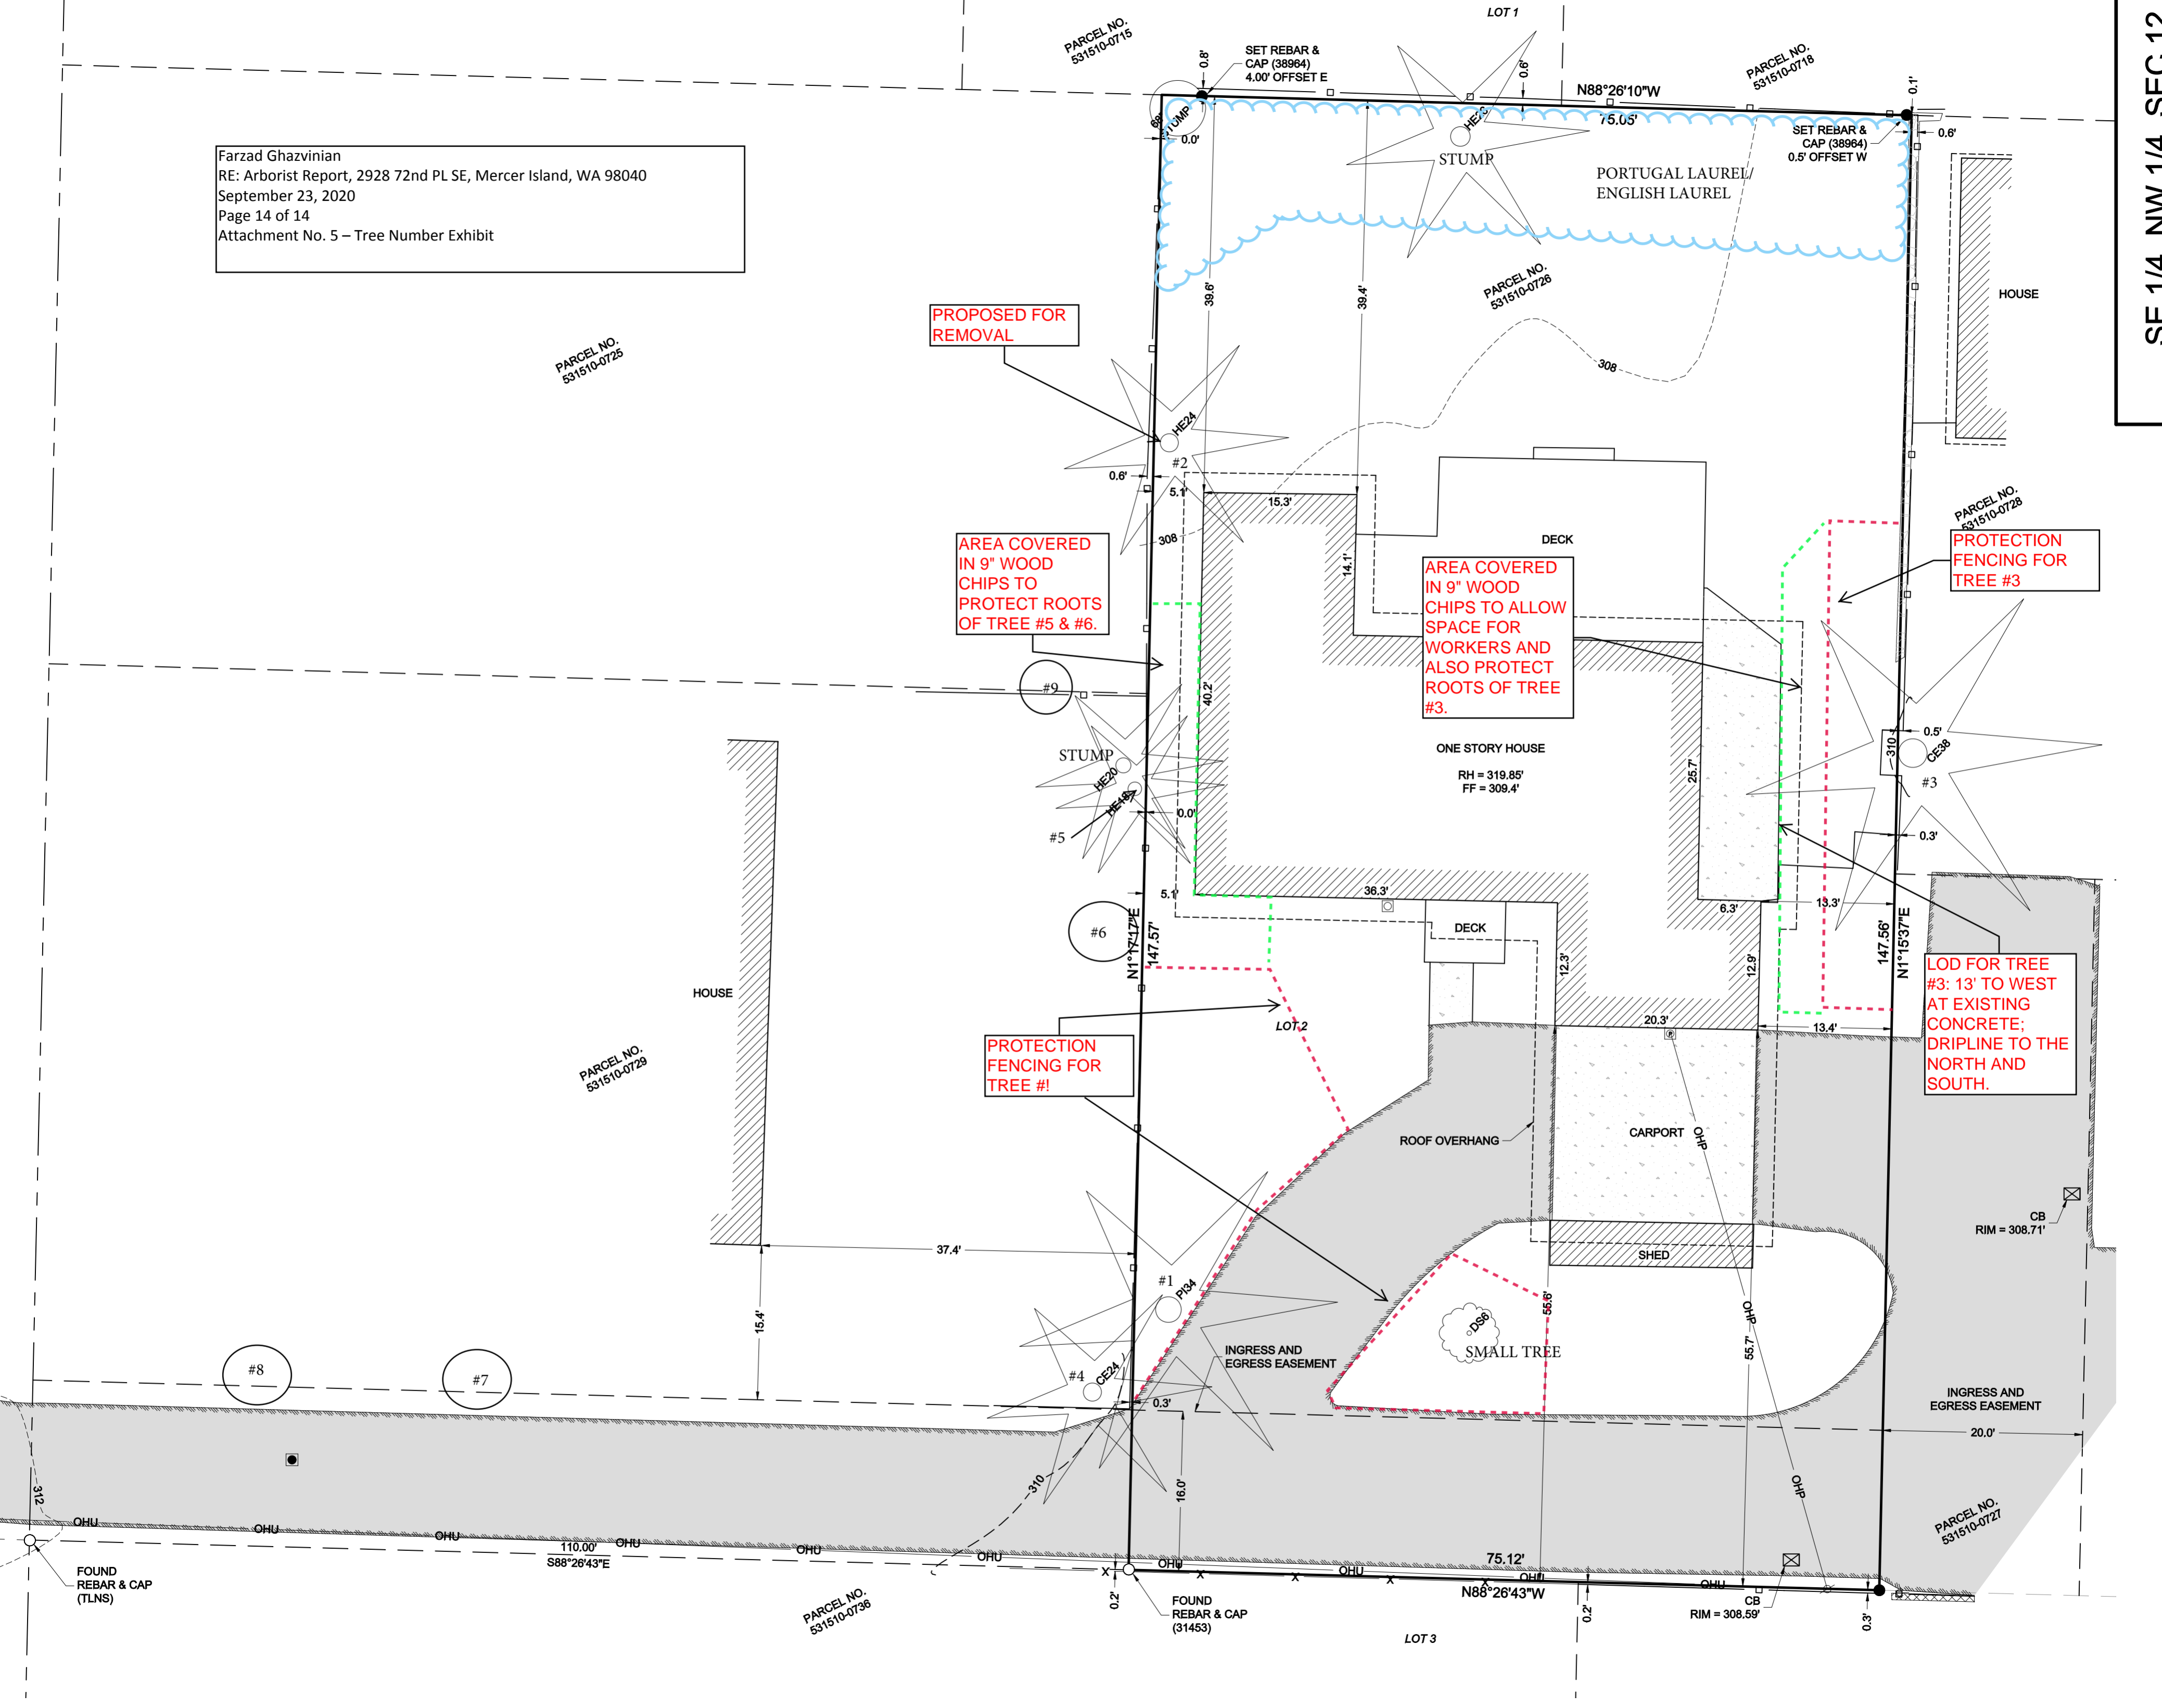
Farzad Ghazvinian
RE: Arborist Report, 2928 72nd PL SE, Mercer Island, WA 98040
September 23, 2020
Page 14 of 14
Attachment No. 5 – Tree Number Exhibit

PROPOSED FOR REMOVAL

LOD FOR TREE #3: 13' TO WEST AT EXISTING CONCRETE; DRIPLINE TO THE NORTH AND SOUTH.

AREA COVERED IN 9" WOOD CHIPS TO PROTECT ROOTS OF TREE #5 & #6.

AREA COVERED IN 9" WOOD CHIPS TO ALLOW SPACE FOR WORKERS AND ALSO PROTECT ROOTS OF TREE #3.

PROTECTION FENCING FOR TREE #3

PROTECTION FENCING FOR TREE #1
