REFERENCE: Regulated Tree Inventory

SITE ADDRESS: 2928 72nd PL SE, Mercer Island, WA 98040

DATE: June 16, 2020

PREPARED BY: Favero Greenforest, ISA Certified Arborist # PN -0143A
ISA Tree Risk Assessment Qualified
ASCA Registered Consulting Arborist® #379

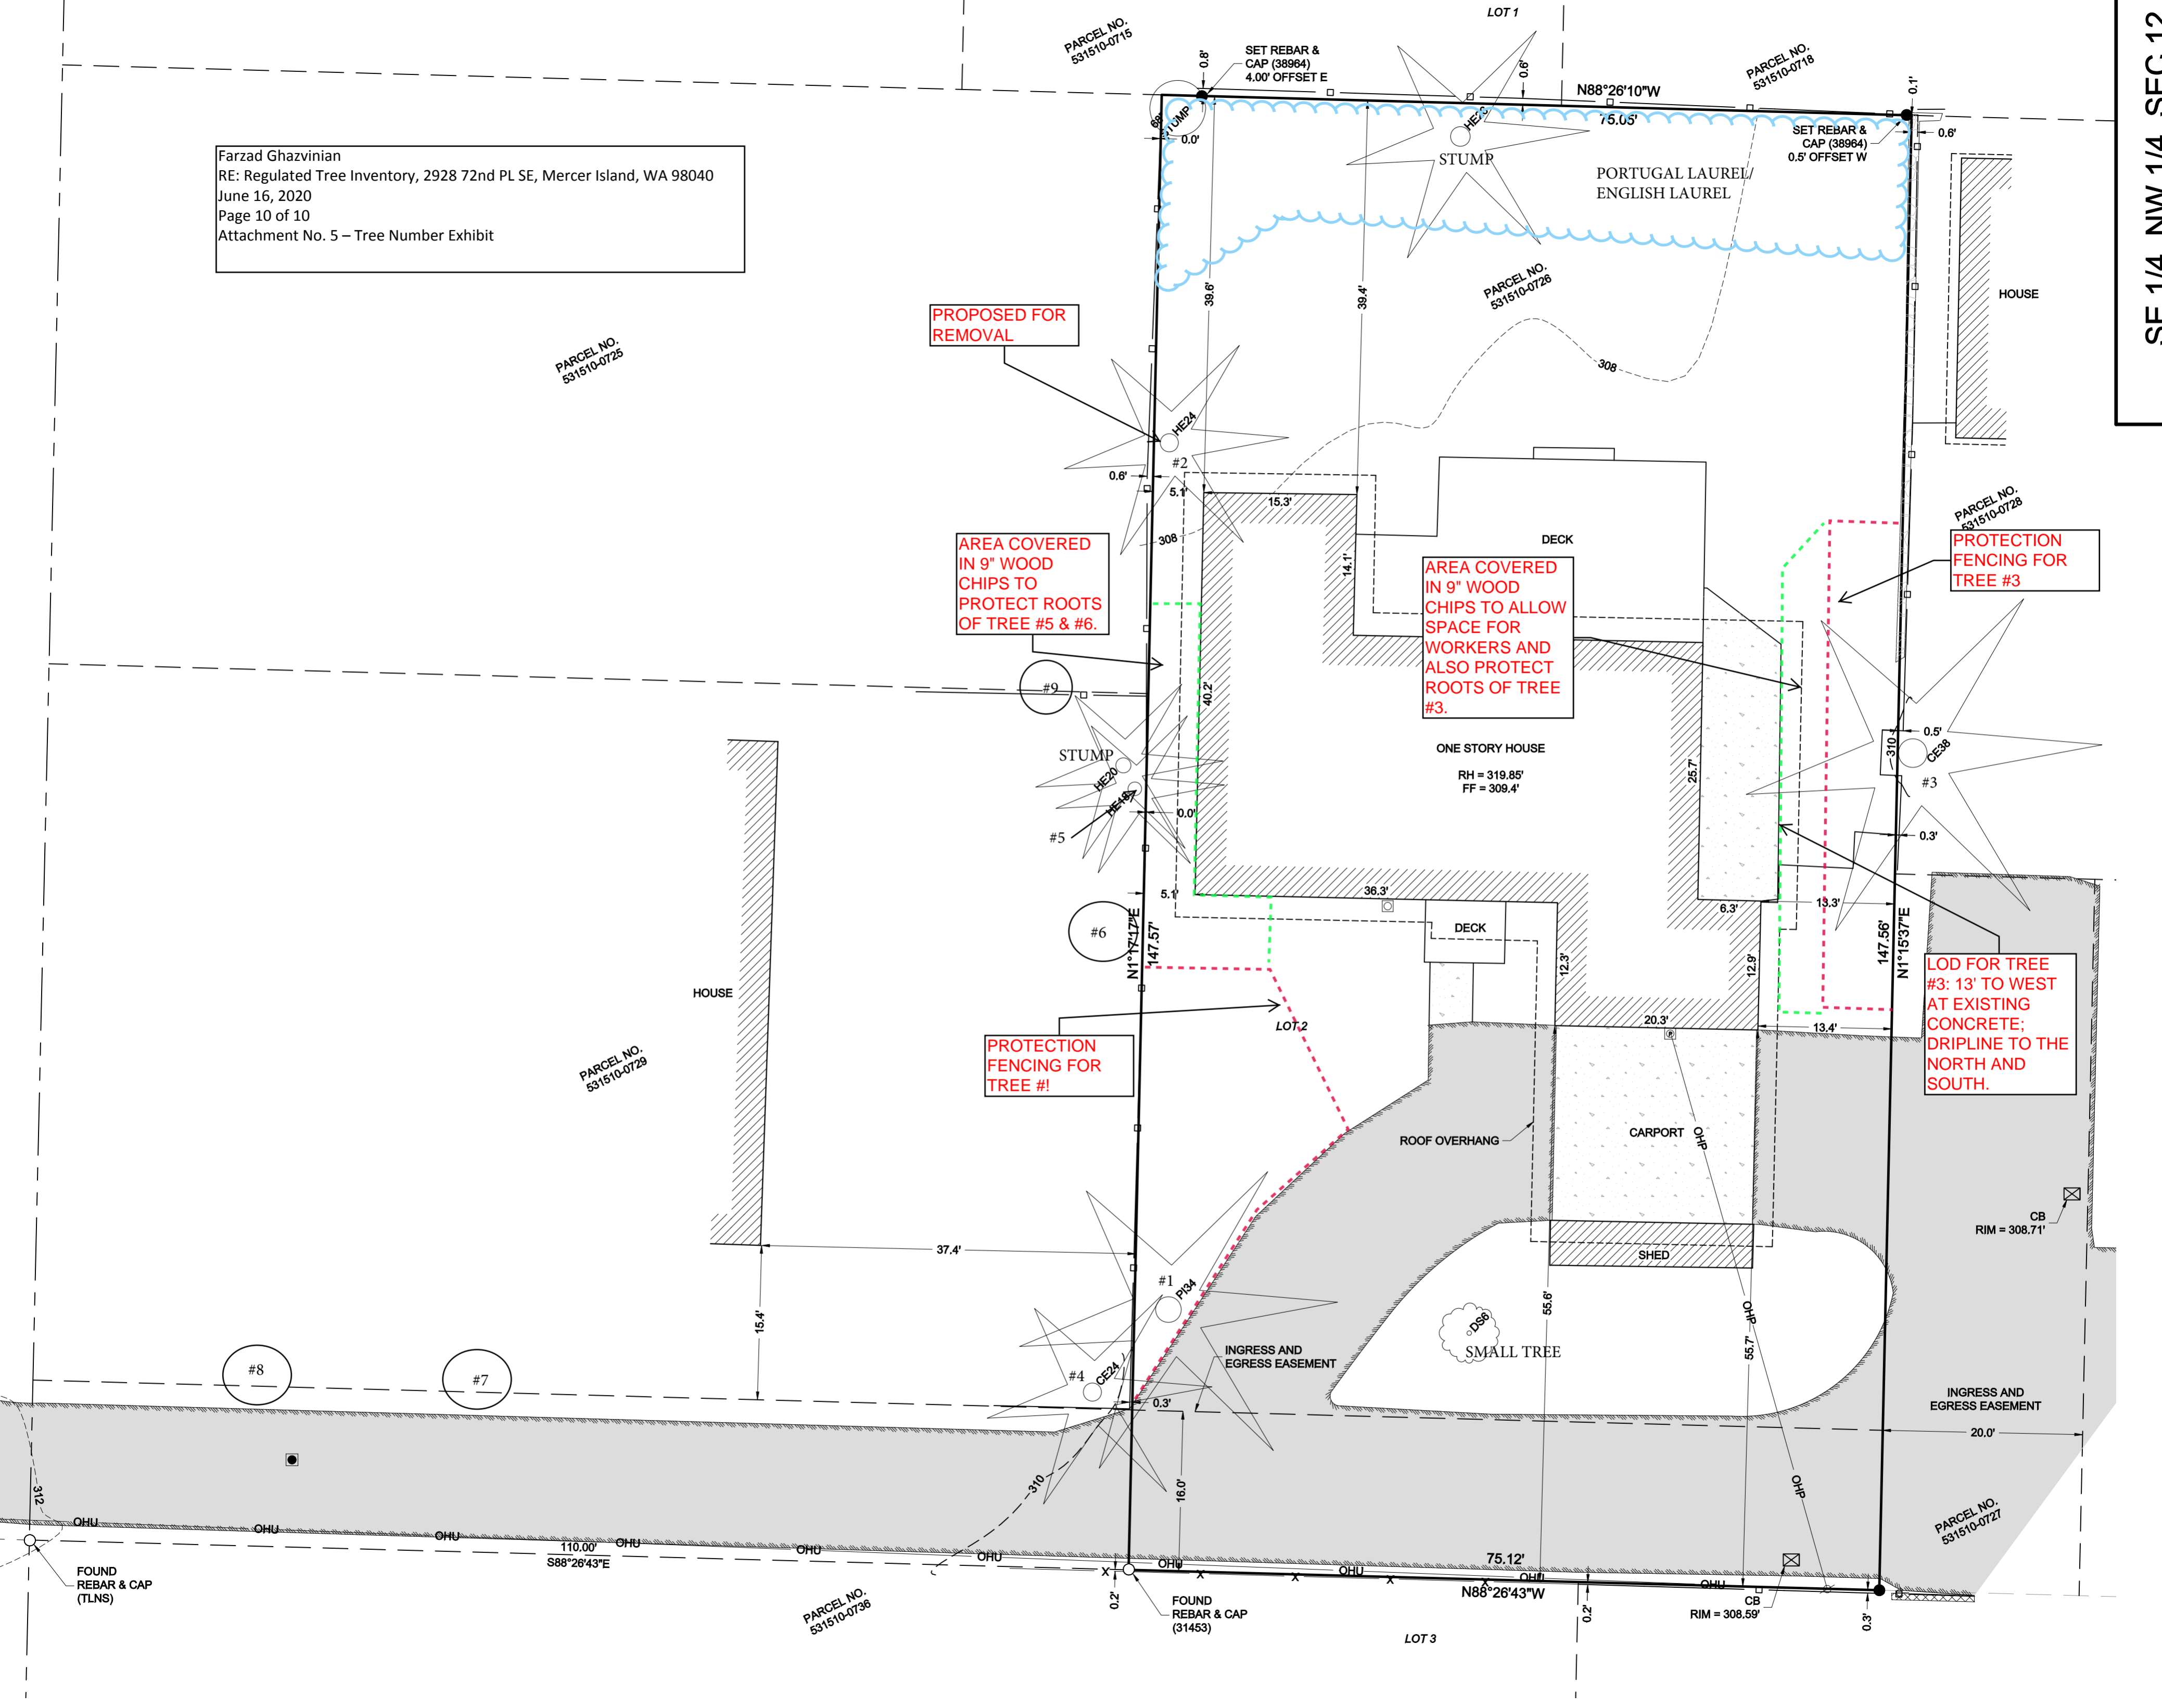
Farzad Ghazvinian
RE: Regulated Tree Inventory, 2928 72nd PL SE, Mercer Island, WA 98040
June 16, 2020
Page 10 of 10
Attachment No. 5 – Tree Number Exhibit

LOD FOR TREE #3: 13' TO WEST AT EXISTING CONCRETE; DRIPLINE TO THE NORTH AND SOUTH.

PROPOSED FOR REMOVAL

AREA COVERED IN 9" WOOD CHIPS TO PROTECT ROOTS OF TREE #5 & #6.

AREA COVERED IN 9" WOOD CHIPS TO ALLOW SPACE FOR WORKERS AND ALSO PROTECT ROOTS OF TREE #3.

PROTECTION FENCING FOR TREE #3

PROTECTION FENCING FOR TREE #!

Minimum six (6) foot temporary chain-link fence shall be installed at the driplines of tree #1, except where covered in paving, and as show on the attached exhibit for tree #3. Install fence posts using pier block only. A City planner must approve any modifications to the fencing material and location.
