## Re: Arborist Assessment

The Watershed Company Reference Number: 200604

We are pleased to present the findings of our tree assessment for the property at 7254 North Mercer Way (parcel #5315100056) in Mercer Island, WA. Jake Robertson, an ISA Certified Arborist® with The Watershed Company, visited the subject property on June 8, 2020 to assess the trees on the subject parcel following the construction of a new single-family home. This assessment was requested by the City of Mercer Island to determine if retained trees have been negatively affected by construction. Anderson Architecture provided a site plan, dated March 5, 2020, which showed surveyed trees and trees proposed to be removed.

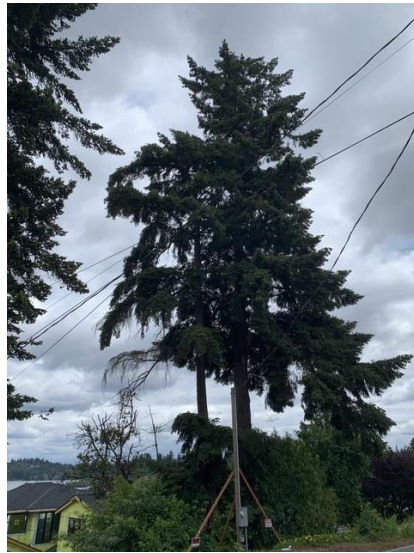
Trees #1 and #2 are mature *P. menziesii* in Fair condition. Tree #1 has a DBH of 31.1 inches and had been topped prior to construction, as no recent cuts are found on the stem. The stem is covered with large amounts of running sap and has a dead branch on the lower canopy approximately 15-feet off the ground. At ground level, the tree is rooted approximately 20 to 25 feet from a retaining wall and where construction of the home began. Tree #2 has a DBH of 44.5 inches and has a height of approximately 100 feet. As with Tree #1, Tree #2 has sap running down the stem but does not have any noticeable deadwood within the canopy. This tree is rooted next to Tree #1 and is 20 to 25 feet from the same retaining wall. It is possible that some critical roots have been cut from both trees; however, it is believed that construction impacts sustained thus far will not lead to decline and tree death.

Figure 2. Two Douglas-firs are growing on the west side of the property. Tree #1 is on the left (with dead branches) and Tree #2 is on the right (with a full crown).

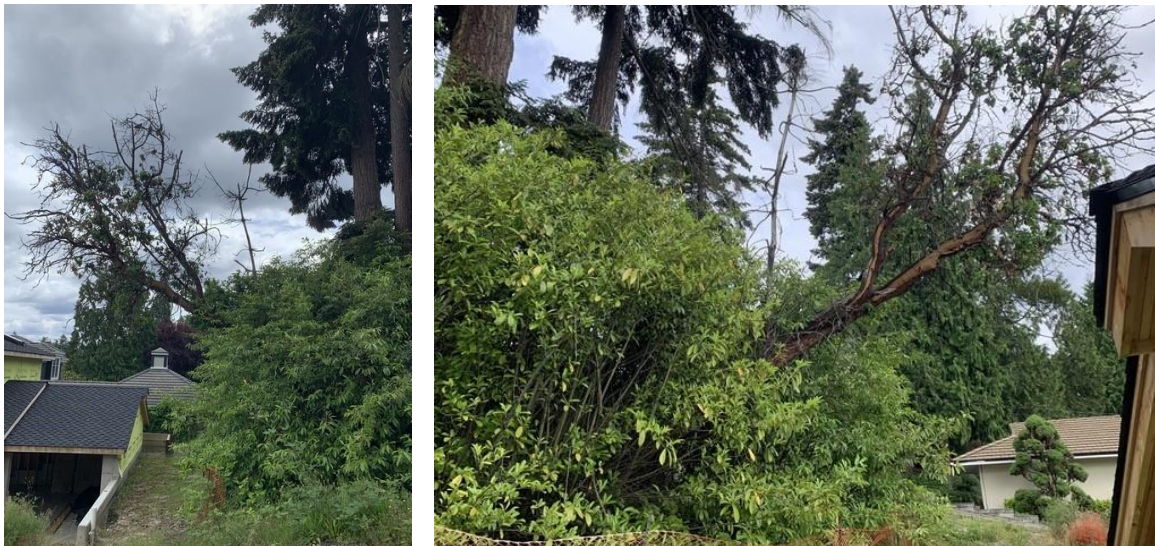
This madrone contains approximately five to ten percent of live foliage in its canopy, with a DBH of 15.5 inches and an estimated height of 40 feet (see Figure 3). This tree is dying and at risk of failing and striking the new home. Selective pruning and crown cleaning would not be effective in minimizing the risk and the tree is recommended for removal. Construction may be the cause of death as the tree is rooted approximately 10 feet from the retaining wall and excavation and many of the critical roots have been lost.

Figure 3. Tree #3 is an *A. menziesii* in severe condition with a substantial lean towards the new home.

Tree #3 has declined into a hazardous state that is at risk of failing and striking the newly constructed home. Destruction of critical roots from excavation is the most likely cause of this decline and removal is the only mitigation option recommended. Enclosed within this report is a completed Tree Risk Assessment Form completed by TRAQ certified Arborist Kyle Braun. Replacement of hazardous trees follow the same replacement ratio as healthy tree removals.

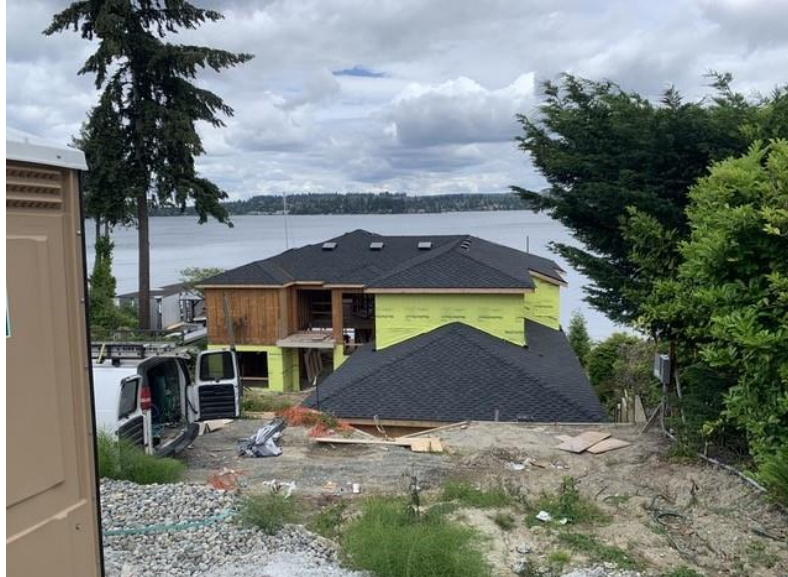
On the survey, two trees were identified for retention in the backyard, to the east of the new residence. The DBH of these trees was recorded as 12 and 18 inches, but these trees have been removed. Below are photographs of the backyard where the trees were previously located (Figure 4).

Figure 4. Two additional significant trees were proposed to be retained in this location.
