ARBOR INFO LLC

**Tree Assessment
For
Seascape Homes
At
Lot 4, 5202 Forest Ave SE
Mercer Island, Washington**

**Date
2/14/2021**

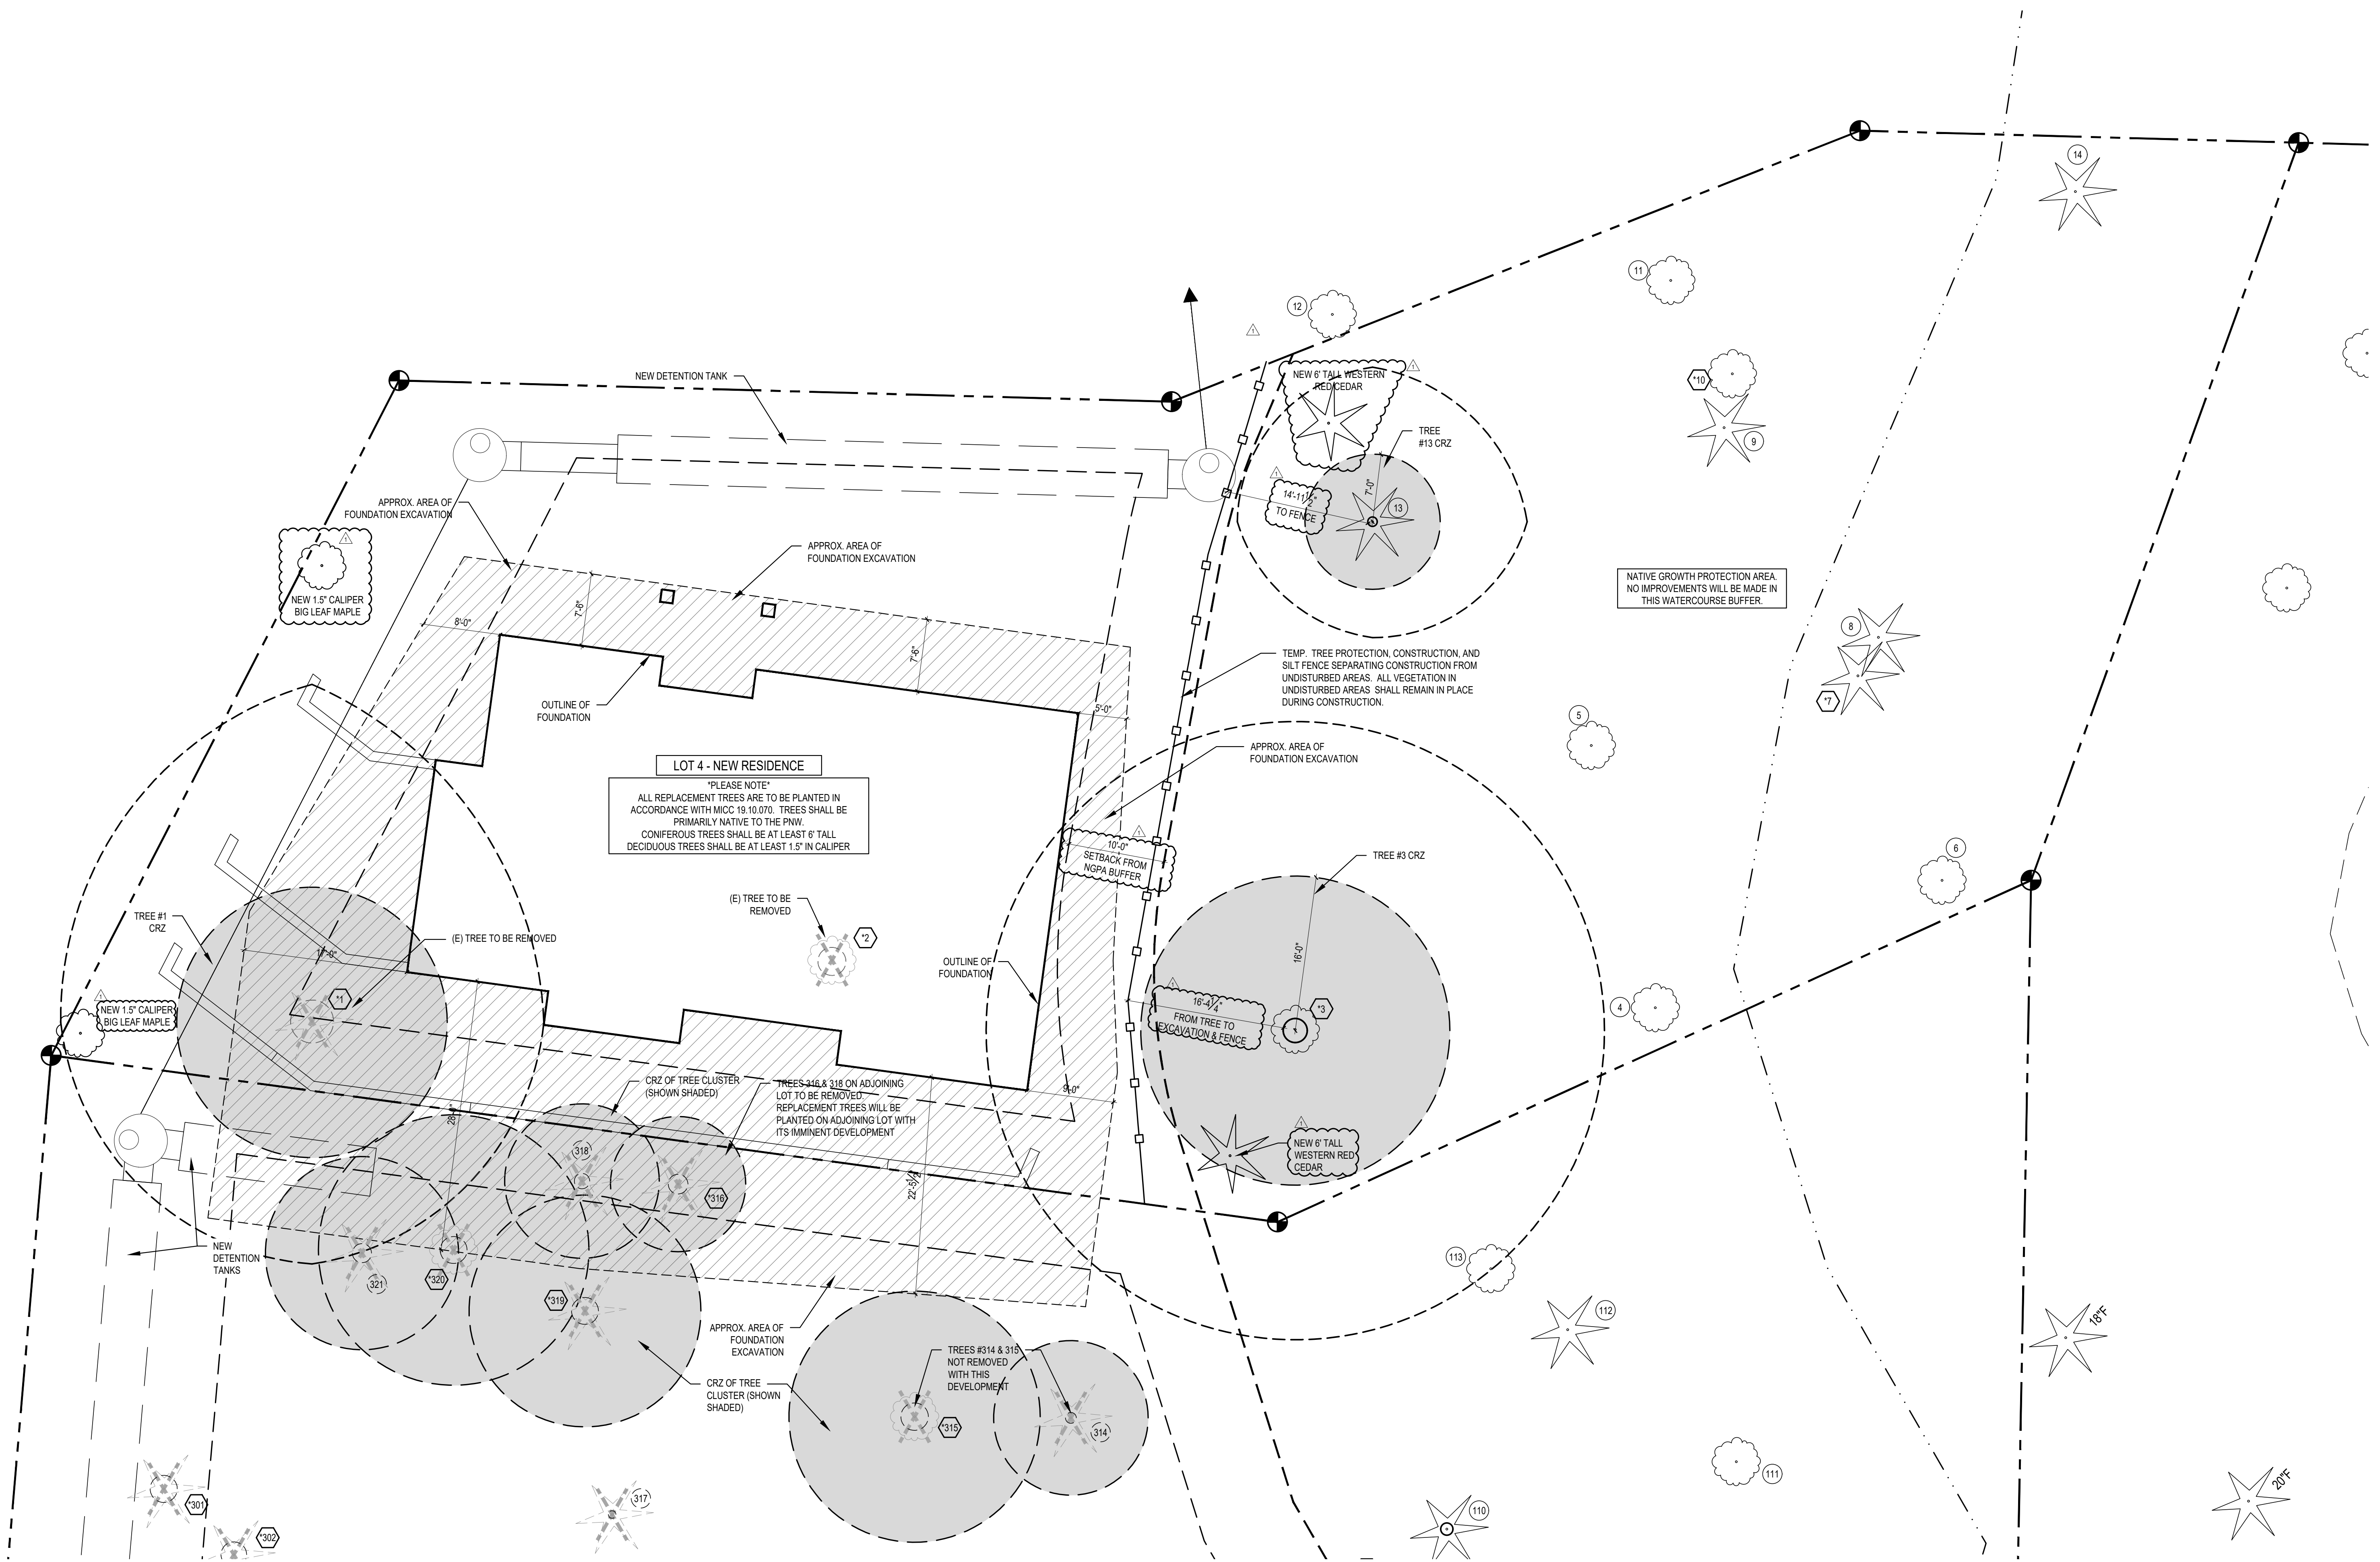
1 LOT 4 TREE PLAN
 SCALE: 1/8" = 1'-0"

Three trees, No. 1 and 2, both bigleaf maples and 6, a western hemlock are non-viable. No. 6 is located away from potential targets and can be retained. Trees 1 and 2 will become high risk hazards once the house is constructed and should be removed.

Trees No. 1 and 2 are within the proposed building foot print. No replacement is required per (MCC 19.10.070). Basic Tree Risk Assessment forms are attached for both trees.

Tree No. 3 within the NGPA is measured at 18.3 feet east of the excavation zone. This encroachment into the root zone will affect about 20-percent of the entire zone and less than 5-percent of the critical root zone. Post construction, this over-mature tree will overhang the house.

In my opinion, Tree No. 3 should be can be retained as the root structure will not be significantly impacted by excavation although it will overhang the house once that is built.

- Certified Arborist on site during excavation activities within the defined root zone of all trees.
- All trees to be retained are to be fenced at the edge of the recommended tree protection zone with 6-foot high cyclone type fencing.

- Utility lines should be bored. Bore access pits to be developed with 18” buckets or hand dug.
- Retaining wall footings to be minimally deep, no more than 12-inches.

- Tree roots over 1-1/2 inches in diameter encountered in all excavations are to be cut cleanly to the trench wall with clean sharp tools. Roots to be covered with soil or wetted burlap if they must remain exposed.

- Supplemental irrigation is to be provided during summer months (generally June-September) for all trees in the construction zones.
- Recommended protected tree root zones are to be covered with 4-inches of hog fuel at all times. Where machinery access is needed, the root zones should be covered with 12-inches of hog fuel, plywood or steel sheets.

- Stumps for trees to be removed are to be ground out (not excavated).
