LAYTON TREE CONSULTING, LLC

ARBORIST REPORT/TREE PLAN

4245 90th AVE SE
Mercer Island, WA

October 12, 2020

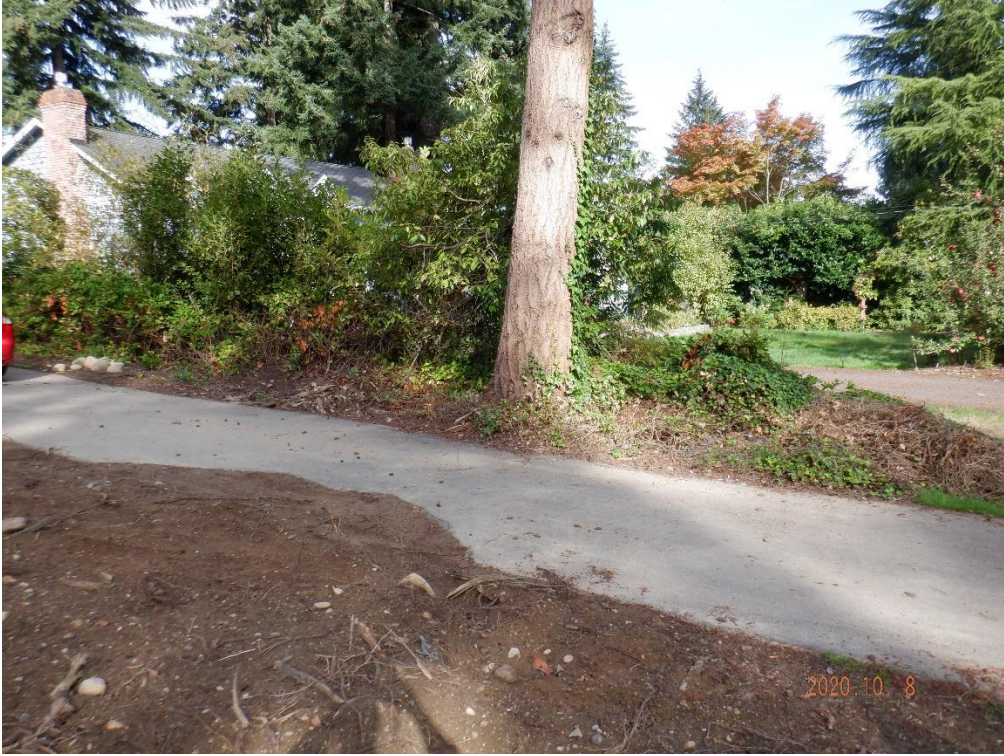
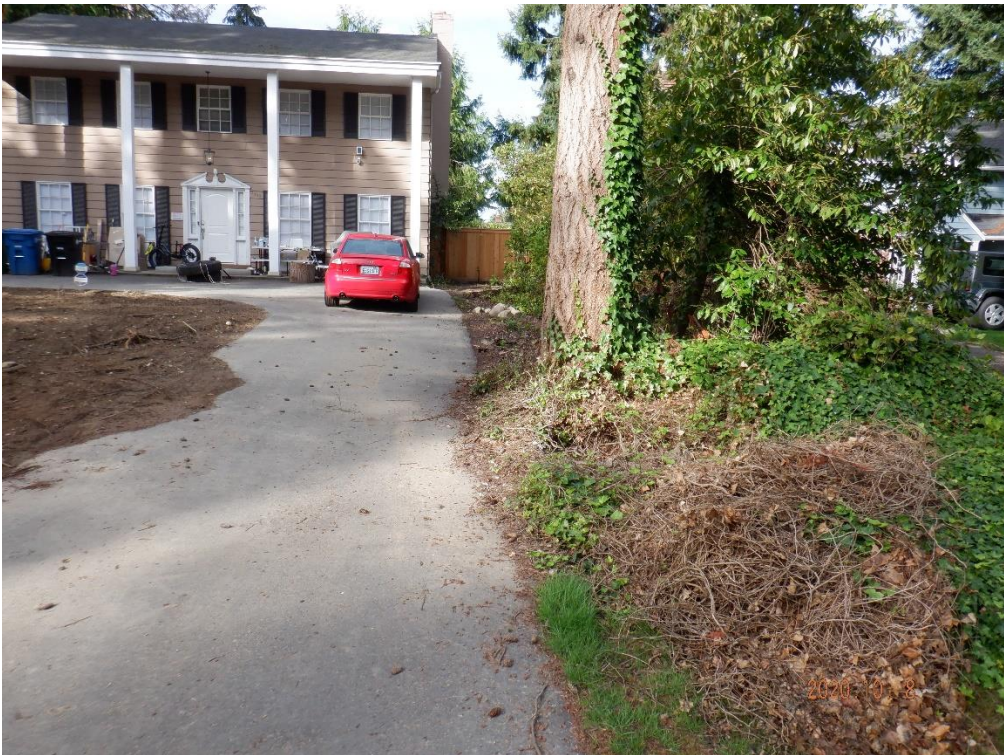
Tree #1 is located near the northeast corner. This is a semi-mature Douglas fir. It has developed good structural form. Vigor is good. The crown is somewhat asymmetric to the south. Trees were recently removed on the north side. The lower trunk is sound with no outward indicators of any internal decay issues. Condition is rated ‘good’.

Tree #1 – lower trunk

No further tree removal is proposed. All of the subject trees will be retained. Tree #1 has been recently exposed or isolated by the removal of trees to the south. This tree should be periodically monitored, particularly after strong wind events. Monitor for changes in lean or ground movement around the base of tree. If any conditions of concern arise, have the tree assessed for risk immediately.

If the existing asphalt driveway is to remain undisturbed adjacent to Tree #1, there should be no impact to the tree. If the driveway is to be replaced, work within the dripline shall be accomplished using hand-labor only. Care shall be taken to preserve any roots that exist underneath the existing pavement. Position a tree protection barrier as shown on the attached map to protect the trunk and soils to the east and west. New pavement placed south of the existing driveway is not expected to have any adverse impacts on the tree.

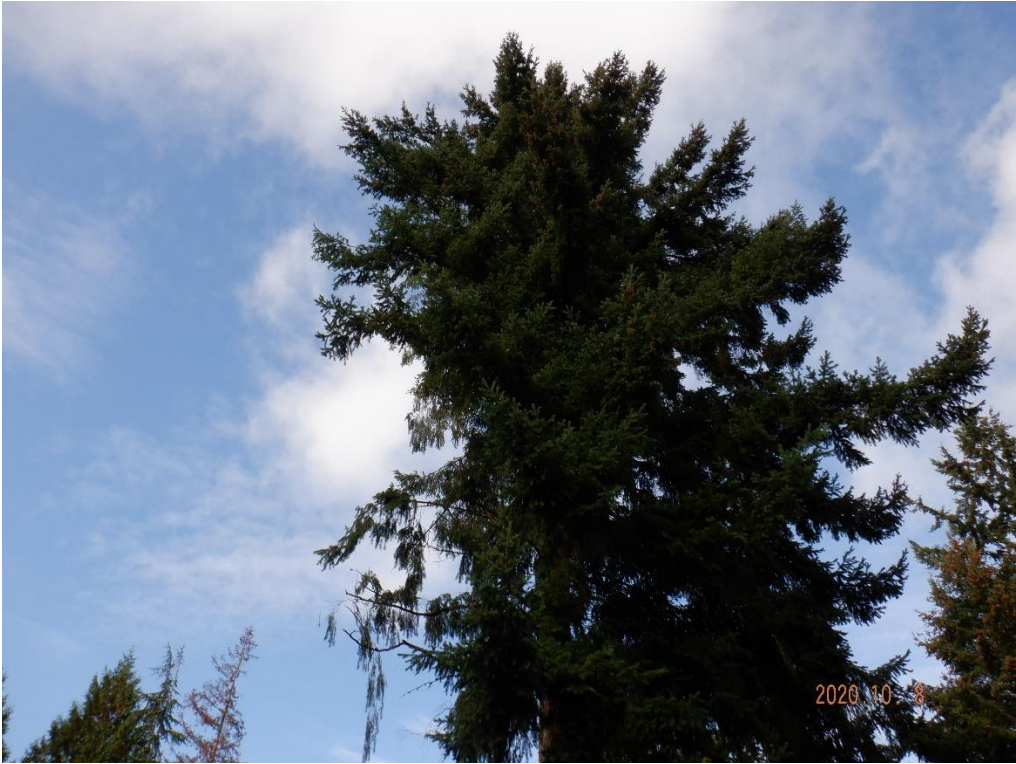
Tree #1 – upper crown, looking west from street

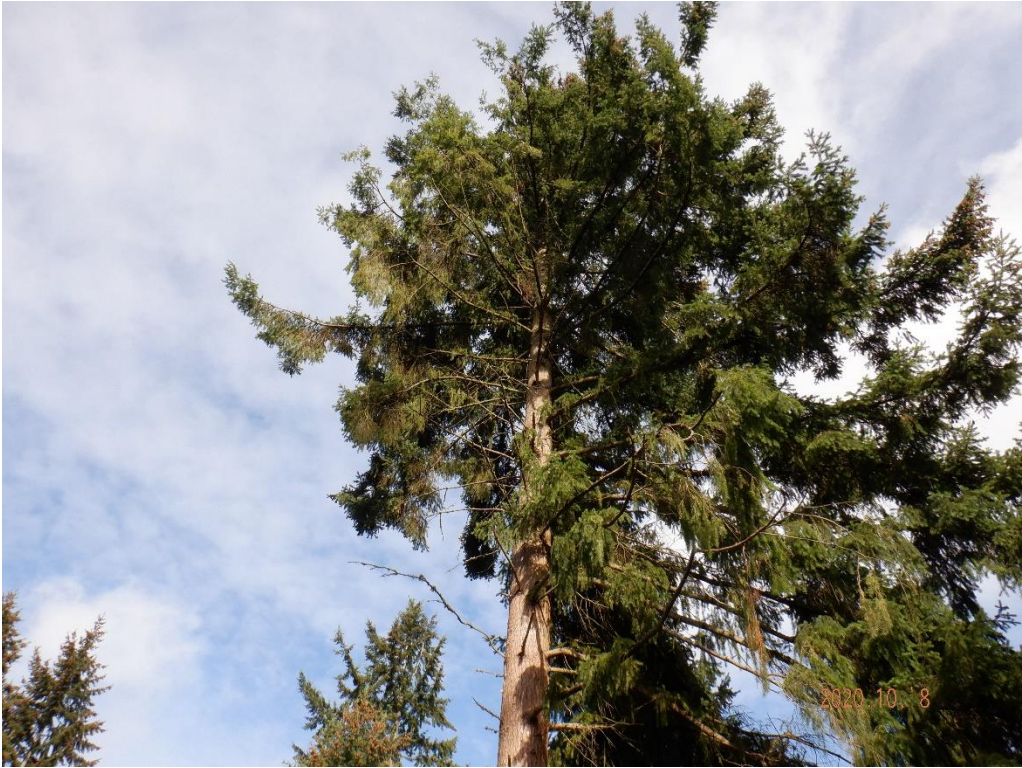
Tree #1 – upper crown, looking north

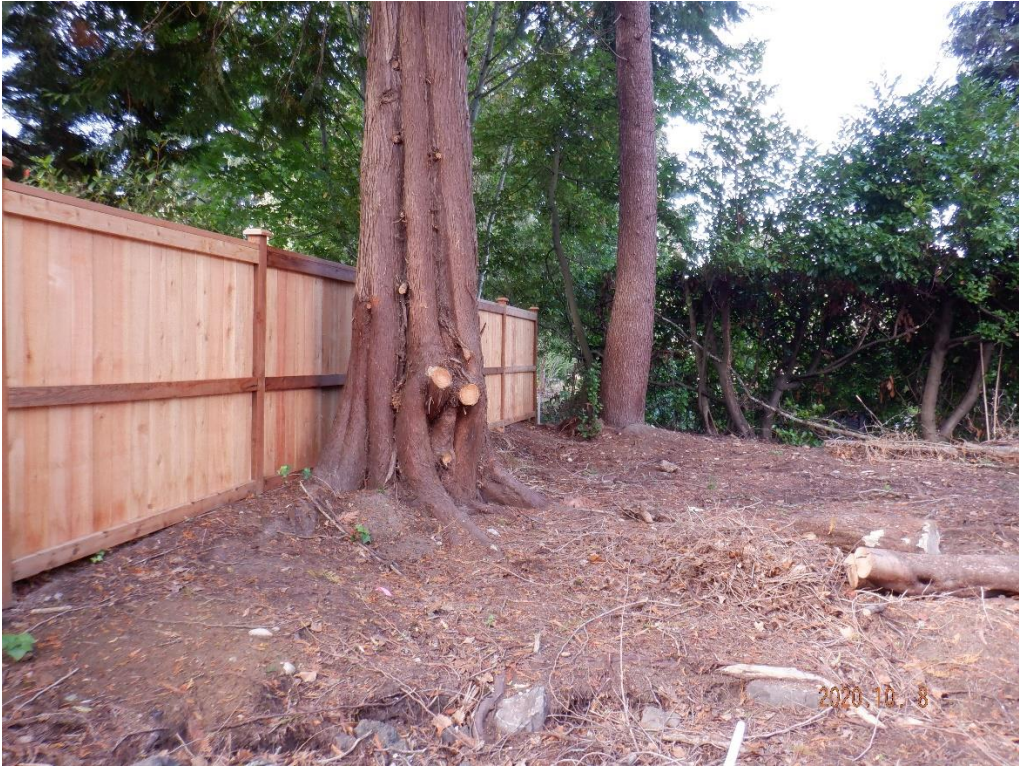
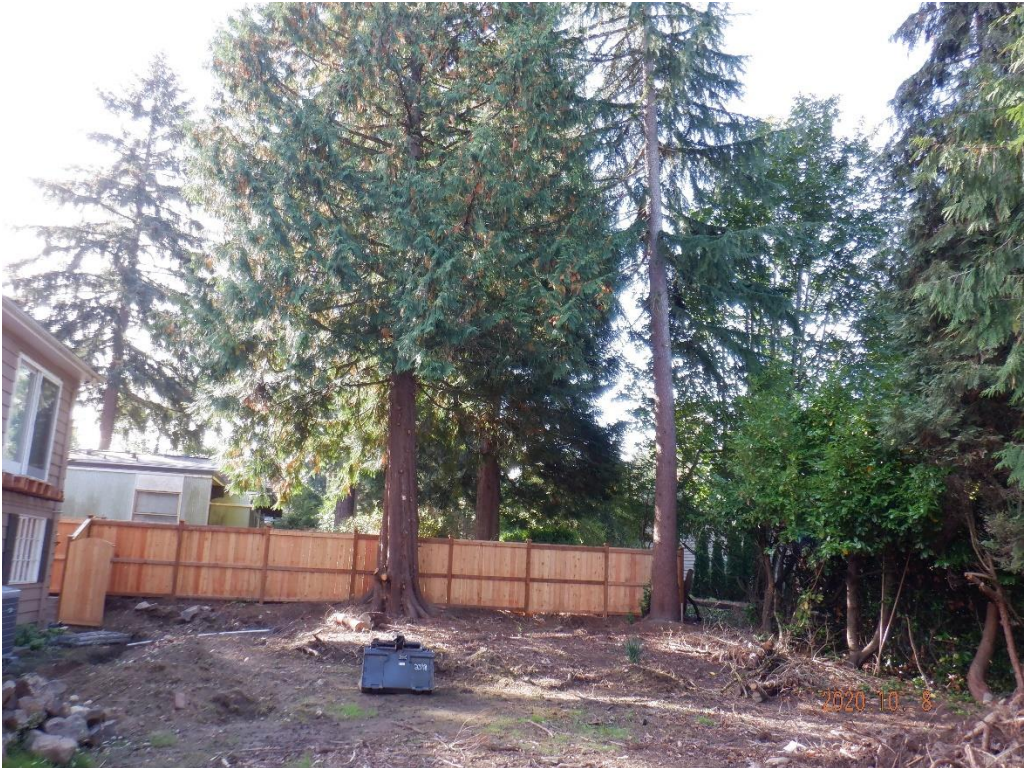
Tree #2 is a semi-mature Western red cedar. It has recently been crown-raised. Vigor is good. Soils and surface roots have been recently disturbed on the north and northeast sides during vegetation removal. The lower trunk is sound with no outward indicators of any internal decay issues. Condition is rated ‘good’. Tree #2 is ‘exceptional’ under City code.

Tree #3 is a semi-mature deodar cedar. Vigor is good. Soils and surface roots have been recently disturbed on the north and northeast sides during vegetation removal. The lower trunk is sound with no outward indicators of any internal decay issues. Condition is rated 'good'.

Trees #2 and #3

Trees #2 and #3, looking south from backyard

No work is proposed in the backyard other than landscaping. A significant amount of vegetation was recently removed from backyard of the subject property. The grubbing of vegetation and stumps has disturbed soils and surface roots within the driplines of subject trees. Any further work within the driplines shall be accomplished by hand-labor only. Hand rake soils to establish finish grades. To maintain these trees in the best condition possible, simply finish the landscape within the driplines of

subject trees by placing a 3 to 4-inch layer of organic mulch. Avoid large plantings, the construction of hardscapes and irrigation trenching within the driplines of subject trees. Ensure trees are provided supplemental irrigation during the dry months of June through September.

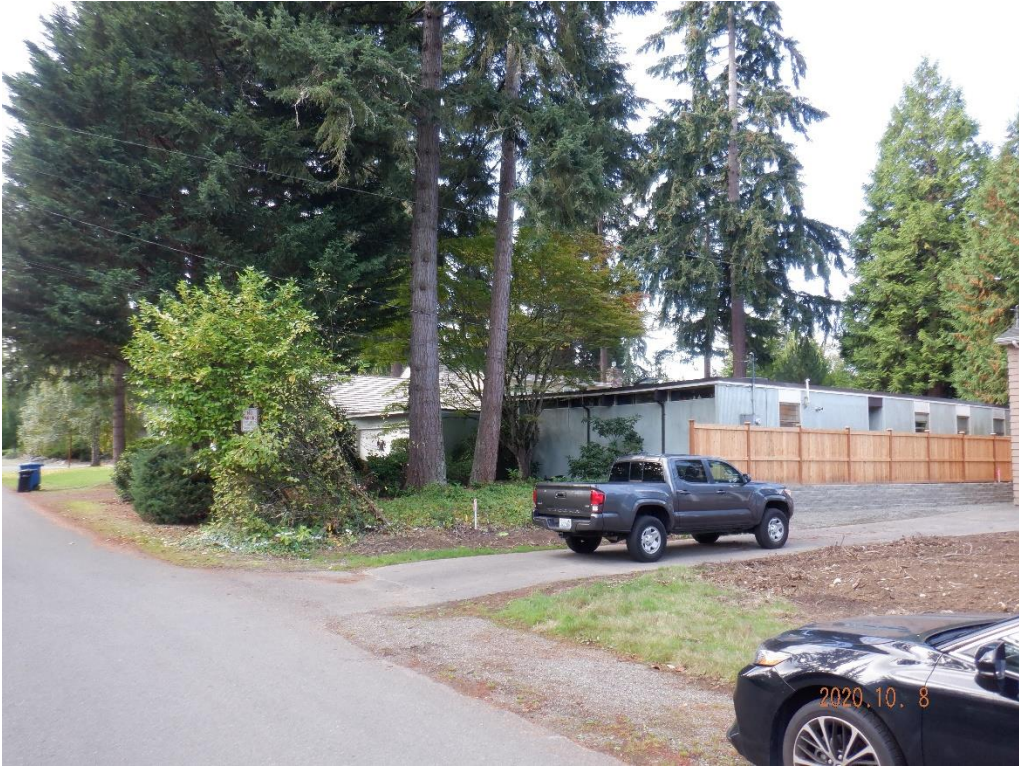
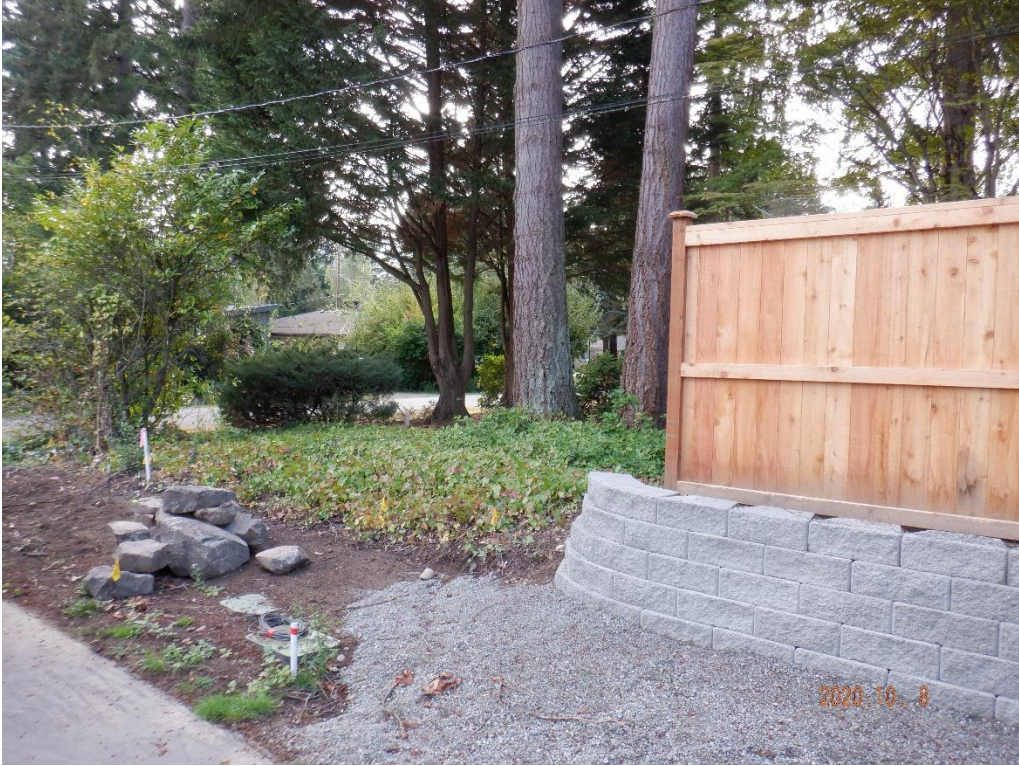
Trees #101 and #102 are semi-mature Douglas fir, located roughly 16-feet off of the property line on the neighboring property to the south. No concerning defects were observed from the subject property. Both are of good vigor and in 'good' condition.

Neighboring trees #101 and #102

South property line looking southeast at Trees #101 and #102

Neighboring trees #101 and #102 are situated several feet (+/- 16-feet) off of the property line. These will not be impacted by the proposal. Work up to the property line is acceptable. Place the tree protection barrier at the property line to ensure no impacts.

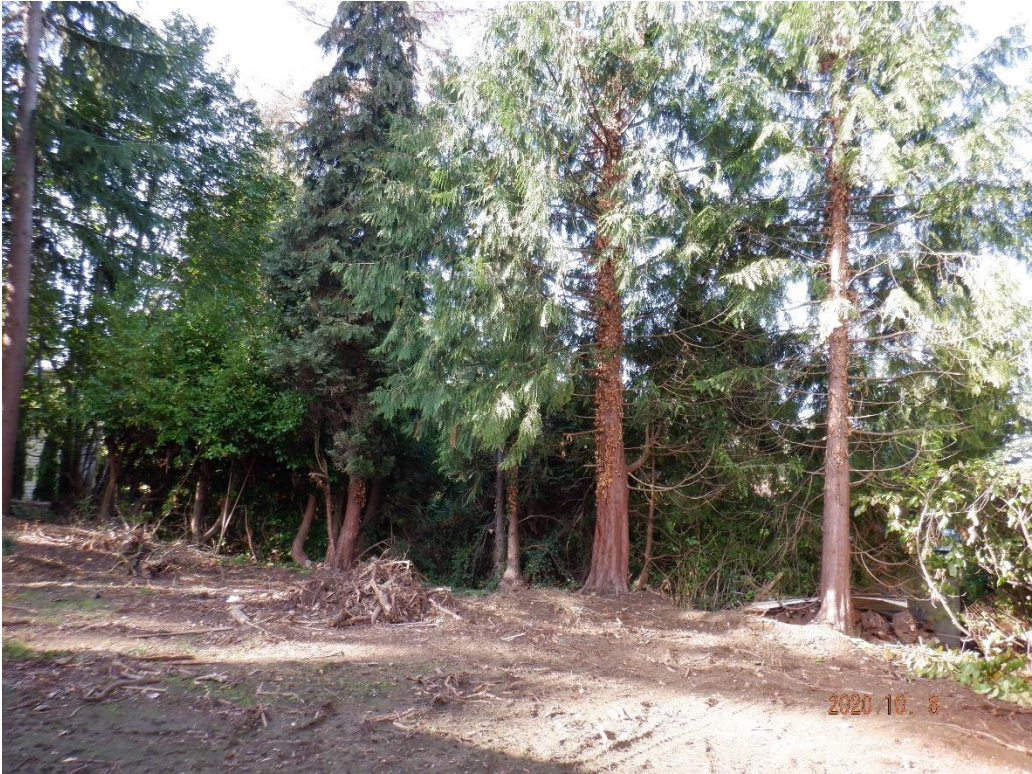
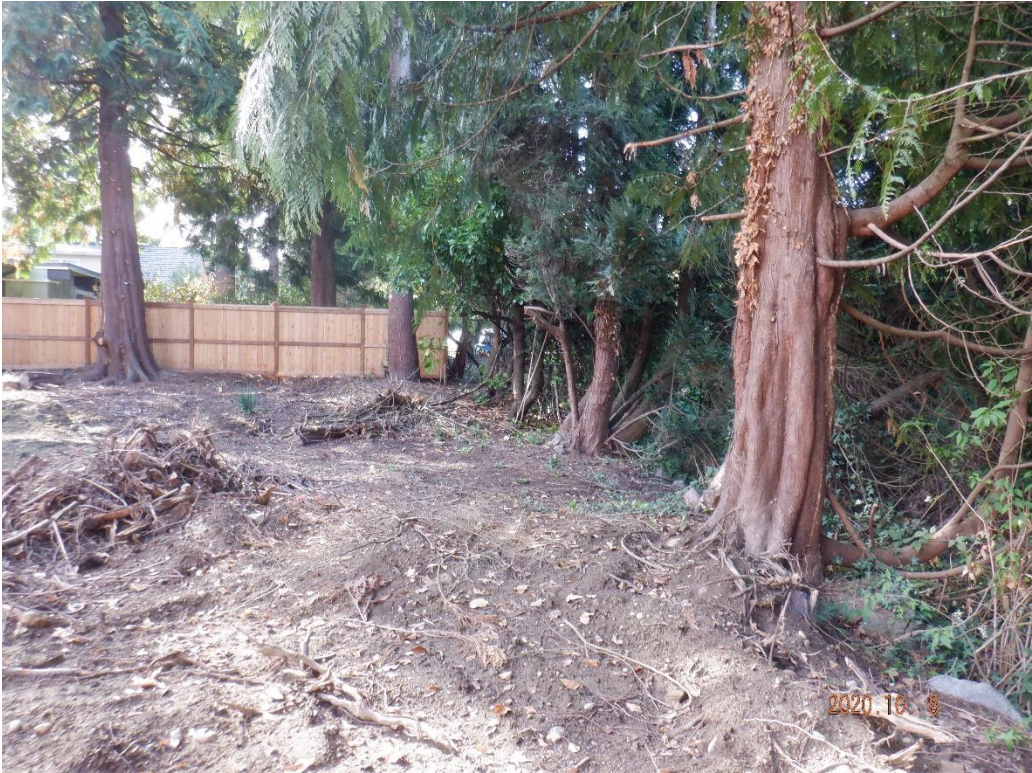
Tree #103 is a young to semi-mature cluster of Lawson cypress. It has developed typical form for the species. Vigor is good.

Tree #104 is also a young to semi-mature cluster of Lawson cypress. It has been topped at roughly 12-feet above ground. Structure has been compromised. Condition is 'poor'.

Trees #105 and #106 are young to semi-mature Western red cedar. Both are of good vigor. #105 has an old broken top. #106 has a natural lean to the west. Both appear structurally sound.

Soils on the east sides of Trees #103 > #106 have been recently disturbed. See pictures below.

Neighboring trees #103 > #106

West property line, looking south
