**Project:** Pre-construction assessment for lot development at Villa Marbella Lot 6, Mercer Island, WA. Parcel number 8944220060.

**Objectives:** Evaluate health of existing trees and establish criteria for the preservation of those to be retained. Update original inventory report from 11/24/19.

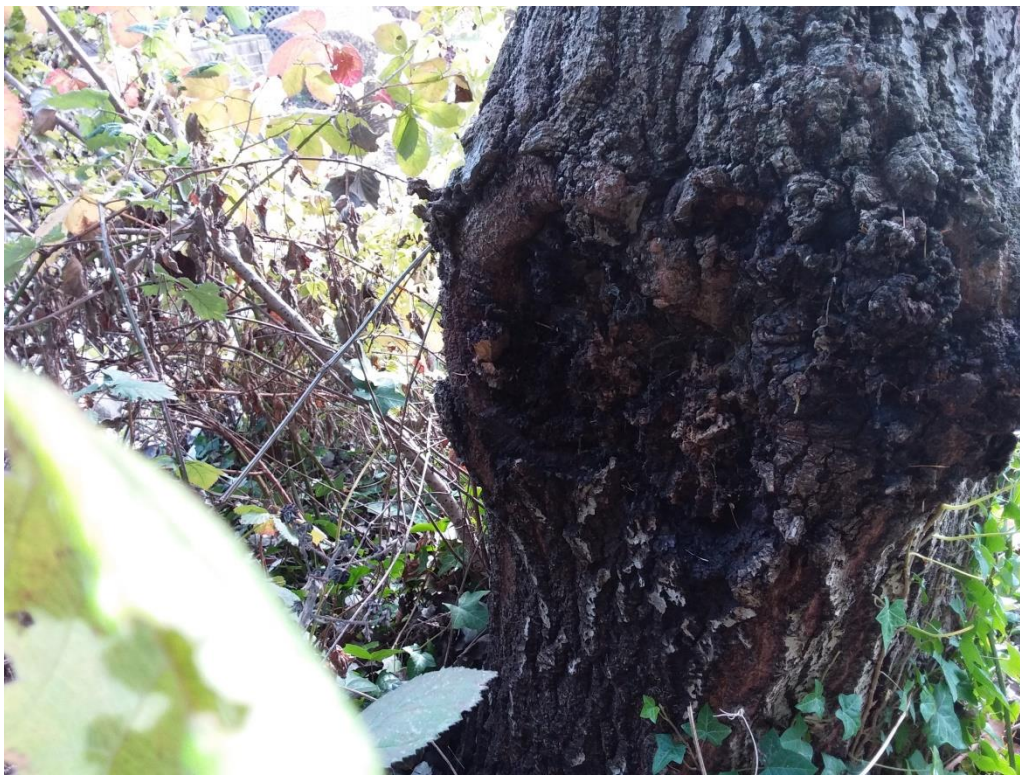
- 5) Western Red Cedar 8" DSH, 35' tall standing 7' W of the #4 tree and subordinated to it. It is in below average condition.
- 6) Silver Poplar (*Populus alba*) 21" DSH, 50' tall, 20' spread standing 11.5' W of the private drive and 16' S of the #4 cedar. It is in weak condition with a large canker near the base on its north side (Figure 4). The tree leans markedly to the south and it has a large scaffold extending over the drive.

Figure 4. Photo of the canker on the base of #6 Silver Poplar.

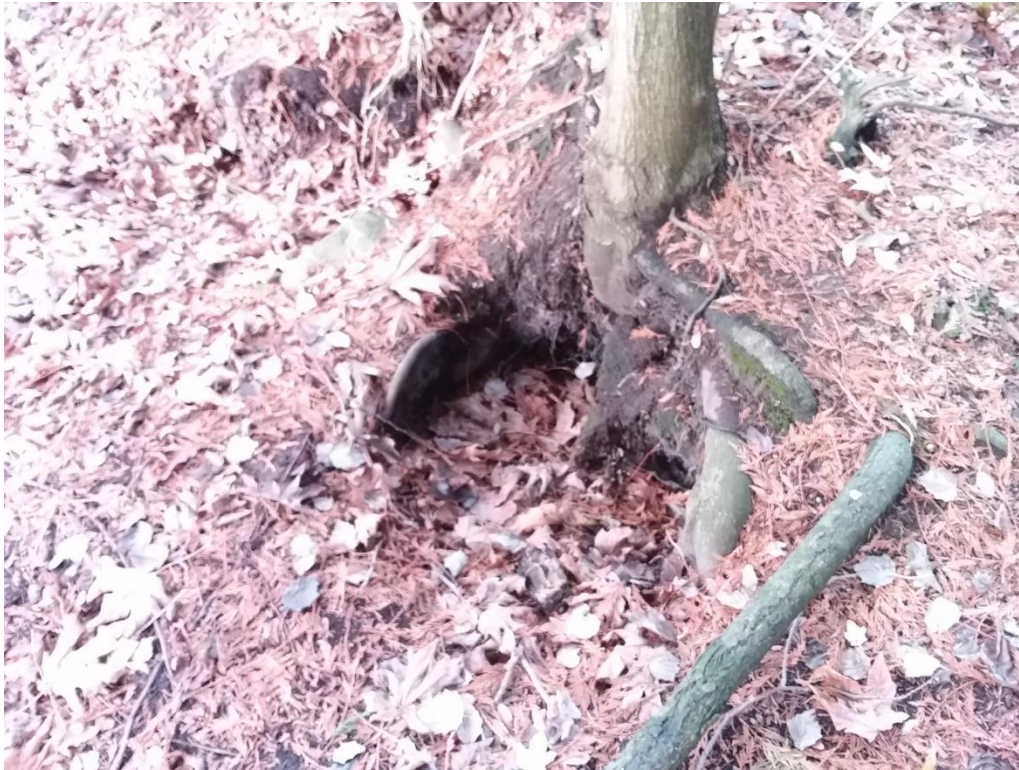
- 9) Big Leaf Maple (*Acer macrophyllum*) 7" DSH, 40' tall, 12' spread to the north only. It is standing 10' N of the #8 tree and is growing out from under its canopy. The tree leans noticeably to the north and has a dug out area on its south side (Figure 5).

Figure 5. Photo of hole at base of the #9 maple.

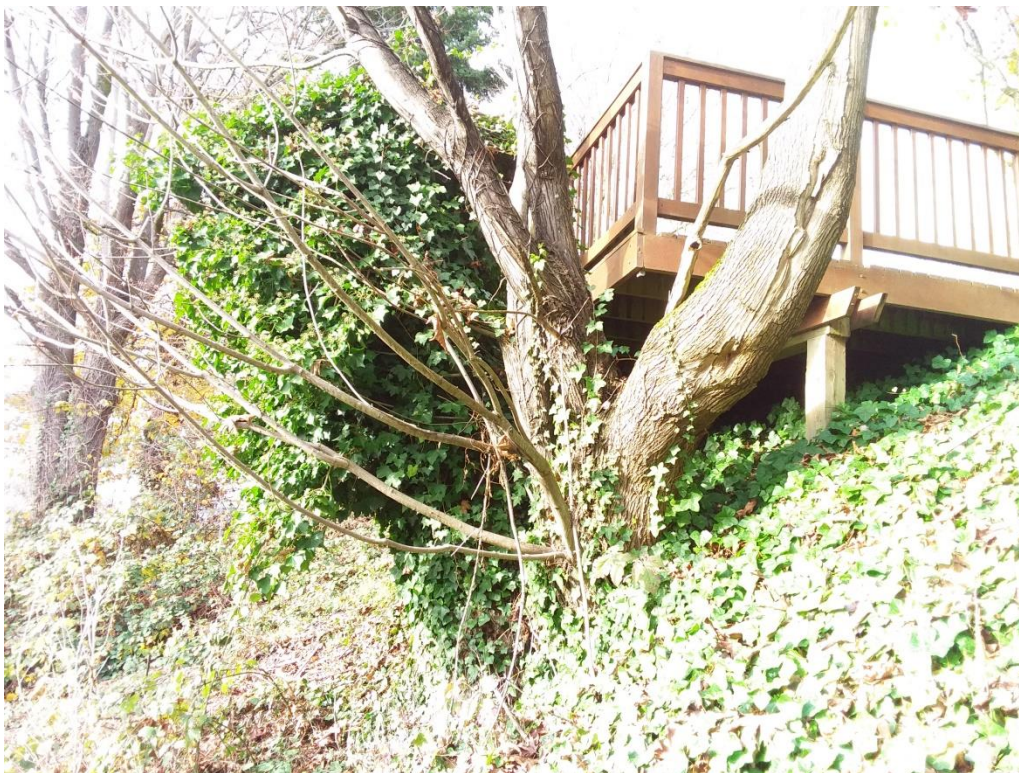
- 11) Big Leaf Maple growing out from under the SE corner of the center deck (Figure 6). The tree separates into three stems from the 30" level. The largest is 18" DSH and grows to the NE before turning vertical near the 8' mark finally reaching 55' tall with a 9' spread. The center stem leans to the south, is 10" DSH, goes to 40' tall, and has an 8' spread. The west side stem is 9" DSH, twists somewhat around the base of the deck before going vertical to 35' S with a 6' spread. The tree appears to be in fair health overall but has a compromised structure.

Figure 6. Photo of base of the #11 maple.

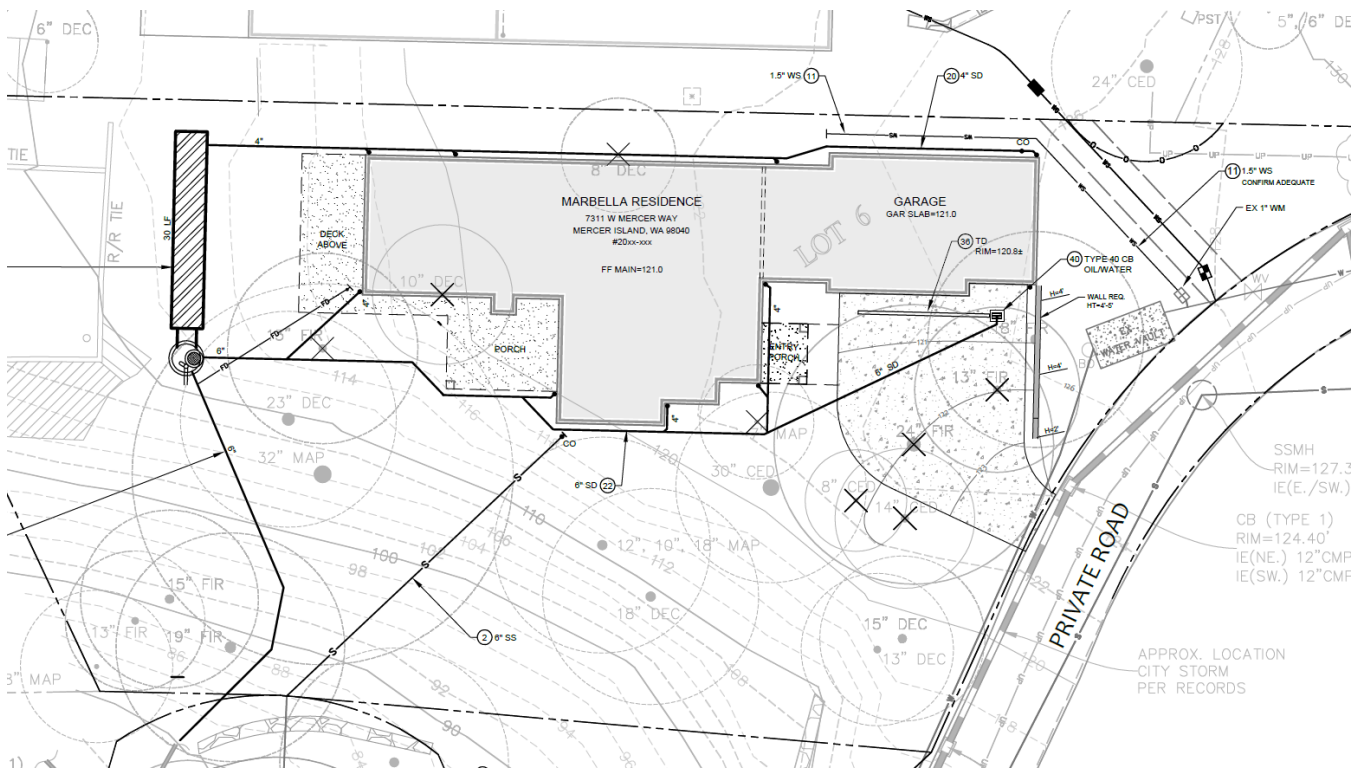
In the case of the #8 cedar mentioned above, while the excavation for the proposed foundation will be at least 14' from its base, the cut for the driveway curves to within 10' in the NE quadrant, and the storm drain is shown coming as close as 7' from the base of the tree. From Figure 8 the Structural Root Plate for a 33" DSH tree is given as 10' so the foundation excavation work will be clear of the SRP, the driveway work will just graze it, and the trenching for the drain line will potentially cut 3' into it. This is not ideal for a large tree on the south side of the home and will likely create a destabilizing event.

The #14 chestnut (23" DSH) has a 9.5' SRP. The storm drain line is shown running 8' north of this tree and there is a drain junction box 15' off in its NW quadrant. But the excavation work will be at least 20' away.

The #14 chestnut (23" DSH) will theoretically experience impact at 35% CRZ for a loss of near 36% CRA. This will be too great for the tree as chestnut trees are more sensitive to disruption than some of the other species. If the drain line could be installed such that it does not impact the roots then this tree will experience little to no impact from the home construction.

The #15 maple has a 40" DSH and will be potentially impacted on two sides by the storm drain 17' to its north and the sewer line running 20' off through its SE quadrant. The storm drain trenching would create a loss of 34% of the maple's CRA. The sewer line trenching would result in a loss of 32%. Combined they would account for at least 60% of the maple's rooting space and would push this already struggling tree into a rapid decline cycle.

The proposed sewer line trench also crosses 11' off the base of the #26 fir. This could potentially result in a loss of 34% of the tree's Critical Rooting Area, just over its recommended survival threshold.

Figure 7. Excerpt from the proposed plan set showing location of new house in relation to the onsite trees. Note that the circles set around the trees do not indicate the extent of their Critical Root Zones necessarily. Some circles are close to representative. Others, like the one for the #15 maple are short by close to 15' radially. The sizes shown for each tree are also not always correct. Please refer to the Description section to ascertain the correct diameter for any tree in question.

**Recommendations:** There does not seem to be a feasible way to safely retain the #8 cedar. Even though it qualifies as an Exceptional tree per MICC 19.16 it also qualifies for removal per MICC 19.10.06(3)(a) because attempting to retain it will create an unavoidable hazardous situation. The tree is too exposed, on the south side of the house, and will lose a significant portion of both its SRP and CRA.

If in any way possible it would be excellent to not cut the roots on the #14 (and potentially #15) tree when installing the storm drain. Perhaps using an air spade to open the trench (assuming it is not singularly deep) and then threading the pipe through the roots, just severing the minimal amount for clearance purposes, would be feasible.

Ideally the sewer line running past the #15 and #16 trees could be shifted somehow to prevent or minimize the impact to both trees. Perhaps once the existing side sewer stub line at the base of the slope is examined some thought could be made to adjusting the track of the line from the house to its attachment point. Maybe a joint could be added such that the line heads closer to due south and then cuts back toward the existing line from lower on the slope.

Typically tree protection fencing is set at the limit of the CRZs of the trees to be retained. In this instance the fence should run the full 20' off the #6 and #7 trees and then over to the deck which is going to be removed. From the west end of the deck it should follow the top of the slope making sure to stay at least 23' back from the #14 tree. It is acknowledged that setting the fence around the chestnut in this manner will cross through the building site. The purpose for this is to ensure that an arborist oversees the excavation which will occur near this tree. The fence should not be moved without the arborist present.
