Site Visit Report

Client: Chung Youn

Date: 12/01/20 (rev)

Address: 7002 78th Ave SE, Mercer Island, WA

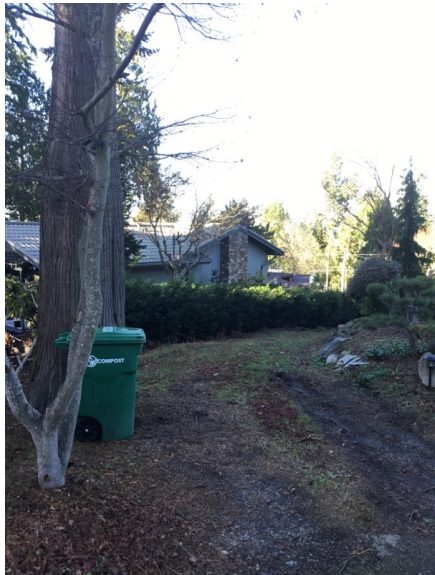
Tree located near driveway. Compacted turf/gravel two-track vehicle pathway passes through drip line area. See reference images on following page. Strongly encourage further protection of root zone within drip line due to anticipated travel of heavy equipment to/from construction area.

Existing vehicle pathway adjacent to Tree 4

View from south

Recommend installation of tree protection fencing along boundary of equipment travel area (within existing compacted pathway) and following drip line on north side of canopy to prevent disturbance of the critical root zone. Add protection for equipment travel path by installation of 12 inch layer of woody mulch or 6 inch layer of mulch with 3/4-inch plywood sheets or matting on top. Alternate material solutions are also available to provide equivalent or better protection. Finally, recommend installation of plywood protection "box" around lower trunk - 8 feet height, approx. 18 inches from trunk - to prevent mechanical damage by passing equipment.

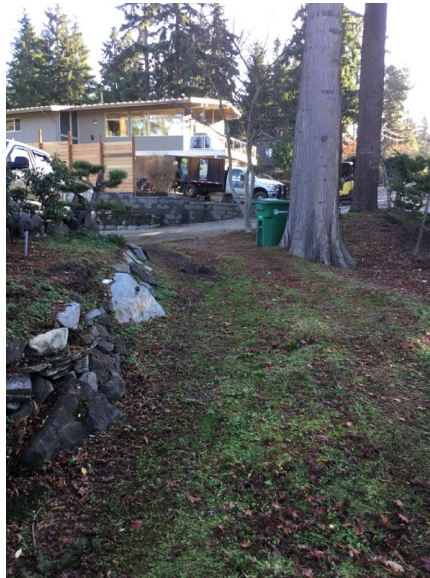
View from north
