January 22, 2019

**Project:** Pre-construction assessment for lot re-development at 8359 Juanita Drive, Kirkland, WA. Parcel number 3760500222.

**Objectives:** Evaluate health of existing trees and establish criteria for the preservation of those to be retained.

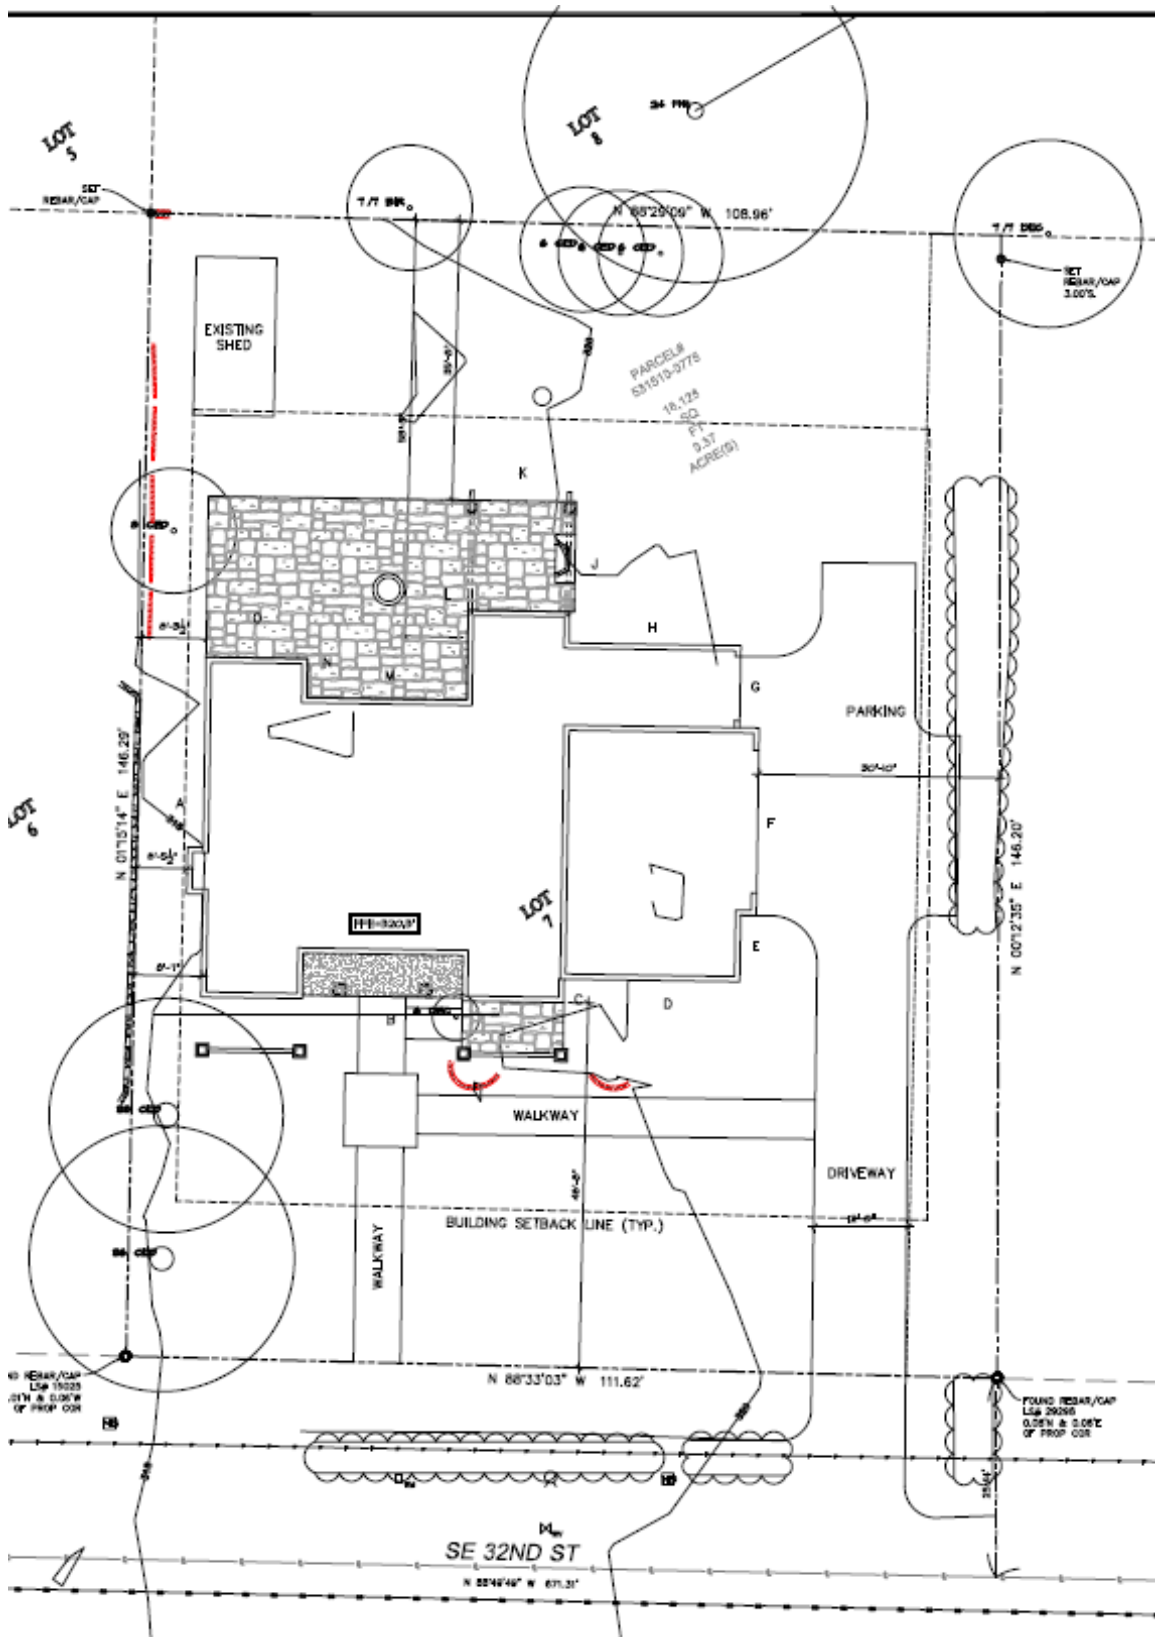
The excavation for the SW corner of the proposed home foundation will be just 13' N of the #2 cedar and even with its center line. The result is essentially a full cut line running on the north side of the tree. From the chart in Figure 16 it results in a potential loss of at least 40% of the tree's CRA. It could in reality be closer to a 55% impact based on the concentration factor due to the neighbor's driveway and the existing driveway forcing the roots into the proposed impact zone.

Figure 7. Excerpt from the proposed plan set showing the new layout. The #4 tree is not shown in this image either. Note the proximity of the SW corner of the new house to the #2 cedar. The circles around the trees are in no way representative of the extent of their Critical Root Zones.

The small architectural wall at the SW corner of the house should be excluded from the plans to alleviate the root impact it will cause. Either that or its placement could be explored with the air spade to expose what roots may be in its place and a decision made at that time.

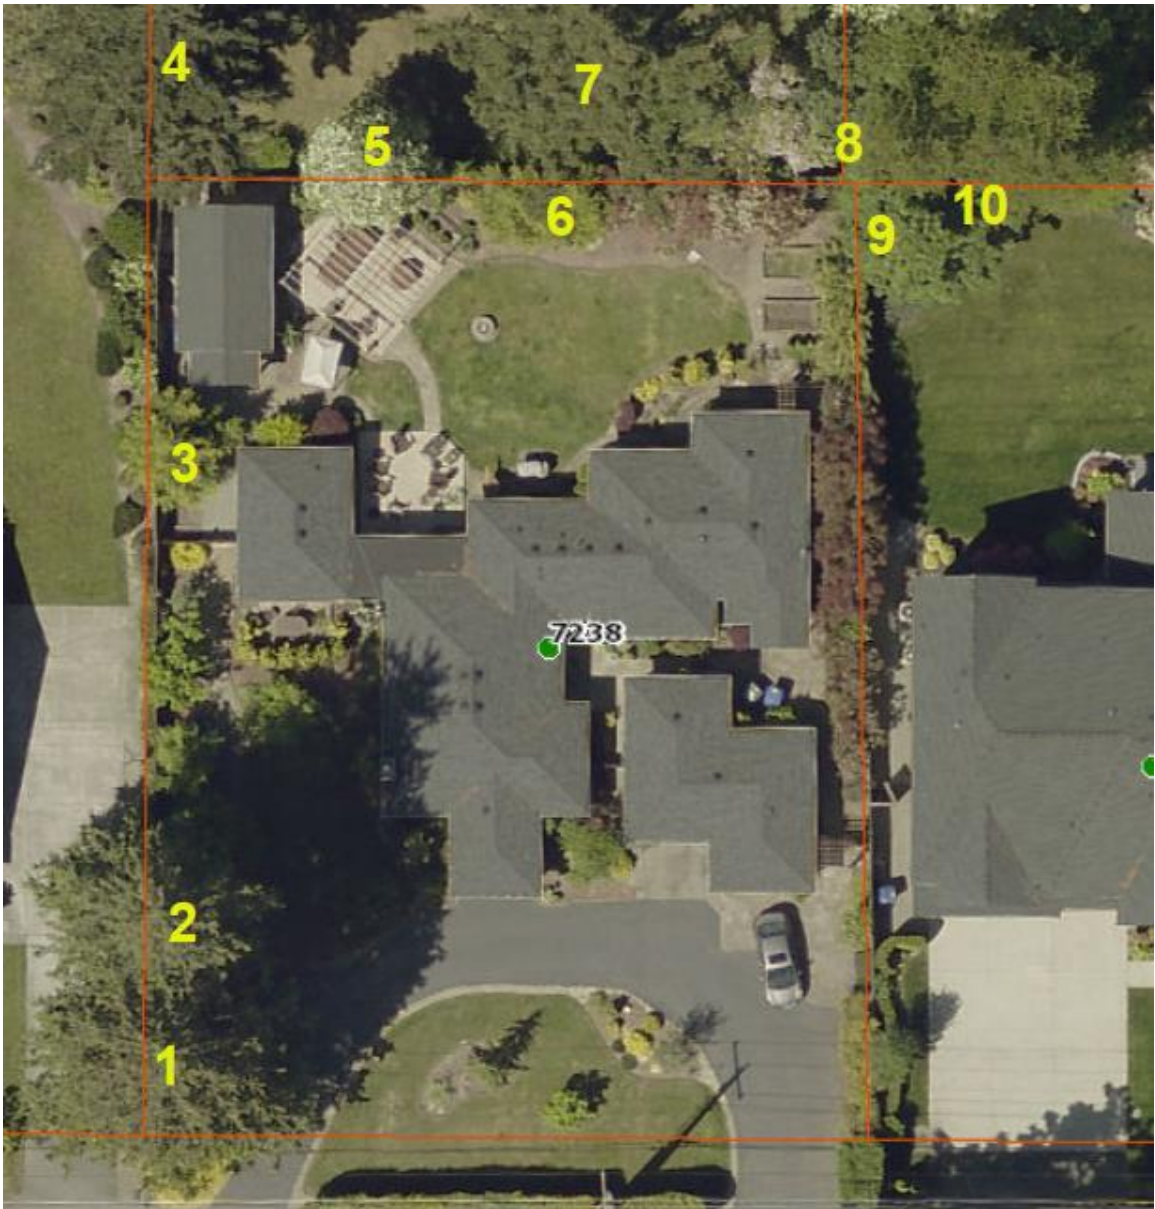
Figure 8. Aerial photo circa 2019 showing the approximate locations of the trees noted in the study (yellow numerals). The #3 and #6 trees were not present at the time of the site visit.

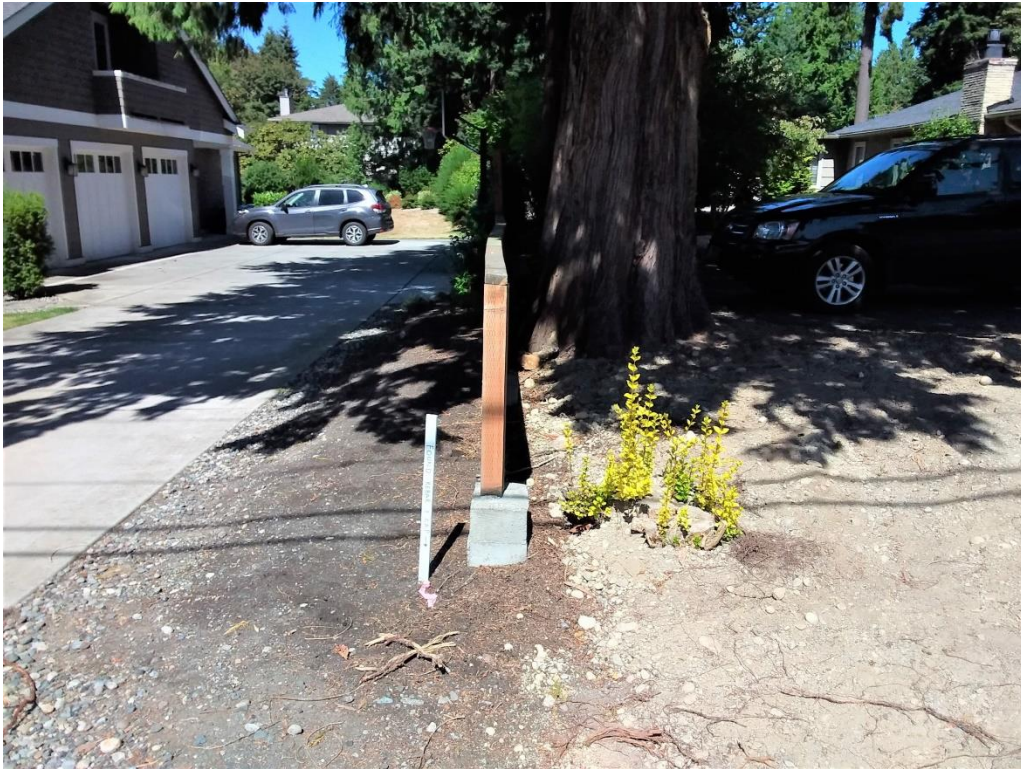
- 1) Western Red Cedar (*Thuja plicata*) 43" DSH, 70' tall standing 29' N of 32<sup>nd</sup> Street and 7' E of the 7226 driveway (Figure 9). The driveway for the subject property currently curves around the tree at 13.5' radial distance but there is a dogleg parking spot which extends beneath this tree and the #2 cedar. The SW corner of the asphalt for the spot is 3' from the base of this tree and there are signs of uplift (Figure 10). The tree is 20' N of the high voltage lines and its south side canopy has been pruned for proper clearance. It has a low, full canopy which exhibits average new growth and color in the lower half but is beginning to show stunting in the upper quarter.

Figure 9. Photo taken during the August 2020 site visit looking north up the west fence line at the base of the #1 cedar. Note proximity of neighbor's driveway.

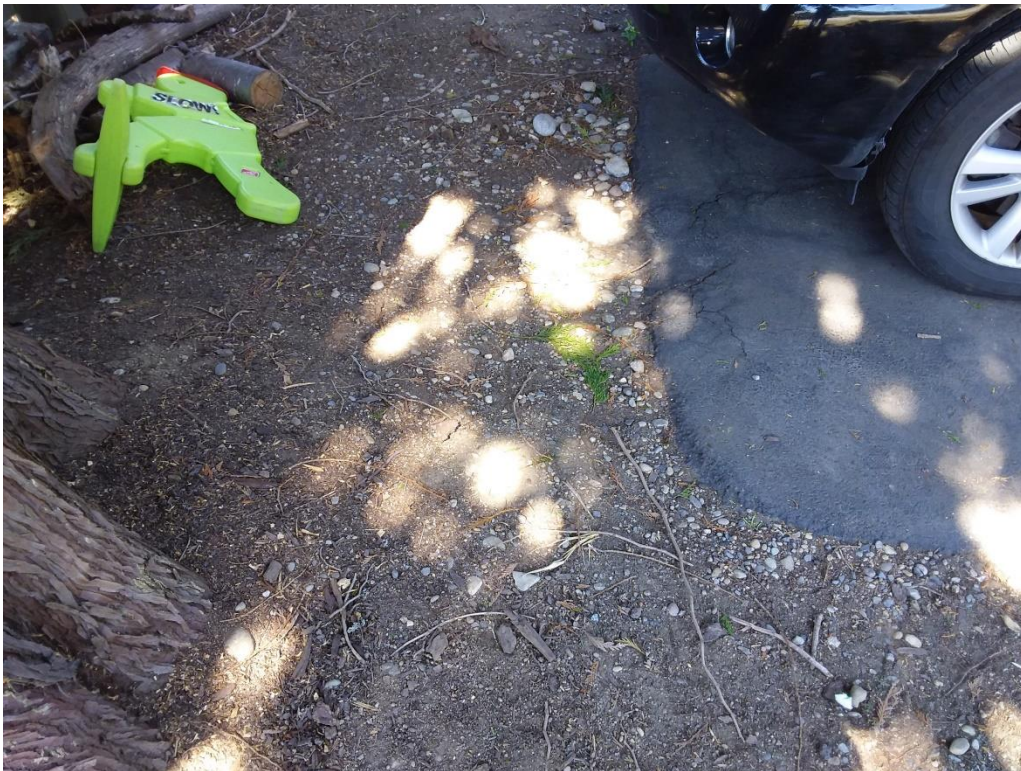
In the case of the #1 cedar mentioned above, the demolition of the existing driveway will come to as close as 3' from the base of the tree. From Figure 15 the Structural Root Plate for a 43" DSH tree is given as 10' so the demolition of the parking spot will be well within this tree's SRP. Likewise the #2 tree is technically within the primary impact zone, being just 6' from the corner of the parking pad.

Figure 10. Photo of the base of the #1 tree showing the corner of the parking spot. Note the cracks indicative of root uplift.

If in any way possible the asphalt under and around the cedars should be removed by hand rather than by an excavator to minimize impact and preserve as many of the roots as possible.

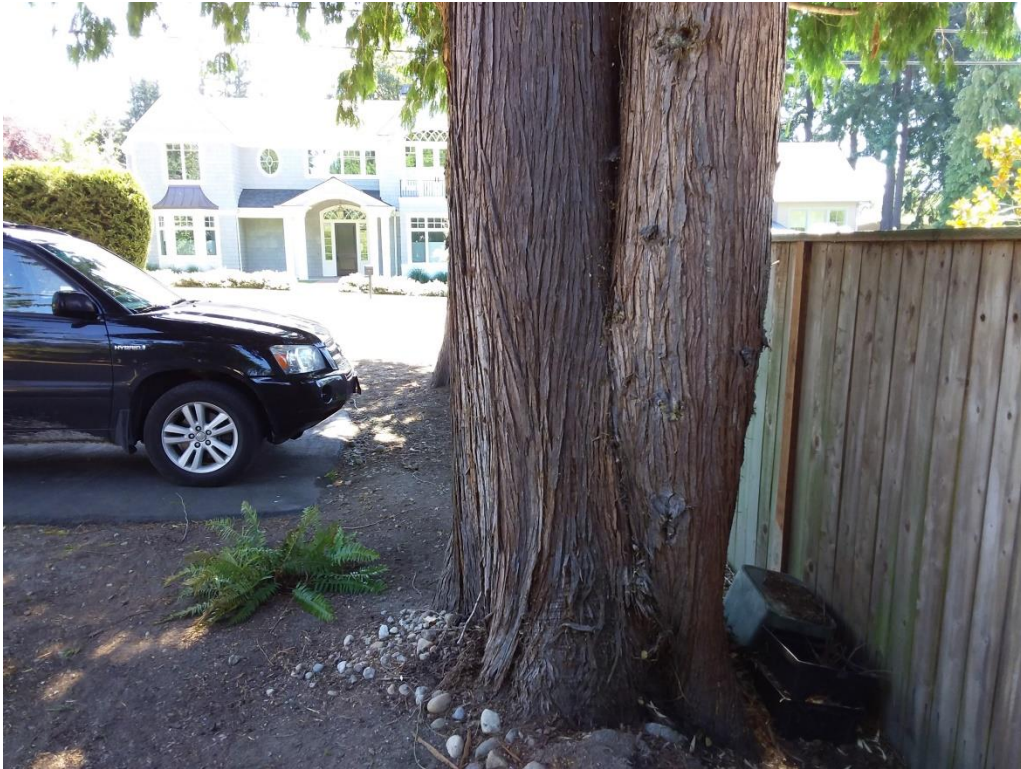
- 2) Western Red Cedar 42" DSH, 75' tall standing 16' N of the #1 tree. Its diameter measurement was taken 2" below standard as the tree bifurcates right at the 54" mark. The two stems press/grow together until fully separating above the 9' level (Figure 11). The 18" diameter subordinate rises in the NW quadrant, separates again at the 14' mark, and has a 10" spar growing to the west over the neighbor's driveway while its other 12" diameter section grows up the north side of the tree crowding through the branches as shown in Figure 12. The cedar's base is 7' off the neighbor's driveway and 6' NW of the parking spot's NW corner. The existing lawn begins 10' east of the tree. It also has a full, low canopy with average new growth and color from bottom to top.

Figure 11. Photo looking south at the base of the #2 cedar. Note parking pad with same vehicle as in Figure 10.

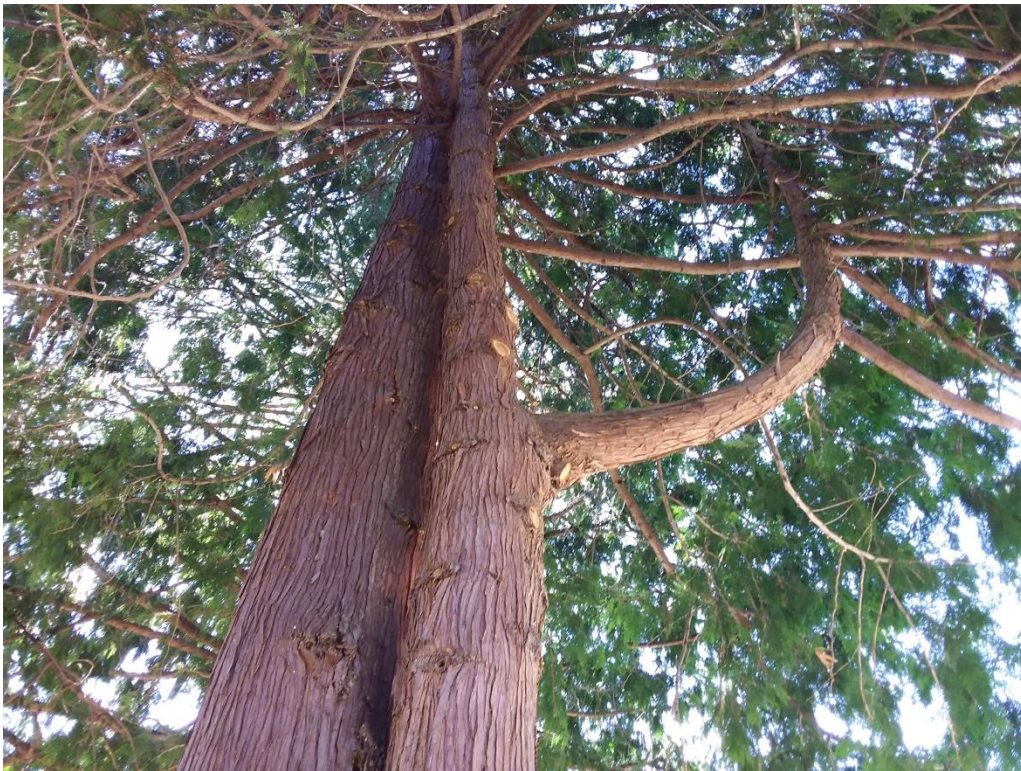
Figure 12. Photo looking up into the #2 tree and showing the bifurcation point of the subordinate spar. This stem should be removed to ensure the proper growth formation of the tree.

The subordinate spar on the #2 cedar will have to be excised. This section will only take energy away from the main stem and will interfere with proper branch, and possibly stem, formation. It may be easier to complete this task before the project starts and while there is plenty of space to the north side.

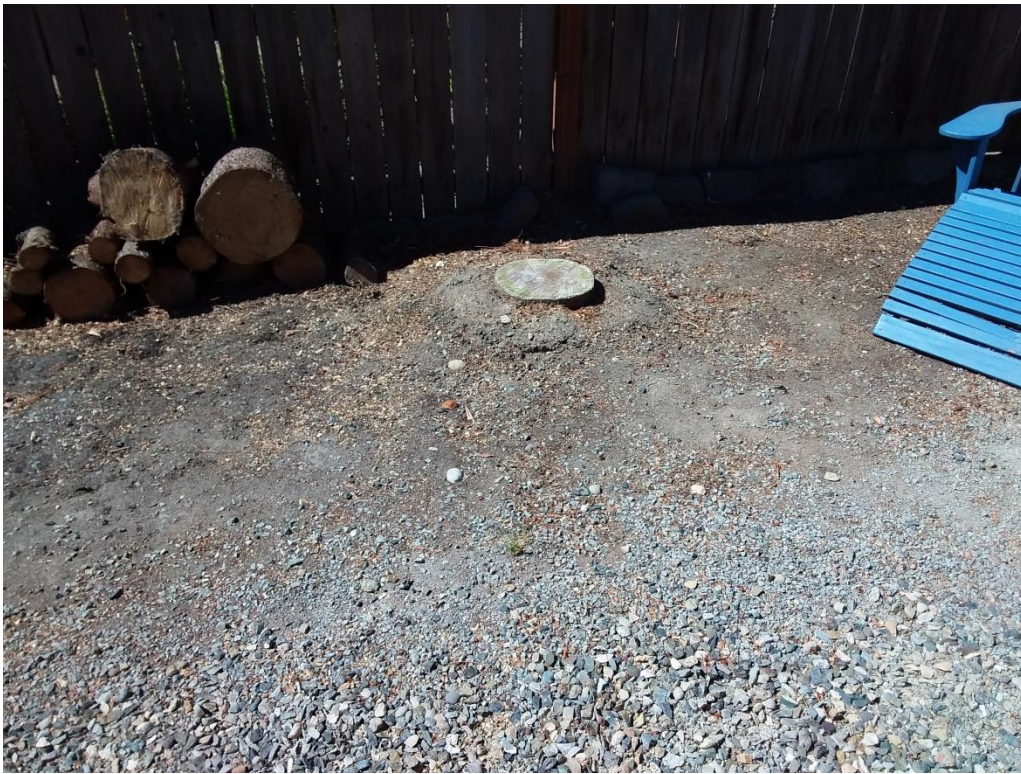
- 3) Only a stump present at the time of this assessment at indicated location on the original survey (Figure 13).
- 4) Douglas Fir (*Pseudotsuga menziesii*) approximately 36" DSH, 80' tall standing 16' N of the NW corner of the subject property and slightly east of it. Tree is in fair condition with average color and new growth. A handful of its branches on the south side extend over the client's yard. Not noted on original survey.

Figure 13. Photo of stump in the location indicated on the plan sheets.

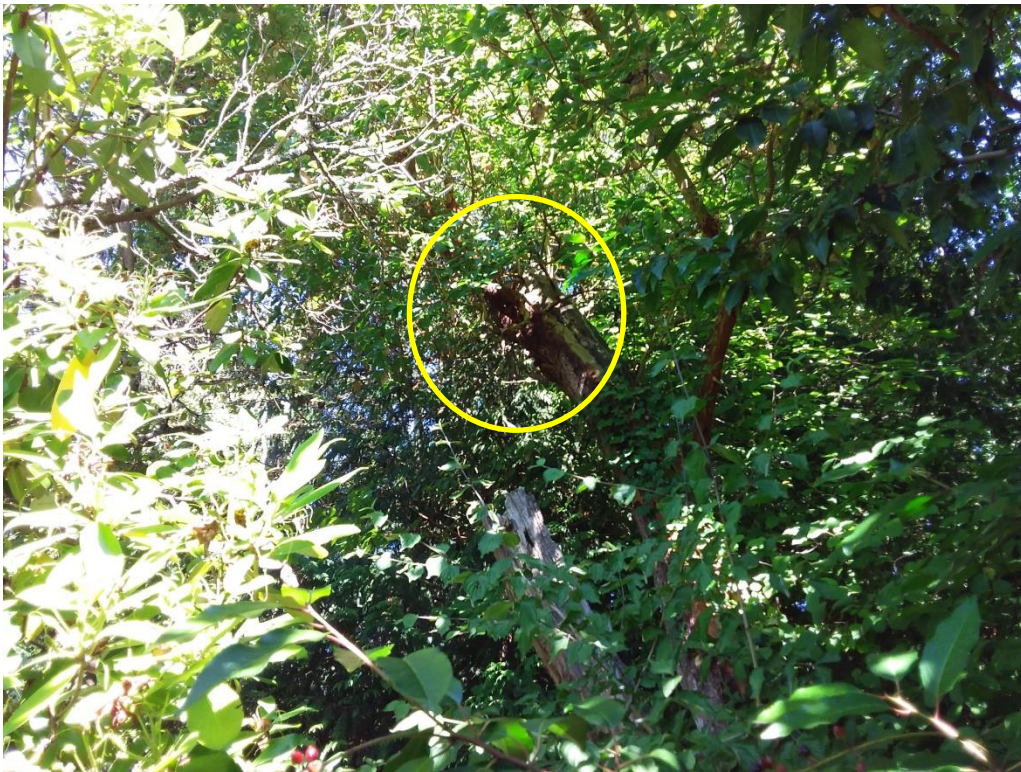
- 8) Pacific Madrone (*Arbutus menziesii*) approximately 20" DSH standing 11' NNE of the NE fence corner. The tree was cut/broke off near the 18' level some time ago and has three new leaders rising above this point to about 40' tall (Figure 14). The tree leans to the NW from the base and has good new growth and color. None of its canopy extends as far as the fence line.

Figure 14. Photo of the madrone standing in the neighbor's yard to the north. The circled area is where the tree broke and/or was cut.
