**RE: #1 and #2 Cedars airspading 2009-183 7238 SE 32<sup>nd</sup> Street**

This is an addendum to the August 2020 arborist report for this site.

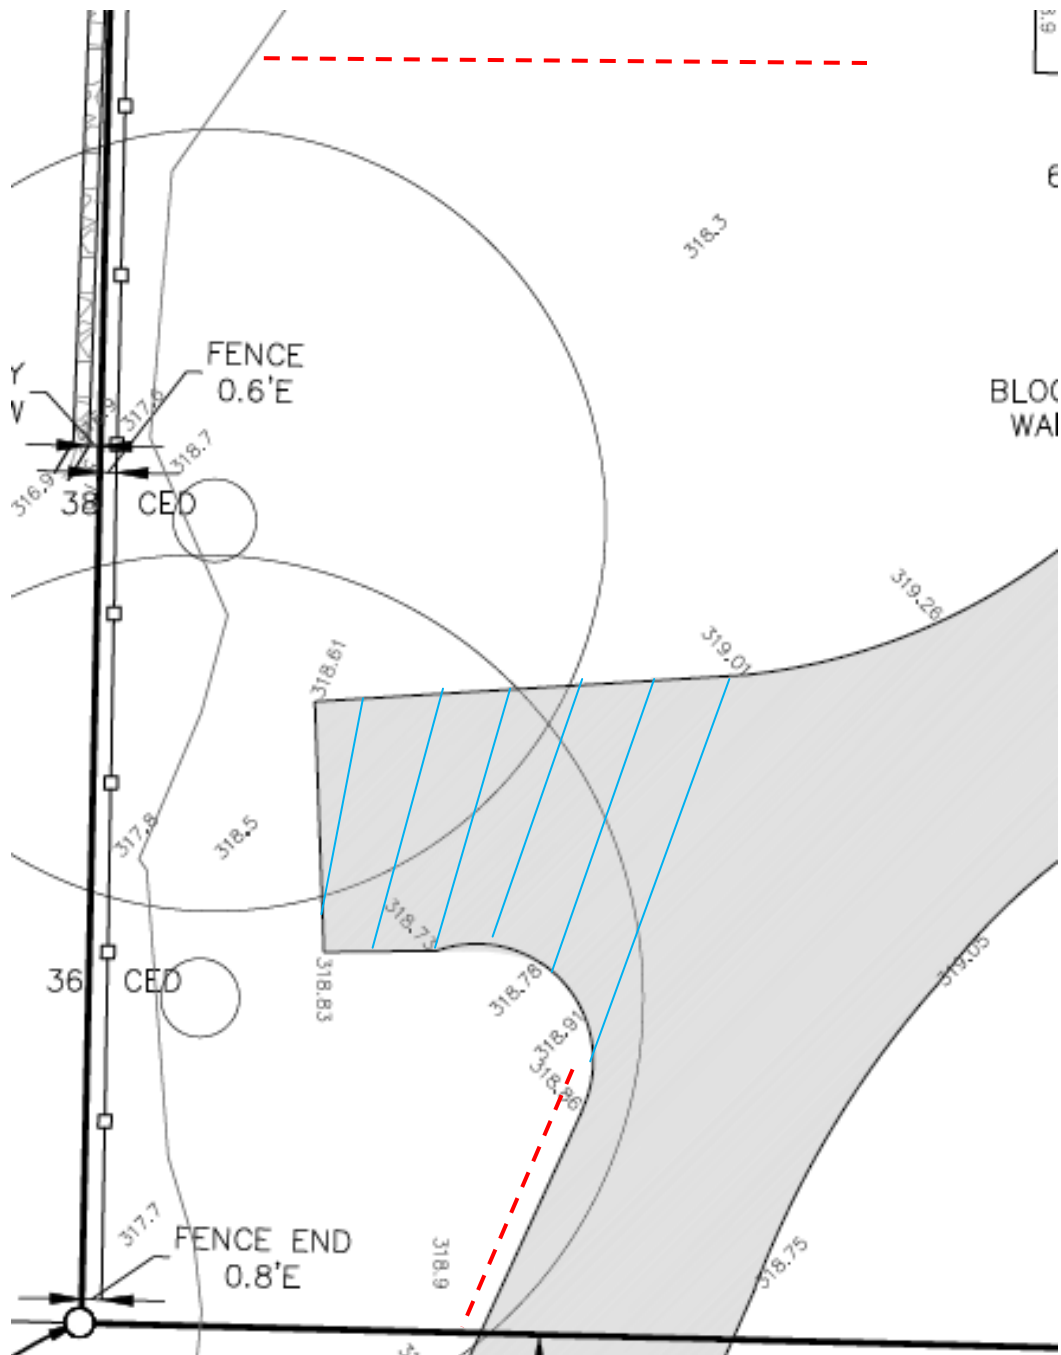
On January 11, 2021 airspading was completed to exposed the roots along the west side of the driveway and the north side of the #2 tree. Figure 1 shows where the work was done.

Figure 1. Excerpt from the plan set showing where the air spading was done (dashed lines). The section crossed with the blue lines will have to be extracted quite carefully.

Very few feeder roots were seen alongside the driveway (Figure 2). It should be completely fine to raze this section with heavy equipment. The parking space portion will have to be lifted quite carefully as there are definitely roots beneath it.

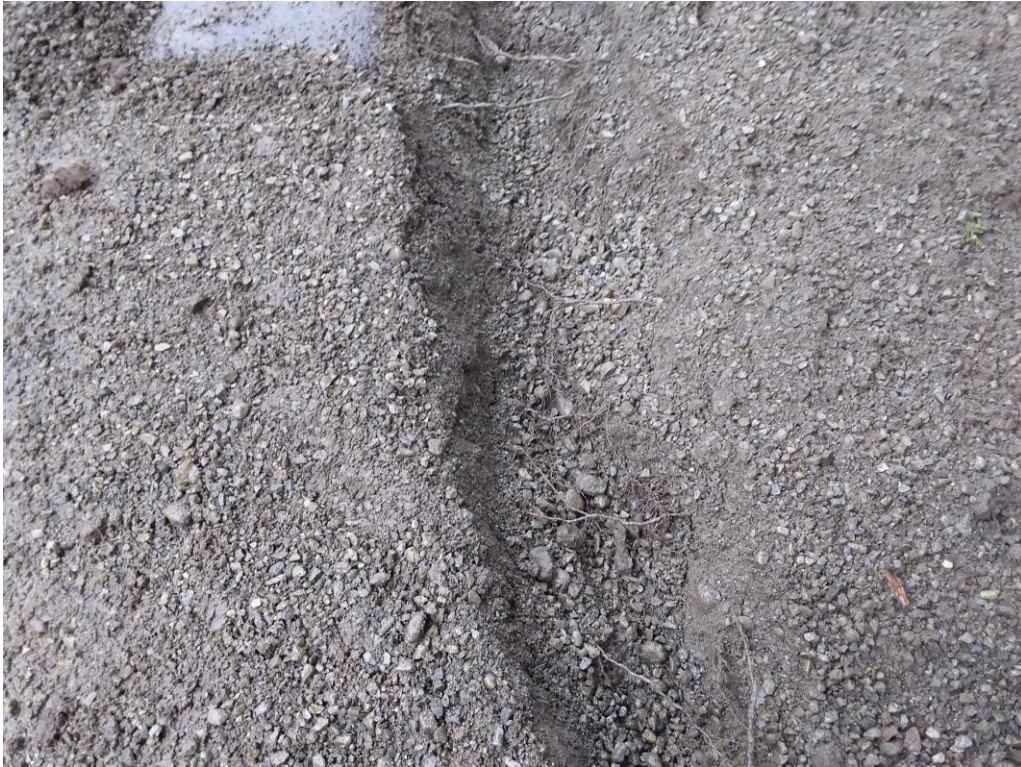
Figure 2. No roots alongside the driveway.

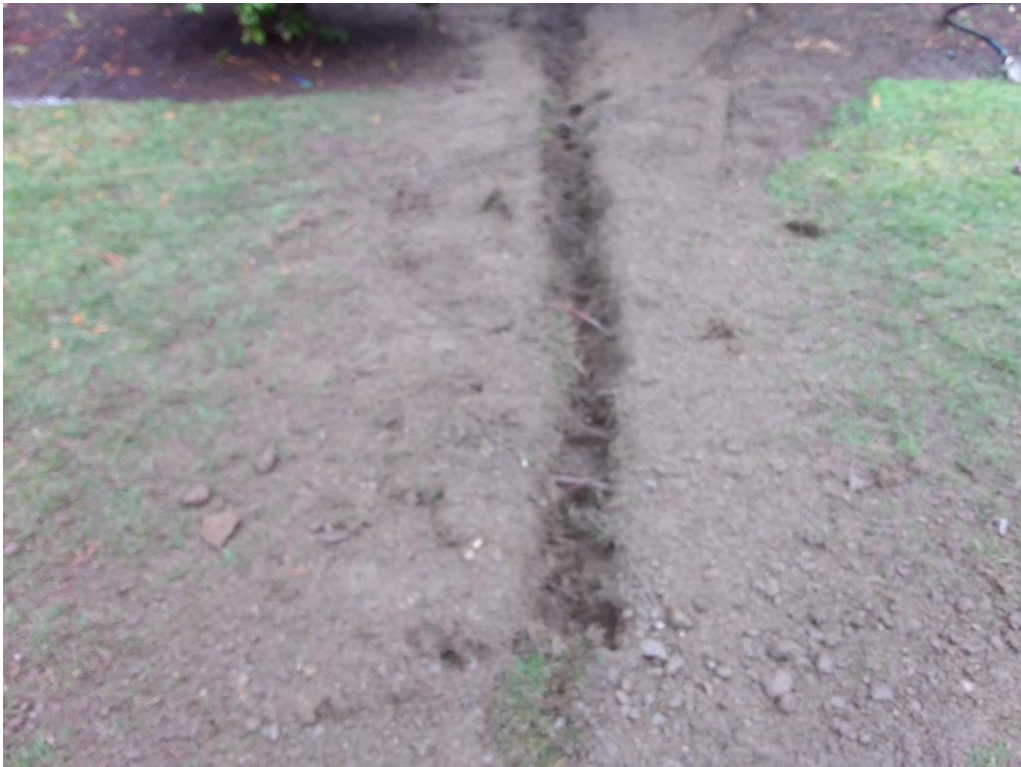
The trench made 13' north of the second cedar showed a high density of roots present. They ranged evenly from ¼" to 2" over the entire 28' length of the trench (Figures 3 and 4).

Figure 3. The north trench.

This area will have to be fenced prior to demolition to absolutely minimize root impact. Before excavation for the new foundation is started the cut line will have to be laid out with thought to preserving the maximum of roots present. The minimum possible clearance should be allowed for the foundation forms (8-12" rather than the 24-30" normally given) in this region. Once this line is established the roots will have to be severed cleanly with a chop or reciprocating saw.

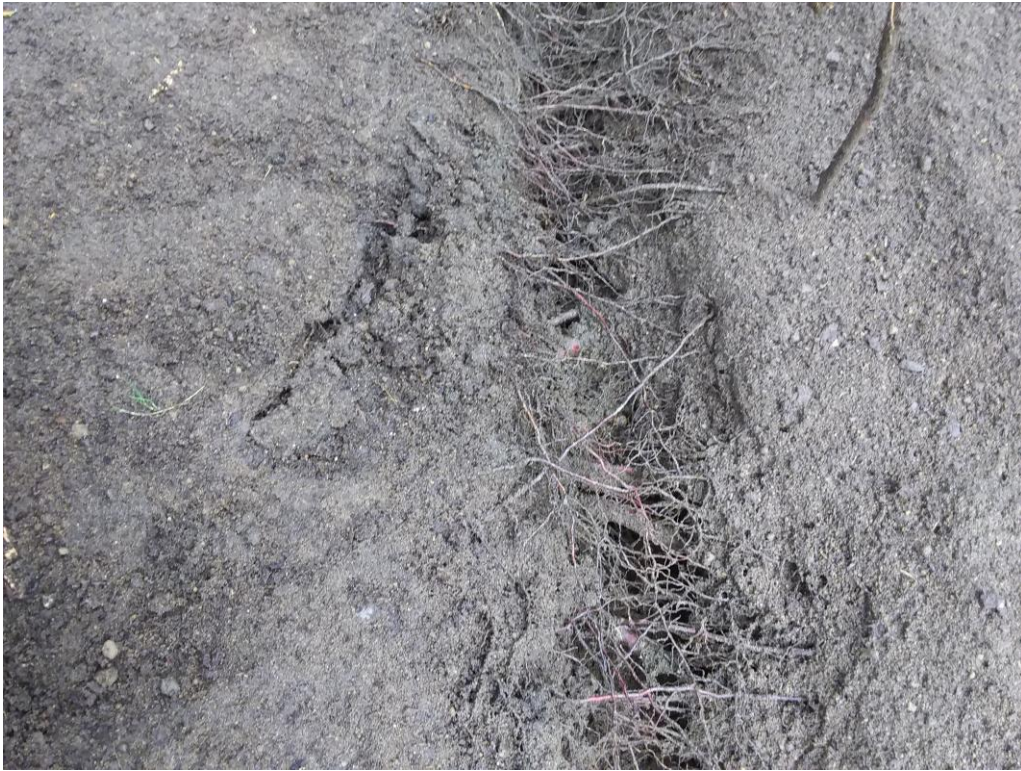
Figure 4. Close up of roots in the north trench.

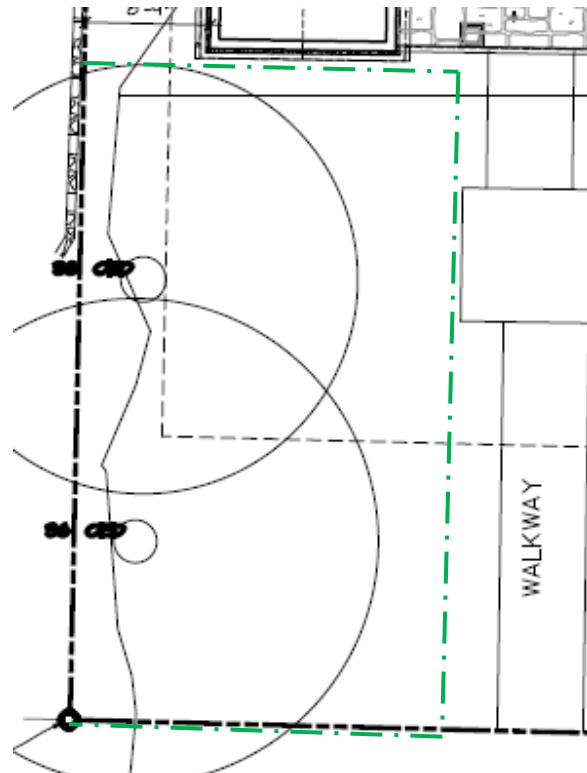
Figure 5. Placement of protection fencing for the #1 and #2 cedars. The area inside should be filled with arbormulch.

The protection fence will then be set at that line and will remain undisturbed for the remainder of the project. The fence will turn south where the entrance walk will be sited for the new home as shown in Figure 5. Once the asphalt is lifted the entire area will have to be filled with 6-8" of arbormulch to protect the roots and aid in the long term recovery of the trees.
