# ARBORIST REPORT

January 8, 2021

7036 81<sup>st</sup> Ave SE  
Mercer Island, WA

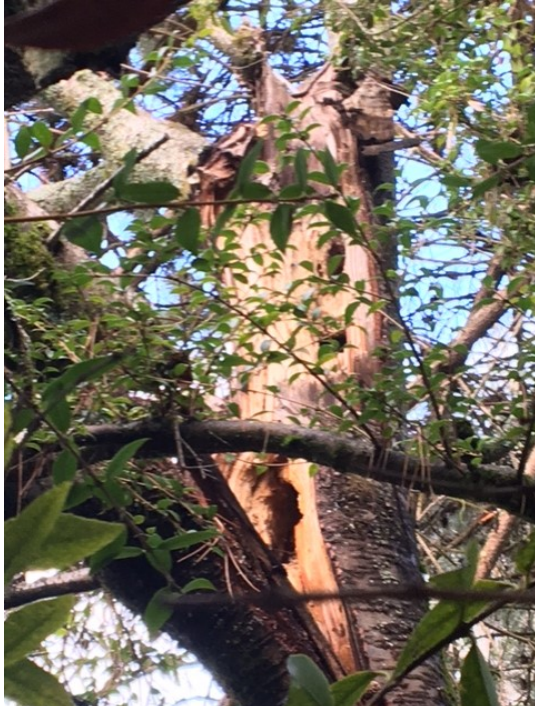
Tree #5 is a 14.5" DBH ornamental or fruiting cherry that has significant failure as detailed in Photo #1 below.

Photo 1. Large broken and hanging tree  
Top of Tree #5.

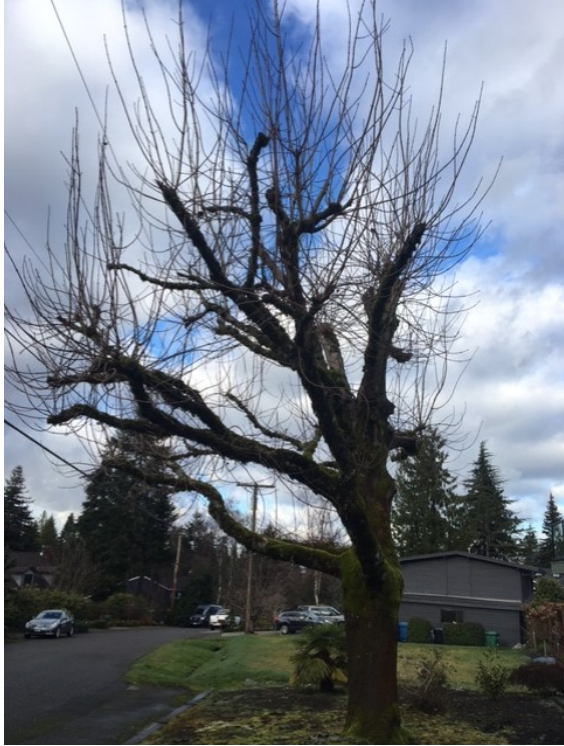
Tree #1 is a 24.8" DBH Big Leaf Maple located in the front yard area. This area will be used to install an underground, storm-water capture tank, which will require the removal of the tree. The subject tree has been mal-pruned which significantly increases its likelihood of future limb

failure due to poor limb attachments at the previous pruning cuts. Photo #2 below was taken December of 2020.

Photo 2. Big leaf maple, Tree #1.  
December 2020.
