AMERICAN FOREST  
MANAGEMENT

**ARBORIST REPORT  
2885 78th Ave SE.  
Mercer Island, WA**

**January 16<sup>th</sup>, 2020**

XING HUA GROUP LTD.  
2885 78TH AVE SE  
MERCER ISLAND, WA

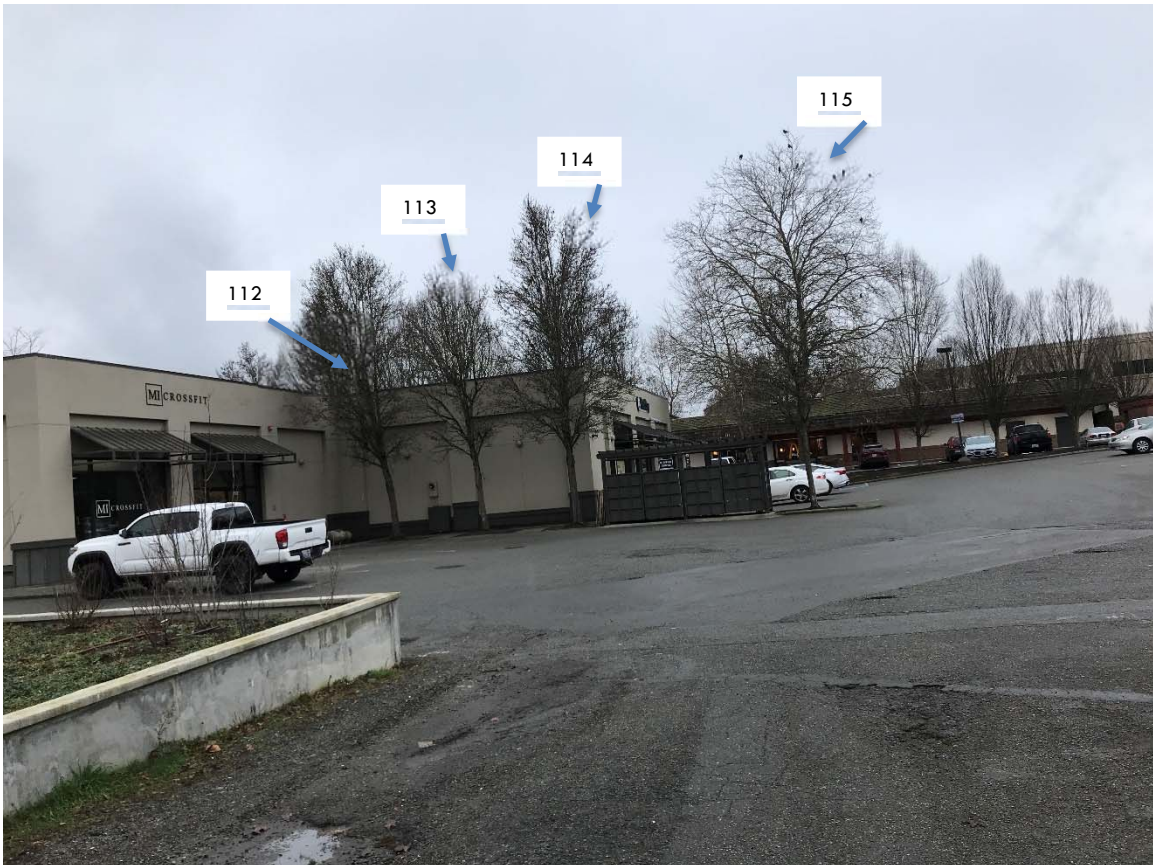
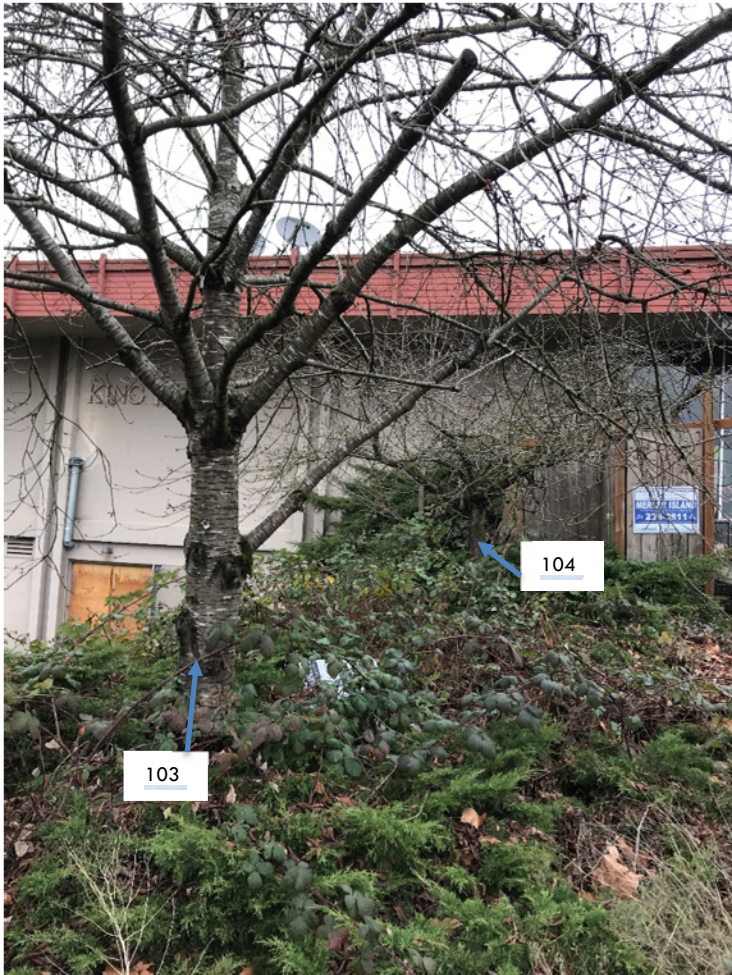
Trees #101, 102, 112, 113, 114, and 115 are flowering pears (*Pyrus caleriana*) planted in the northwest portion of the property as perimeter trees around the building at 2750 SE 77th St. These range in size from 6 - 9.6 inches in diameter at 4.5 feet above grade (DBH). None of these are considered 'Large' trees by the City of Mercer Island.

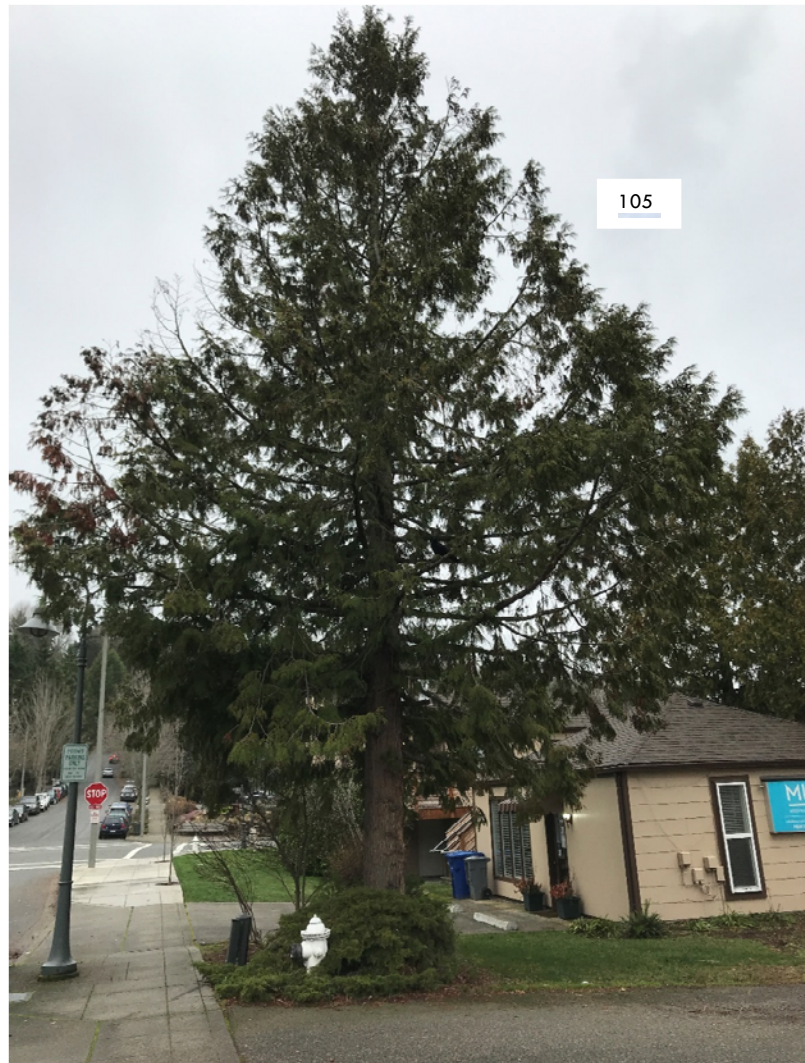
Tree #105 is a western red cedar with a DBH of 22 inches growing near the southwest edge of the subject property bordering what is identified as the Bitney Parcel. This tree is in good condition, but shows some stress in the canopy with somewhat thin foliage.

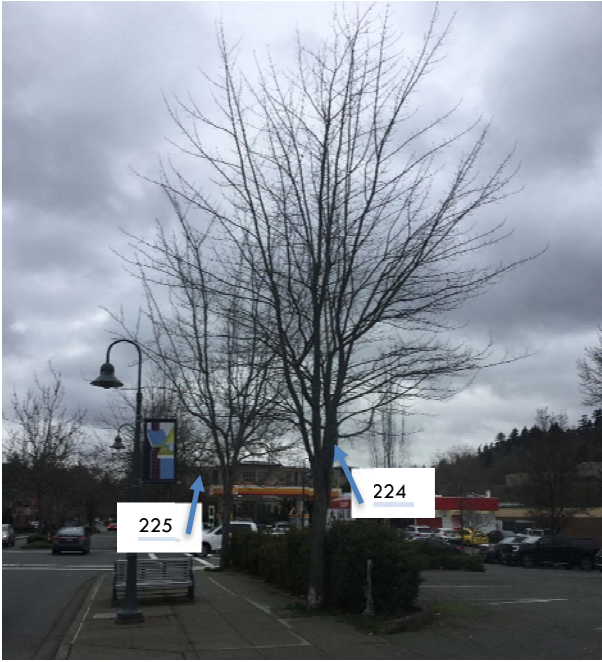
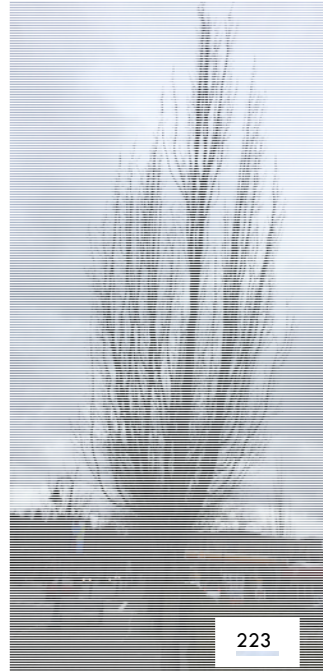
Trees #219-229, 234, 235, and 236 along the right of way (ROW) on the west, south, and east sides of the subject parcel have been approved for removal by Mercer Island Design Commission on January 22nd 2019. These trees would be in the middle of the sidewalk in the proposed condition, in conflict with current town center streetscape standards.

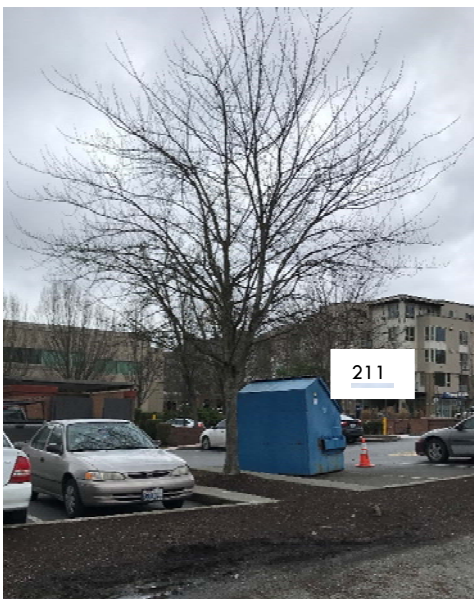
Trees #206, 211, and 218 are red maples (*Acer rubrum*) found further north in the McDonald's parking lot. The proposed development is south of their critical root zones and will not negatively impact their structure or viability. Of these only #206 is considered 'Large' with a DBH of 11.6 inches.

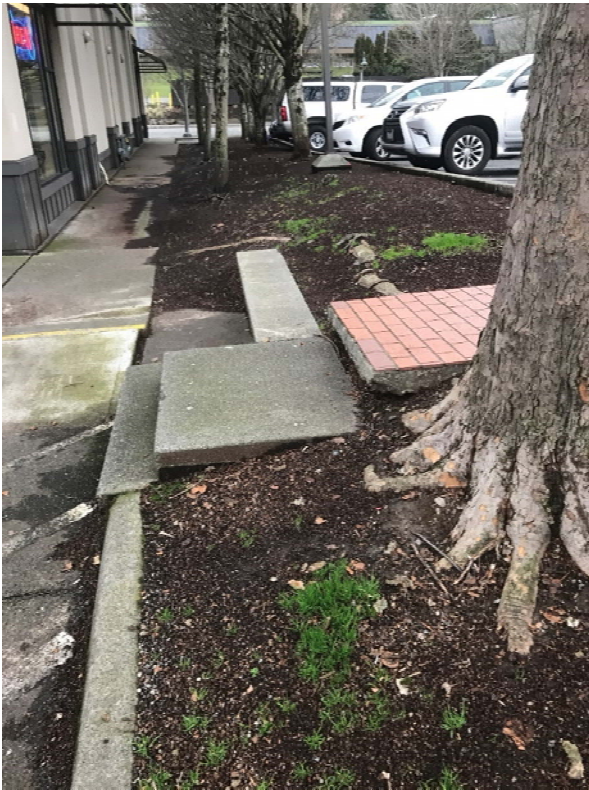
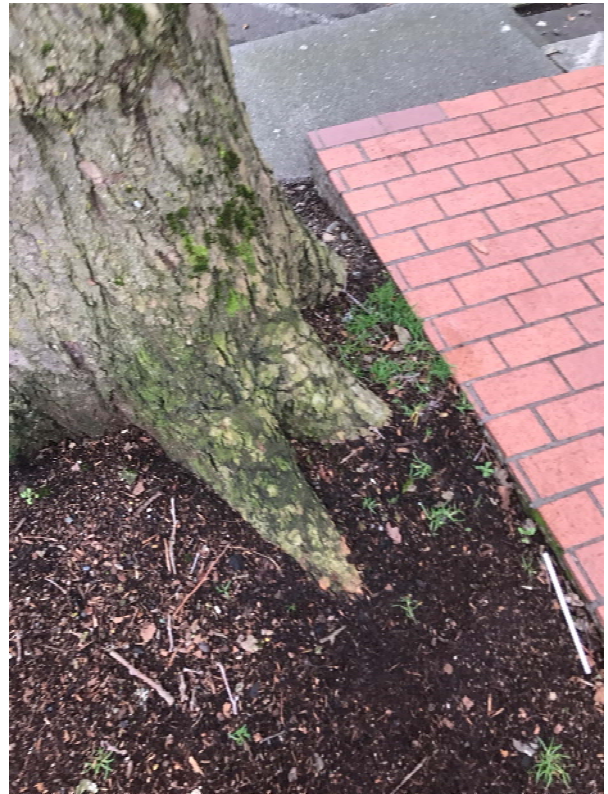
Trees #207 and 217 are 'Large' London planes (*Platanus x. acerifolia*) growing near the north property line. The critical root zone of #217 (14 inch DBH) extends approximately two feet into an area planned for a 'suspended' concrete pavement system. #207 (23.1 inch DBH) is located near, or possibly on the property line and has large surface roots which are disrupting the walkway and steps immediately to its west.

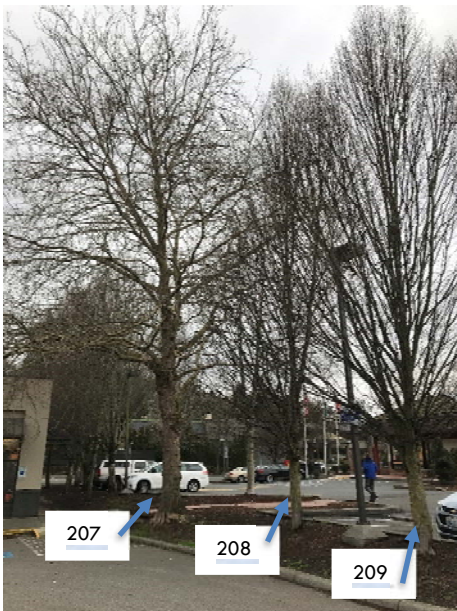
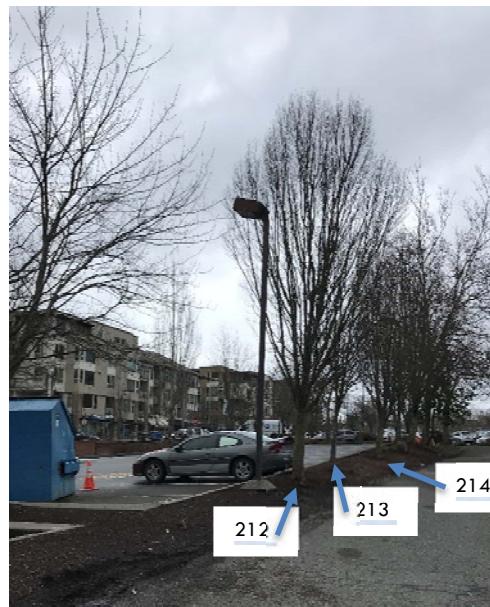
The remainder of the trees north of the subject property are European hornbeam (*Carpinus betulus*). This species is commonly planted in urban settings as it is fairly tolerant of development pressures. These trees are in good condition and are unlikely to have significant roots which extend to into the development area to the south.

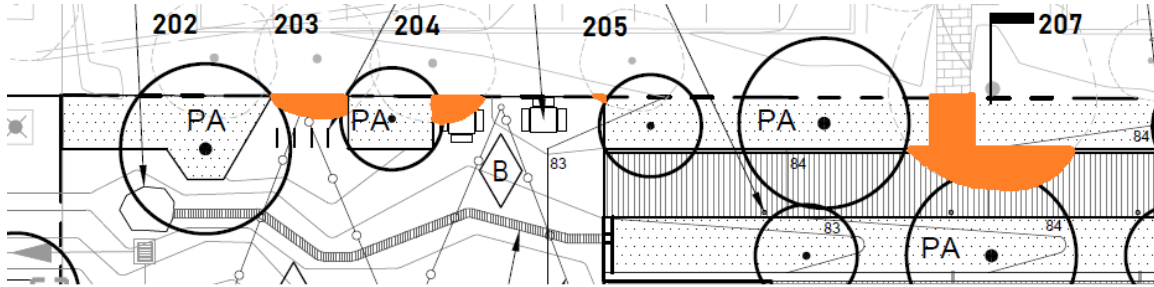
The proposed re-development is extensive and will not allow for tree retention within the subject property lines. The right of ways on the west, south, and east perimeters will be redesigned and the street trees will be replaced per current Town Center Streetscape standards. The priority for tree retention are the trees north of the subject property. A six foot wide planting area is proposed along the majority of this property line. Ground disturbance in this area including any trenching for utilities, or compaction caused by heavy equipment traffic or materials storage shall be prohibited in this area. Pavement installation is proposed within the critical root zones of trees #203, 204, and 207 as shown in orange on the diagram below.

Expanding the adjacent planting areas around #203 and 204 and avoiding soil disturbance in this area will minimize the impacts to these trees. The concrete steps joining the brick path to the north will likely need to be replaced, and a new concrete path is proposed within the critical root zone of #207. There are large structural roots in the area of the steps. A diagram showing removal and replacement of these steps should be developed to instruct crews of the process for completing this work without damaging the structural roots.
