Memorandum

To: Megan McKay
From: Benjamin Mark – American Forest Management
Date: 2/9/2022
Re: Site Work Near Retained Trees at the ‘Mercer Island Mixed Use’ Project

2885 78TH AVE SE.
MERCER ISLAND, WA

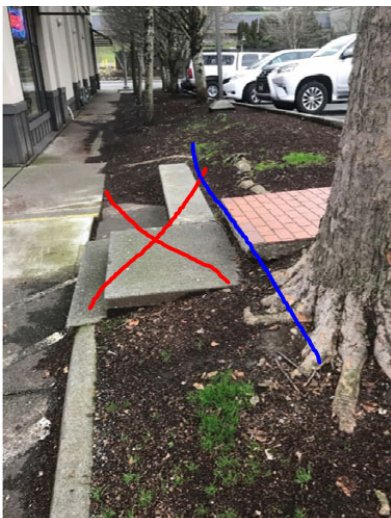
TREE #207 is a ‘Large’ London plane (*Platanus x. acerifolia*) growing near the north property line. This tree has a 23.1 inch DBH and is located near, or possibly on the property line and has large surface roots which are disrupting the walkway and steps immediately to its west. The plan is to remove the existing concrete stairs on the subject property and leave the brick path (right of blue line in photo below) which is on the neighbor’s property in place. No new concrete stairs or ramp is proposed, rather an expansion of the landscape bed.

Lower trunk of Tree #207. Note concrete step to be removed and brick path to remain.

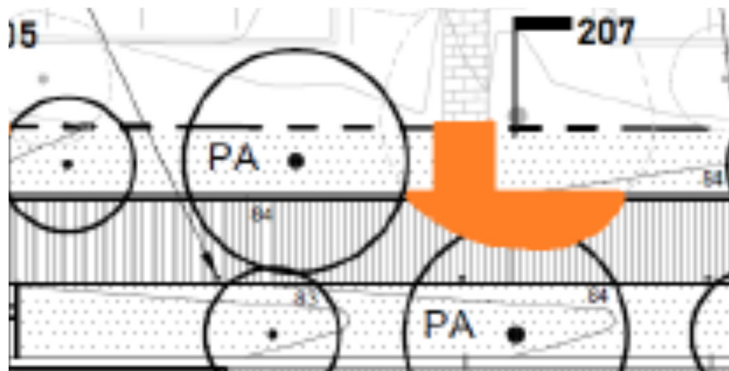
A six-foot-wide planting area is proposed along the majority of the north property line. Ground disturbance in this area including any trenching for utilities, or compaction caused by heavy equipment traffic or materials storage shall be prohibited in this area. Approximately 60 square feet of pavement removal is proposed within the drip line of Tree #207 as shown in orange on the diagram below.

Construction activity is not recommended within a tree's drip line. If disturbance within a retained tree's drip line is required, the best management practices outlined below should be closely adhered to. Any work within the drip line should be supervised by the project arborist.

- Tree protection fencing shall be erected around retained trees and positioned as shown on the attached prior to moving any heavy equipment on site. Doing this will set clearing limits and avoid compaction of soils within root zones of retained trees. Further soil compaction or root disturbance within the drip lines should be avoided to prevent unnecessary damage to the root system.

- Concrete or pavement to be removed from within the driplines of retained trees shall be broken into manageable pieces and removed by hand.
- All work near retained trees must avoid contact from excavator arms or any other equipment with the trunks or branches.
