Memorandum

To: Brandt Design Group c/o Bree Medley
Site: 8163 W Mercer Way, Mercer Island, 98040
Re: Tree Inventory and Assessment
Date: March 11, 2021; revised May 5, 2021
Project Arborist: Connor McDermott,
ISA Certified Arborist #PN- 8704A
ISA Qualified Tree Risk Assessor
Reviewed By: Haley Galbraith,
ISA Board Certified Master Arborist #PN-7512BM
ISA Qualified Tree Risk Assessor
Referenced Documents: Topographic Survey Seaspect Short Plat (Core Design Engineers, 4/20/2015)
Site Plan: Kahn Spec Home (Brandt Design Group, 11/30/2020)
Attached: Tree Table (Tree Solutions Inc., April 30, 2021)

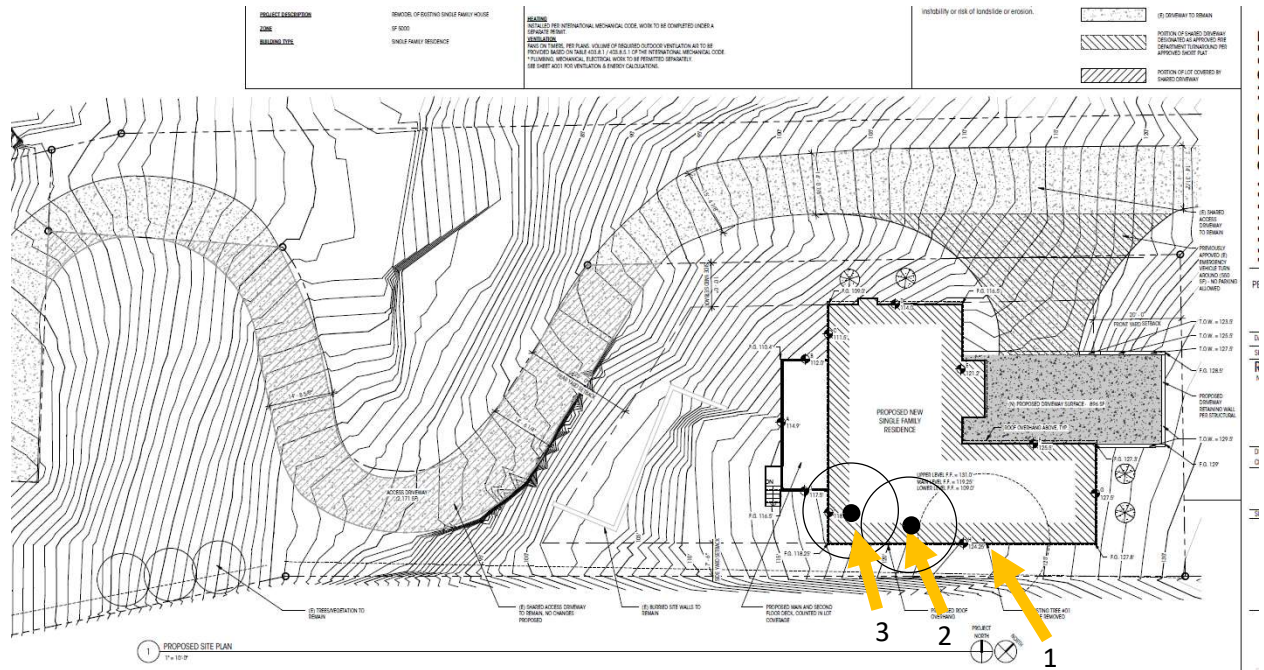
Based on the plans sent by Bree Medley ("Site Plan: Kahn Spec Home", Brandt Design Group, 11/30/2021), I do not believe the trees can safely be retained during construction. There is a direct conflict between the trees and the footprint of the house, including required excavation for the foundation.

Figure 2. Site Plan: Kahn Spec Home (Brandt Design Group, 11/30/2020) with tree locations overlaid on the current development plans.

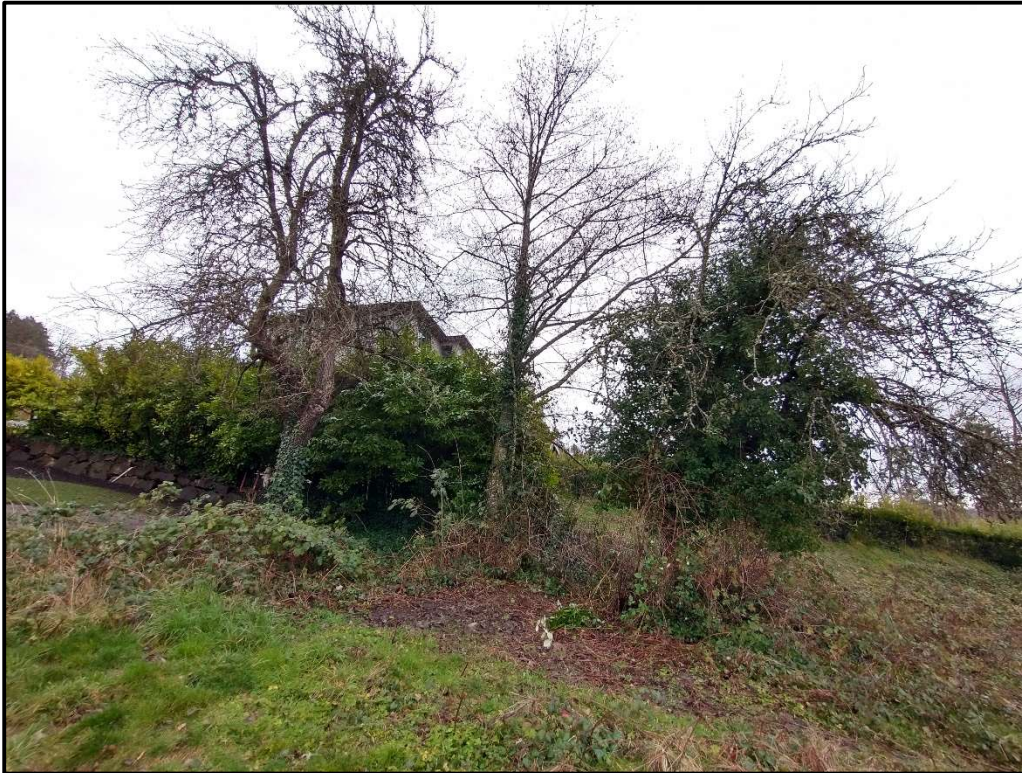
Tree 3 (7.9-inch and 9-inch apple tree) is in fair to poor condition. At the time of my site visit, the tree appeared to be in poor structural condition. There was excessive dead wood and a broken top. However, it was enveloped in ivy and blackberry which limited my visual assessment and blocked my access to the trunk. I could not determine if live buds were present or not. Apple trees grown in western Washington are prone to foliar diseases and insect infestations. They grow aggressively and require regular pruning if grown for apples which causes decay. The combination of these factors contributed to my determination that the tree is not viable for long term retention.

Photograph 1. Site Trees in order Trees 1-3 from left to right.

If these trees are removed, they will require replacement planting. I recommend you replant with the following species, which will maintain the character of the property and be suitable for the available space. These species include:

- Shore pine (*Pinus contorta* var. *contorta*)
- Japanese snowbell (*Styrax japonicus*)
- 'Eddie's White Wonder' dogwood (*Cornus nuttallii* x *florida* 'Eddies White Wonder')

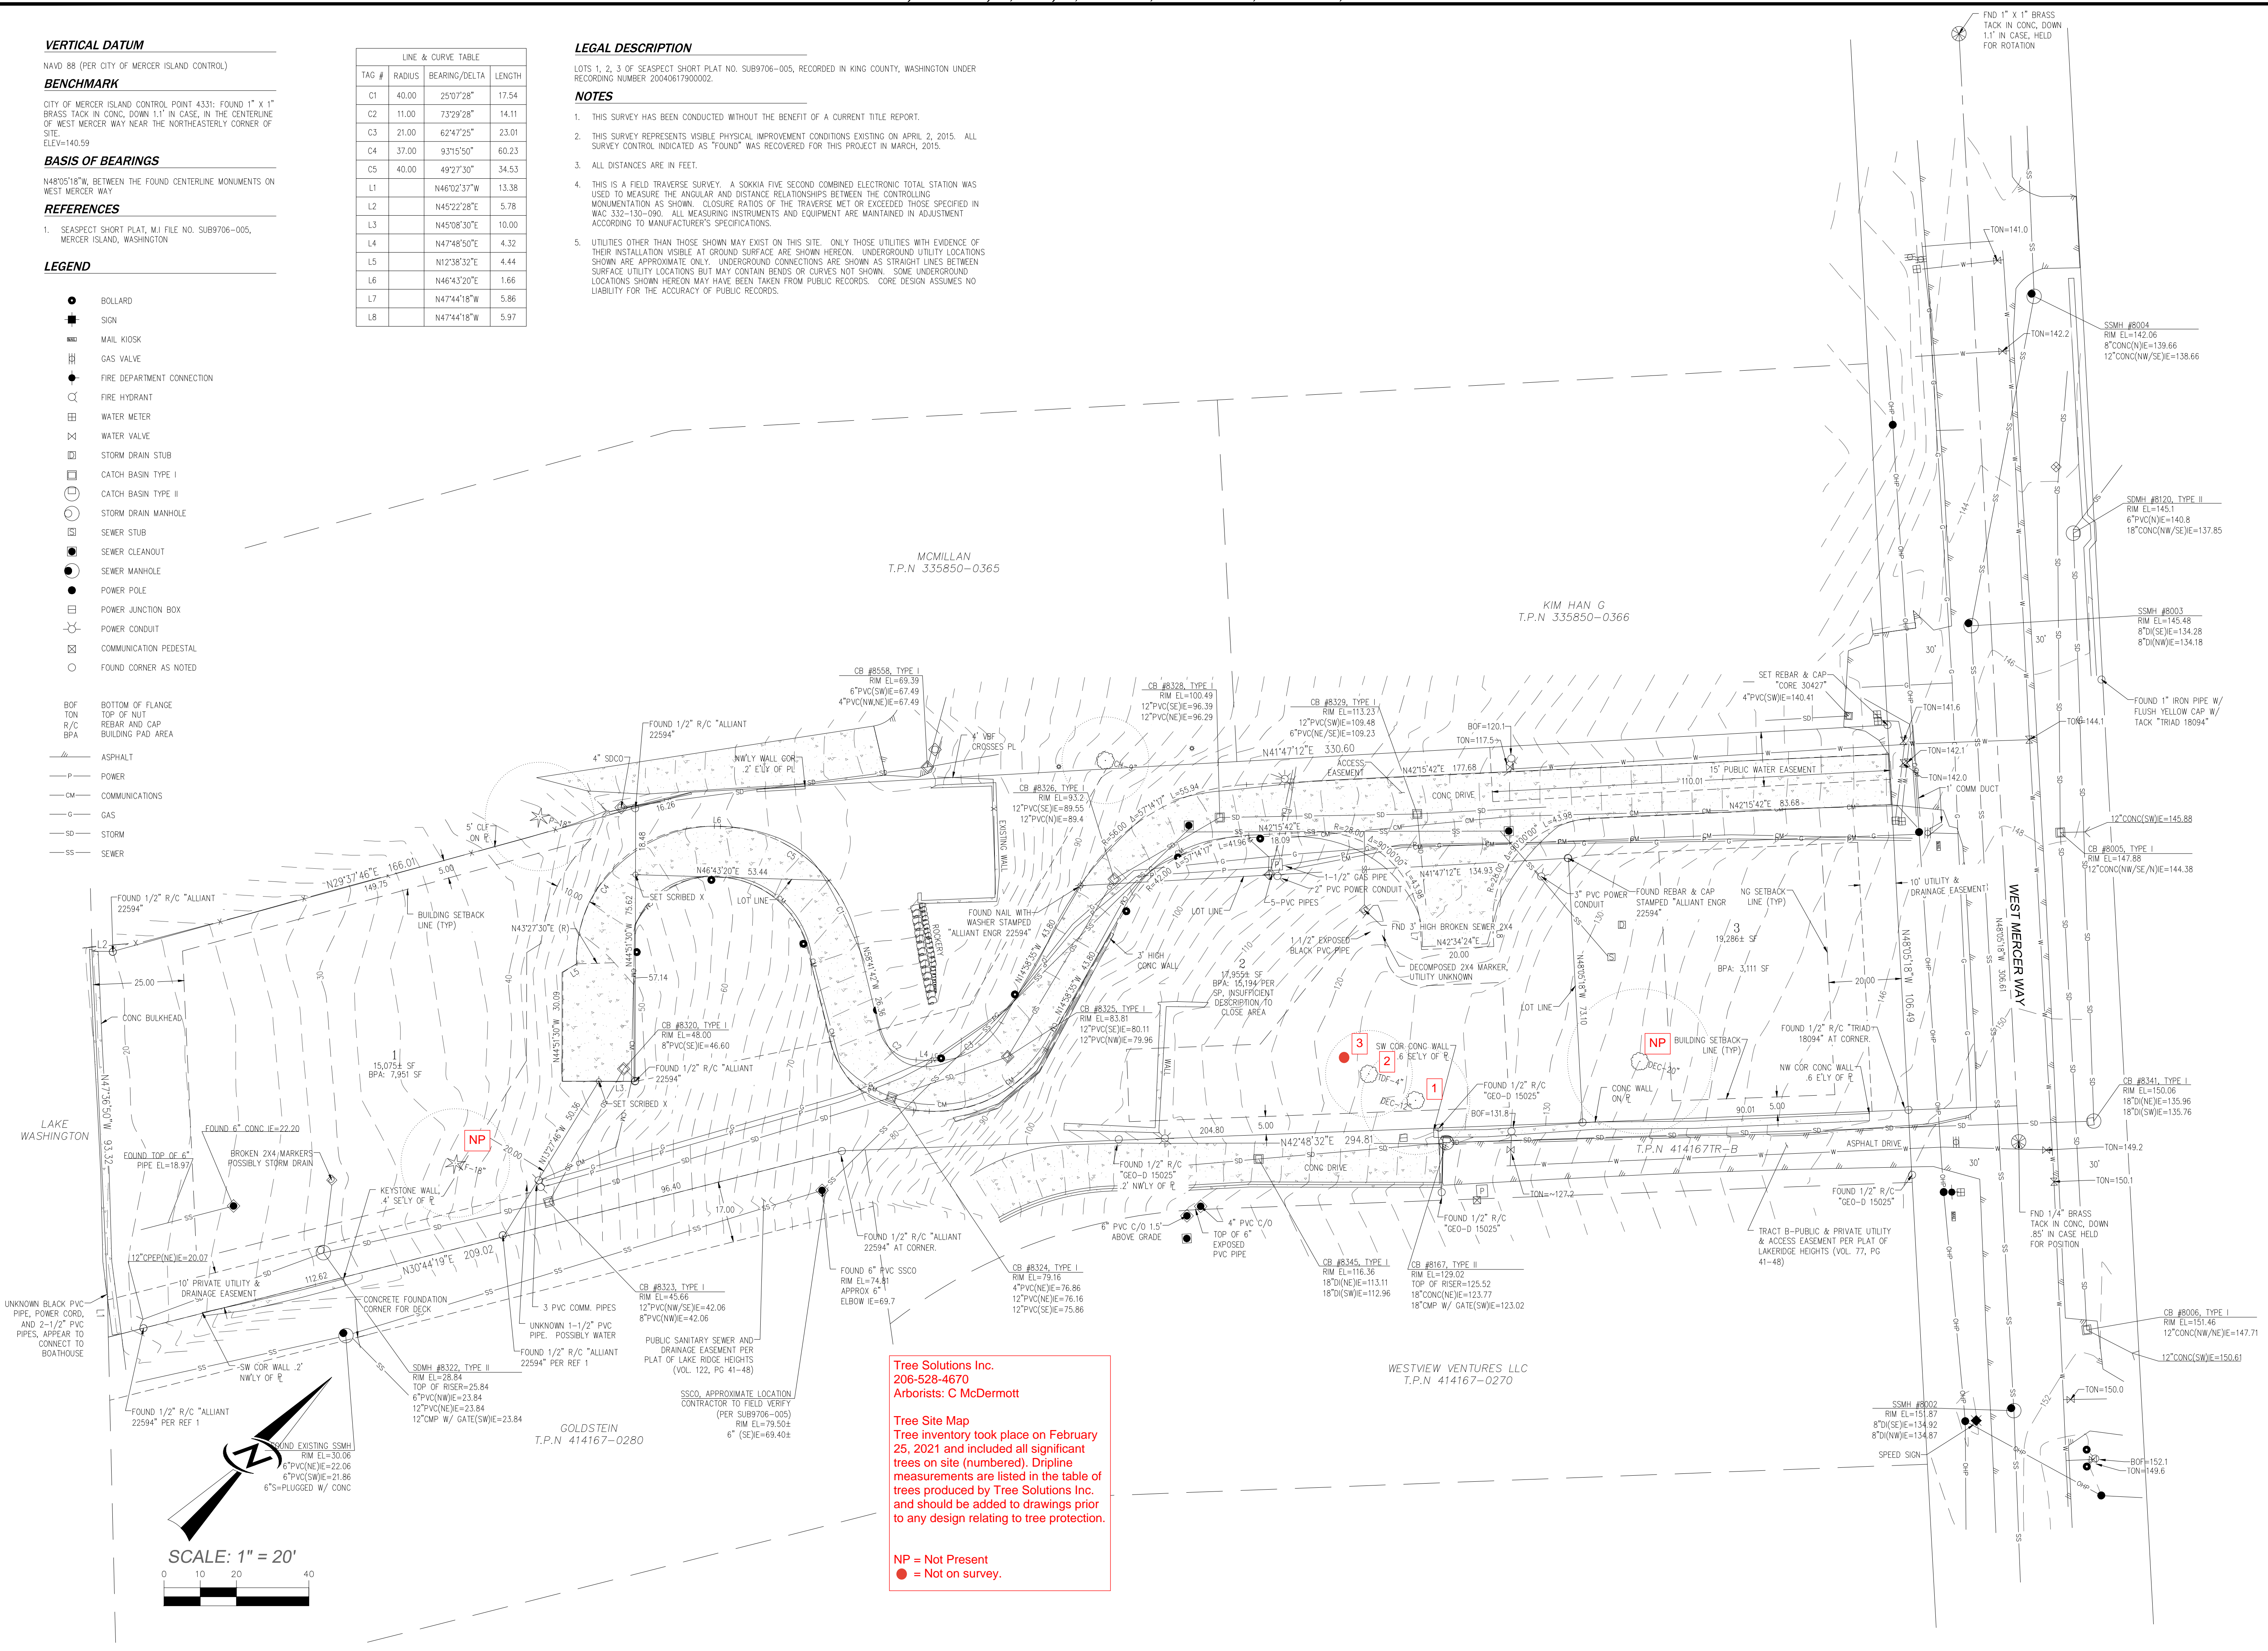
Tree Site Map
Tree inventory took place on February 25, 2021 and included all significant trees on site (numbered). Drip line measurements are listed in the table of trees produced by Tree Solutions Inc. and should be added to drawings prior to any design relating to tree protection.
