Greenforest Incorporated

REFERENCE: Arborist Report

SITE ADDRESS: 3310 97th Ave SE, Mercer Island WA

DATE: January 26, 2021

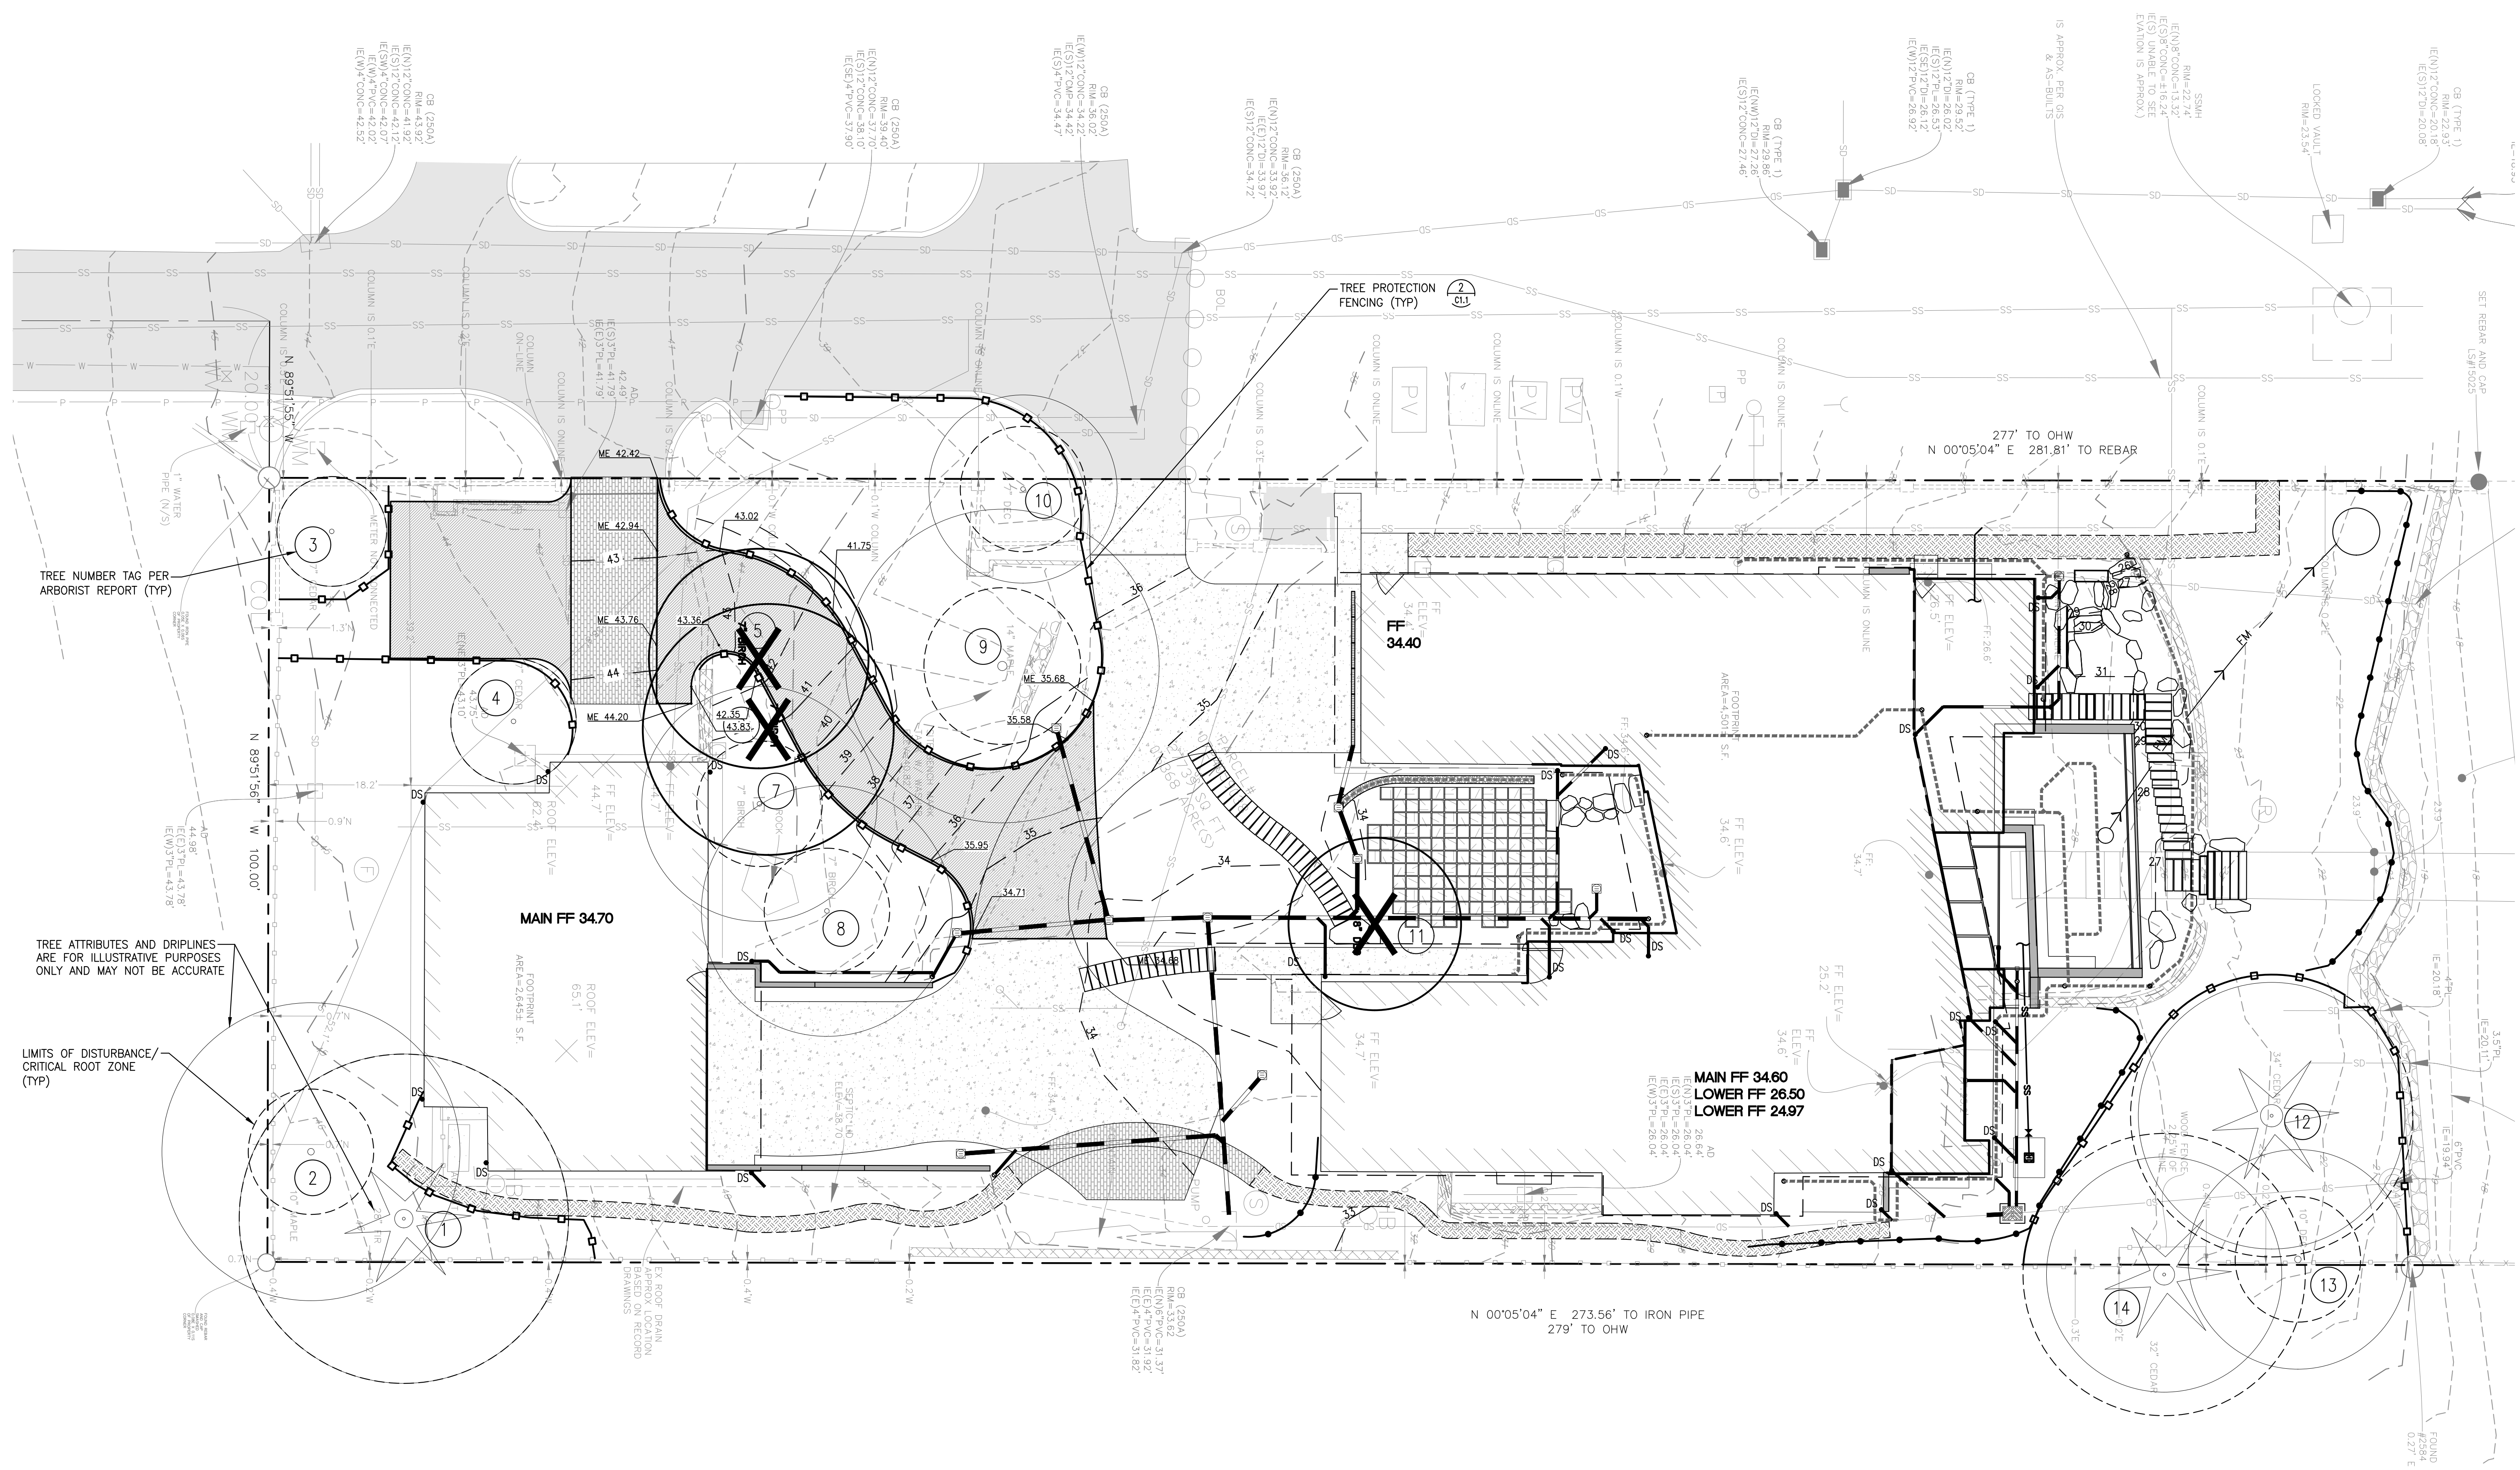
Four trees are listed as non-viable for retention. Two of the birch trees (5 & 6) are infested with the insect Bronze birch borer, and show signs of dieback that preclude death of the entire tree. I understand that the other two adjacent birch trees have been treated with insecticide to prevent them from being infested.

The rootplate of tree 4 has failed the tree is in the (slow motion) process of falling over. Soil is heaving at the rootplate on the opposite side of the tree as the lean. The tree's trunk is less than a foot from the eave of the garage.

Near the shoreline, tree 12 is an exceptional native cedar. Bark is peeling from the buttress roots in multiple locations, and there is a vertical line of visible decay on the SW side of the trunk up past 30 feet from grade. The bark is recessed, and woodpeckers have been actively excavating the dead wood beneath the bark.

Based on this visual assessment of this report, this tree appears to be at increased risk of failure, and has multiple targets within striking distance. If the tree is to be retained, I recommend a level 3 assessment to determine the extent of the wood decay in trunk, and the risk posed to the residence and other targets.

Pruning of branches to create clearance above the proposed temporary construction driveway, and also the existing driveway, is required on trees 7, 8, 9, & 10.

Pruning shall be completed prior to TPF installation, and shall be consistent with a natural pruning system, and with the sole objective of creating vehicle/equipment clearance (to prevent injury to the branches during construction).
