ARBORIST REPORT

PROPERTY OWNER/APPLICANT: Hui Home LLC
2112 22nd Ave S
Seattle, WA 98144
P: 206-910-1989

PROJECT SITE LOCATION: 30xx 69th Ave SE, Parcel 509330-1316
Mercer Island, WA

DATE: April 10, 2020

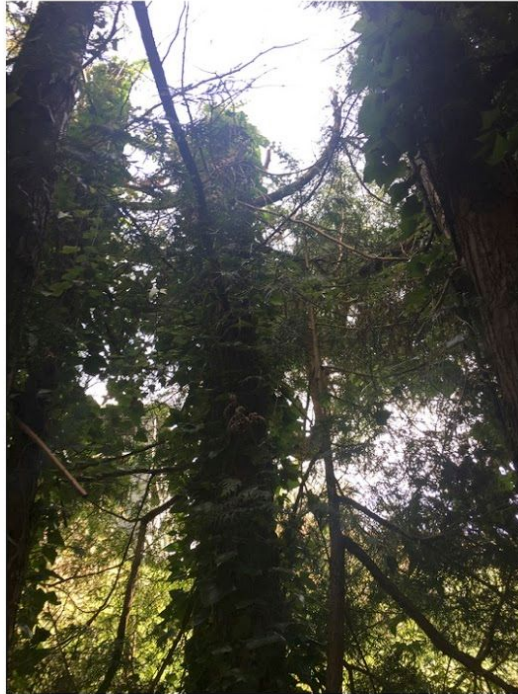
Tree #12 - Western Red Cedar - Topped Leader

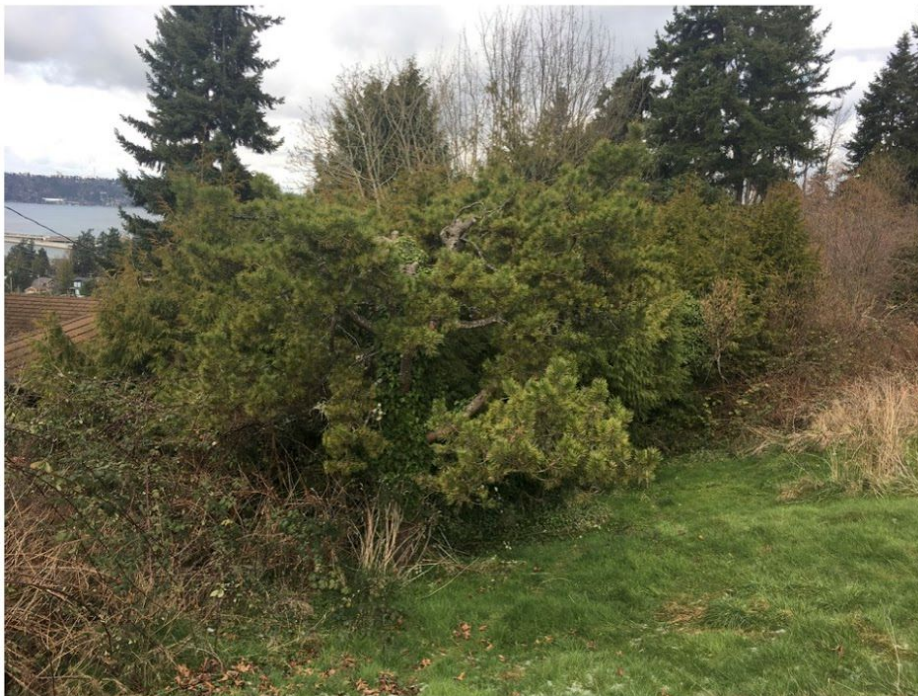
Tree #13 - Shore Pine - Topped Leader

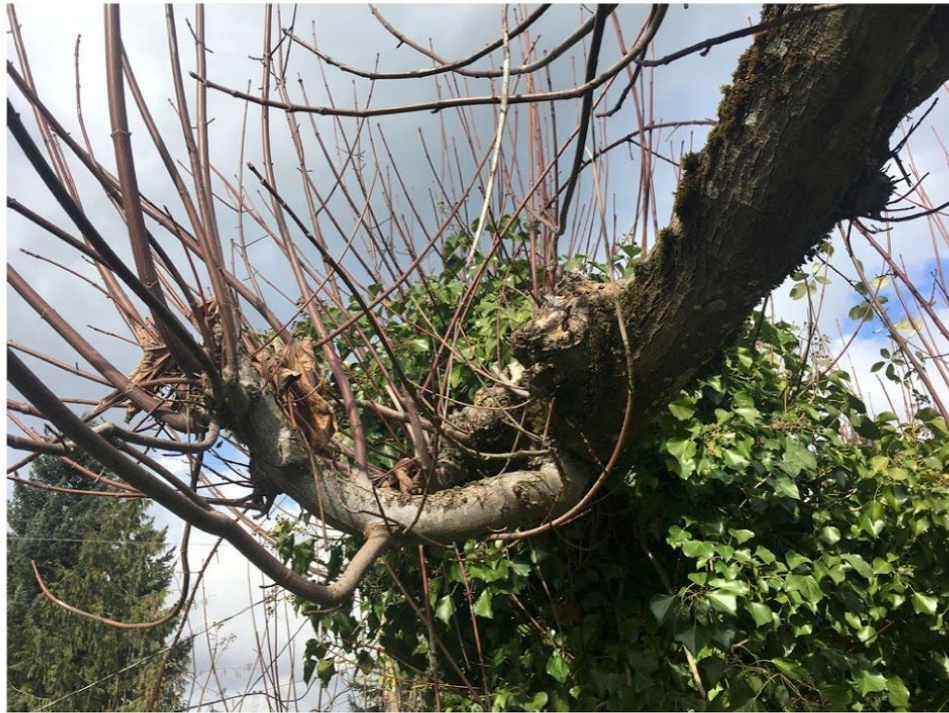
Per MICC tree replacement calculations, a minimum of 9 trees shall be planted as replacement for the 3 trees removed as part of the proposed development. It is noted of the 3 trees planned for removal, tree #14 is in poor condition and would not be viable for retention due to severe topping of central leader and tree #13 is in fair to poor condition with a low likelihood of longevity due to structural defects caused by topping.

Tree #14 - Big Leaf Maple - Topped Leader

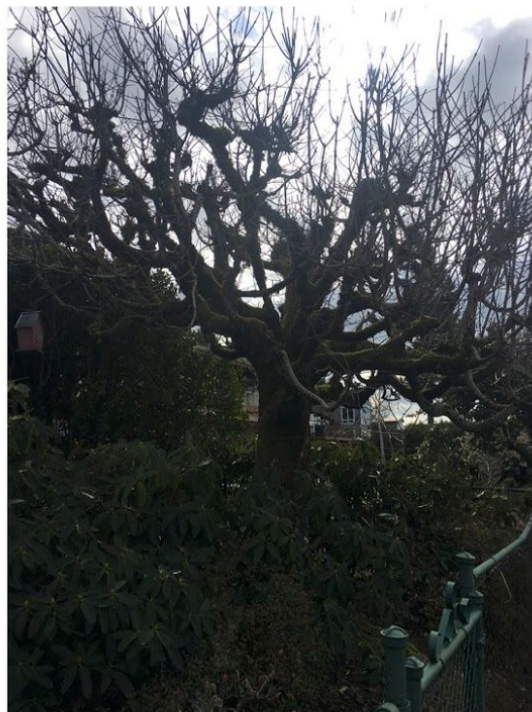
Tree #16 - Japanese Maple - Topped Crown
