5401 W. Mercer Way ~ Bonney St. Storm Drains

Location	Inspector
5401 W. Mercer Way Mercer Island WA	Todd Vecchio Todd@SoundSewerinspection.com 206-619-9990

3/14/2021

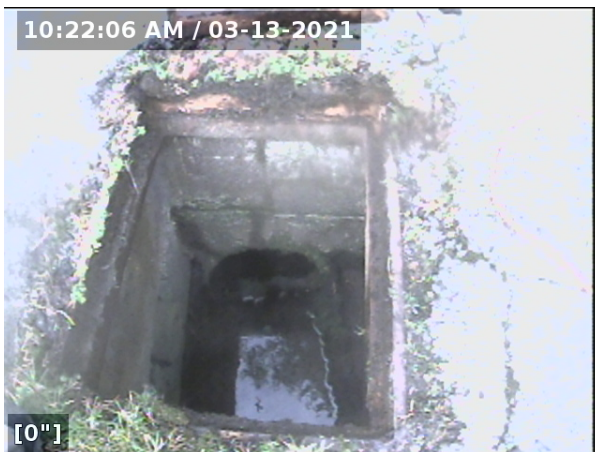
0"

Pipe is approx. 2.5 feet in depth. Video of drain #1:
<https://youtube.com/watch?v=-m30-NWTca8>

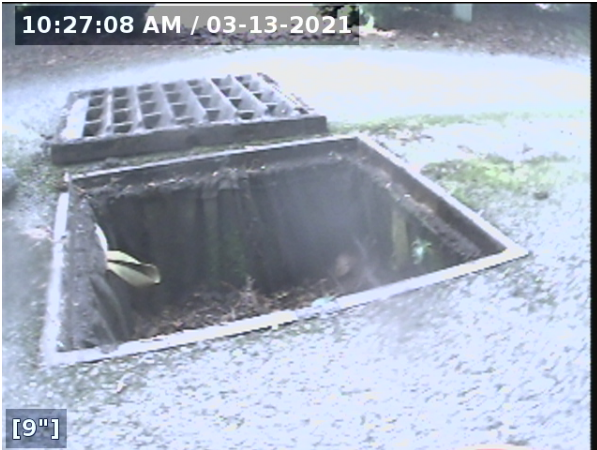
9"

Video of drain #2: <https://youtube.com/watch?v=O0Gn4iibkDU>

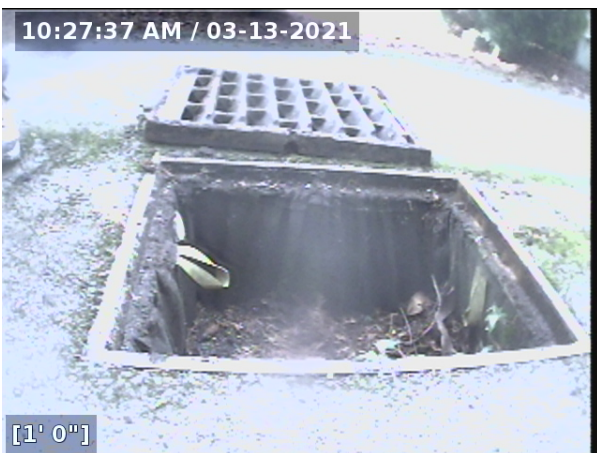
1' 0"

Drain #2 has a catch basket for debris/leaves. The basket was NOT removable to pipe inspection.

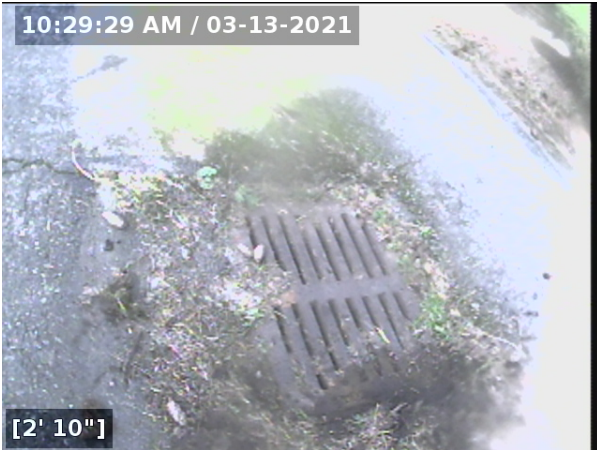
2' 10"

Drain #3 has a catch basket for debris/leaves. The basket was NOT removable to pipe inspection. Video of drain #3: <https://youtube.com/watch?v=X2EZozW7nro>

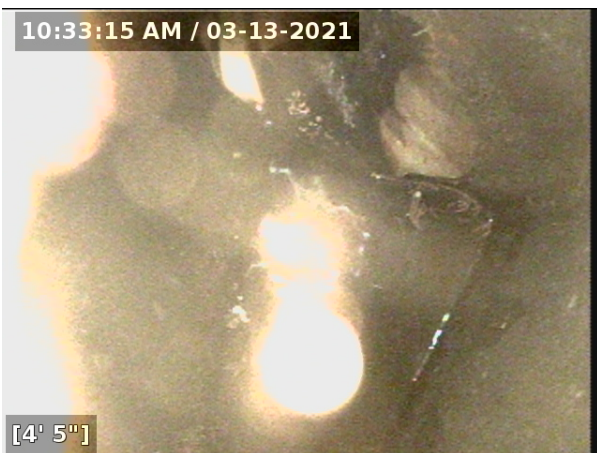
4' 5"

Drain #4, pipe is approx. 4' feet in depth. Video of drain #4: <https://youtube.com/watch?v=aZpbgnsvg7o>

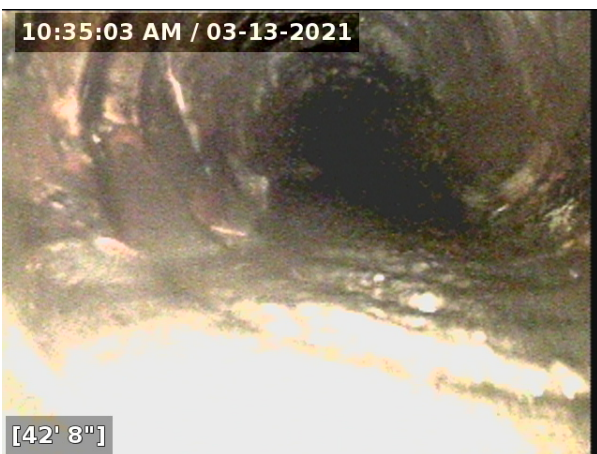
42' 8"

Major debris in the lower drain

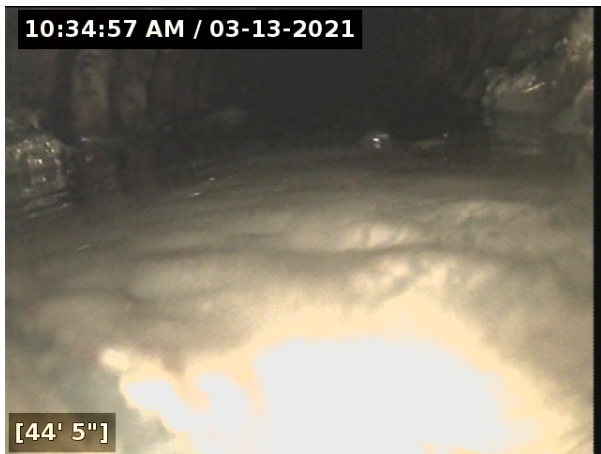
44' 5"

Major blockage down the line. Sewer scope camera can not get past this point in the line.
