# ARBORIST REPORT

August 30, 2021

5401 West Mercer Way  
Mercer Island, WA

Tom Quigley  
ISA Certified Arborist, PN-655A  
Tree Risk Assessment Qualified (TRAQ)

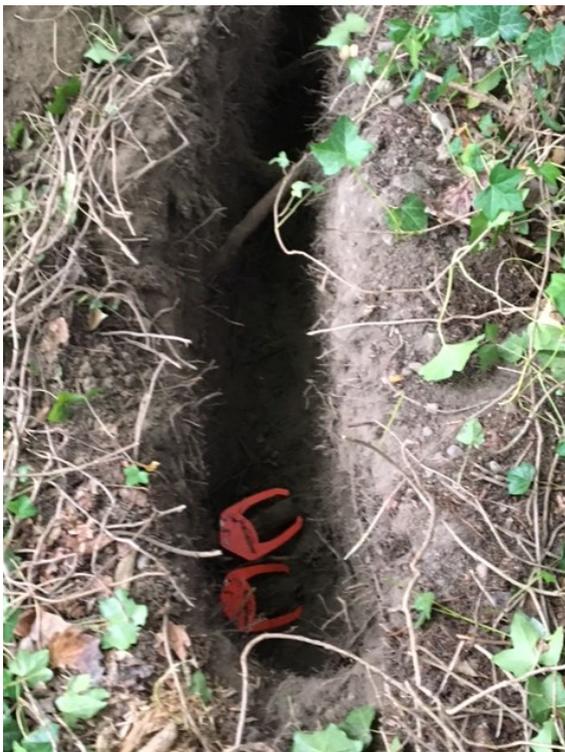
Tree #214 is a Douglas fir of Exceptional size; 41.3" DBH. The dripline radius of this tree extends 33' south and covers the dripline of most of the trees listed immediately above. The development plans include a site wall to be constructed at grade in the eastern portion of this property, said wall would require excavation within the dripline of Tree #214. An exploratory trench was excavated perpendicular to the proposed wall and at a distance of 18' from the centerline of Tree #214. This was determined to be the northern Limit of Disturbance (LOD) for the associated excavation. Tree protection for Tree #214, as well as Tree #213, will mimic the dripline with the exception of a 4' wide excavation 'alley' that will be created with protective fencing. Photo 1A and 1B below attempts to show that the excavated trench was clear of any roots larger than ½" in diameter, other than two roots that each measured 1.75" and 2.5" in diameter. These two larger roots were located at the very east end of the exploratory trench, which was dug 8' long in order to explore beyond what is expected to be the LOD. It should be possible to avoid and protect these specific roots during the excavation and construction of the proposed site wall. The absence of significant roots within the trench does not assure that other roots might be discovered as the foundation trench is excavated. My experience tells me that if there are additional roots present, they will be smaller in size as the excavation moves away from the subject tree. See additional specific protection measures detailed below.

Photo 1 A . Trench near Tree #214. 8' long, 22" deep. Very few roots

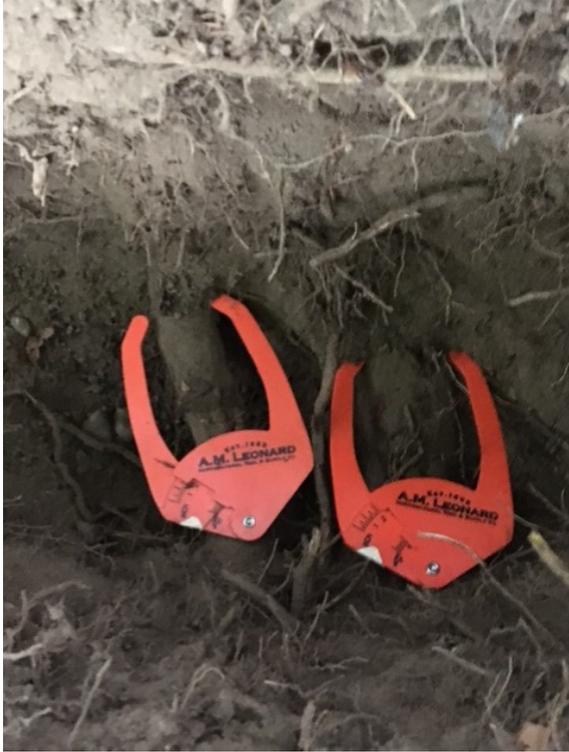
Photo 1 B. Tree #214 - Close-up of calipers 1.75" and 2.5".

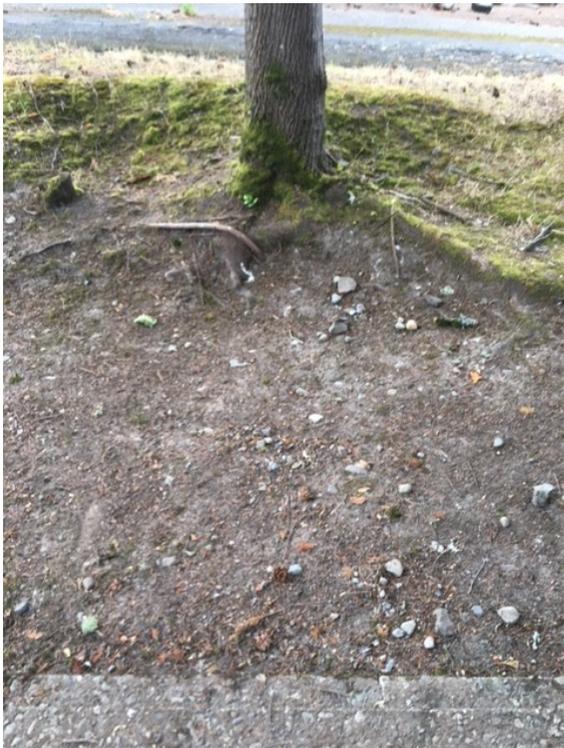
Tree #221 through #224 (four trees) are located on the southern property line, along the ROW. It is unclear from the survey whether these four trees are located on-site or off. For the purpose of tree retention calculations, all four trees were considered as on-site. Tree #224 is less than 10" DBH. Tree #221, 222, 223, and 224 are scheduled for removal as their existing root system is exposed, damaged, and not likely to tolerate the additional impacts of having the existing broken concrete driveway and carport slab removed, regraded and rebuilt. See Photo

Photo 3. Big leaf maple, tree #223. Roots exposed and damaged. Compacted soil.

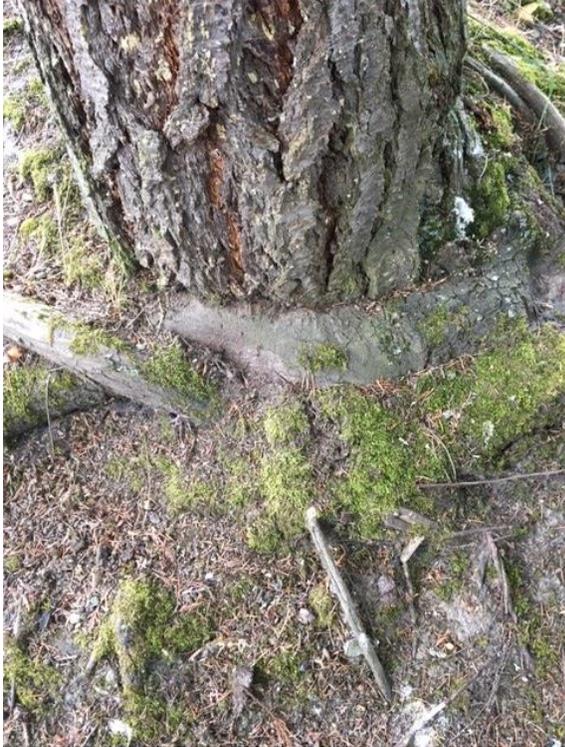
Photo 4. Tree #222. Girdling roots.

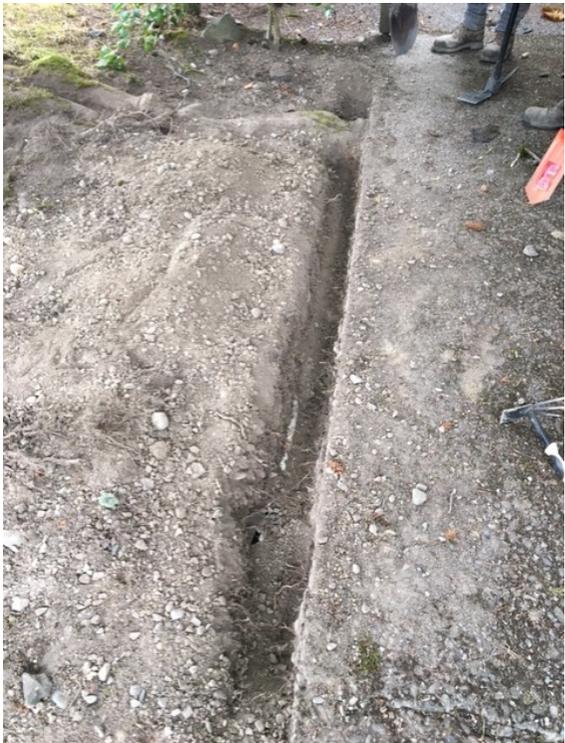
#2 and #3 below. An exploratory trench was excavated parallel to the driveway slab and up against the slab. See Photo #4 below. The soil here is highly compacted. One large (4"-5") was discovered though it was difficult to assess whether it was one root or two roots co-joined.

Photo 5. Along south edge of driveway.  
Large root at top of photo

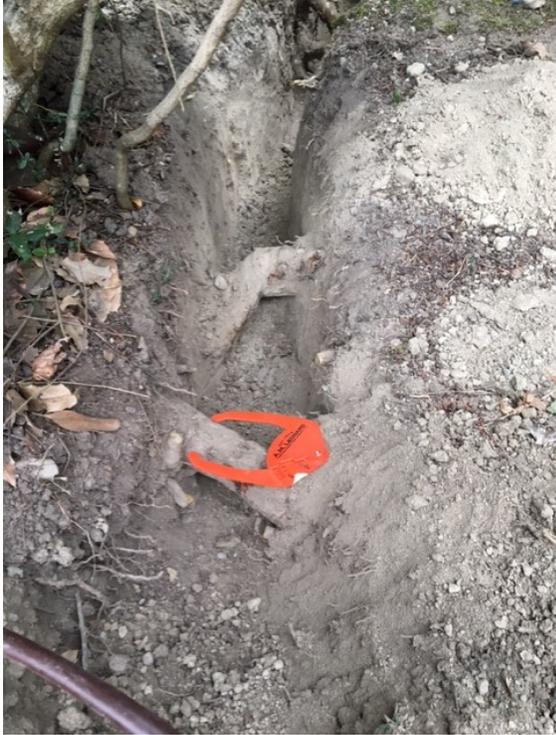
Tree #227 is a 21.0 Douglas fir in Good condition that will be retained. An exploratory trench was dug at the proposed LOD for this tree. Photo #5 and #6 below show the open trench with roots larger than 1" shown. Two roots, each 1.5" in diameter were located north of the existing fence. Two additional roots of equal size were located south of the fence. I believe this tree will tolerate the severing of these roots, provided the mitigation measure detailed below are adopted and implemented.

Photo 5. Tree #227, south of fence.

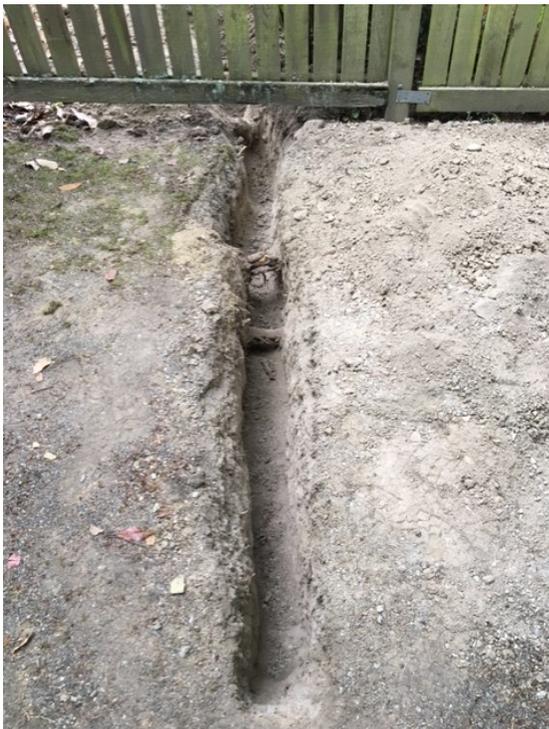
Photo 6. Tree #227 trench looking south
