ARBORIST REPORT

Addendum/Memo

October 21, 2021

5401 West Mercer Way
Mercer Island, WA

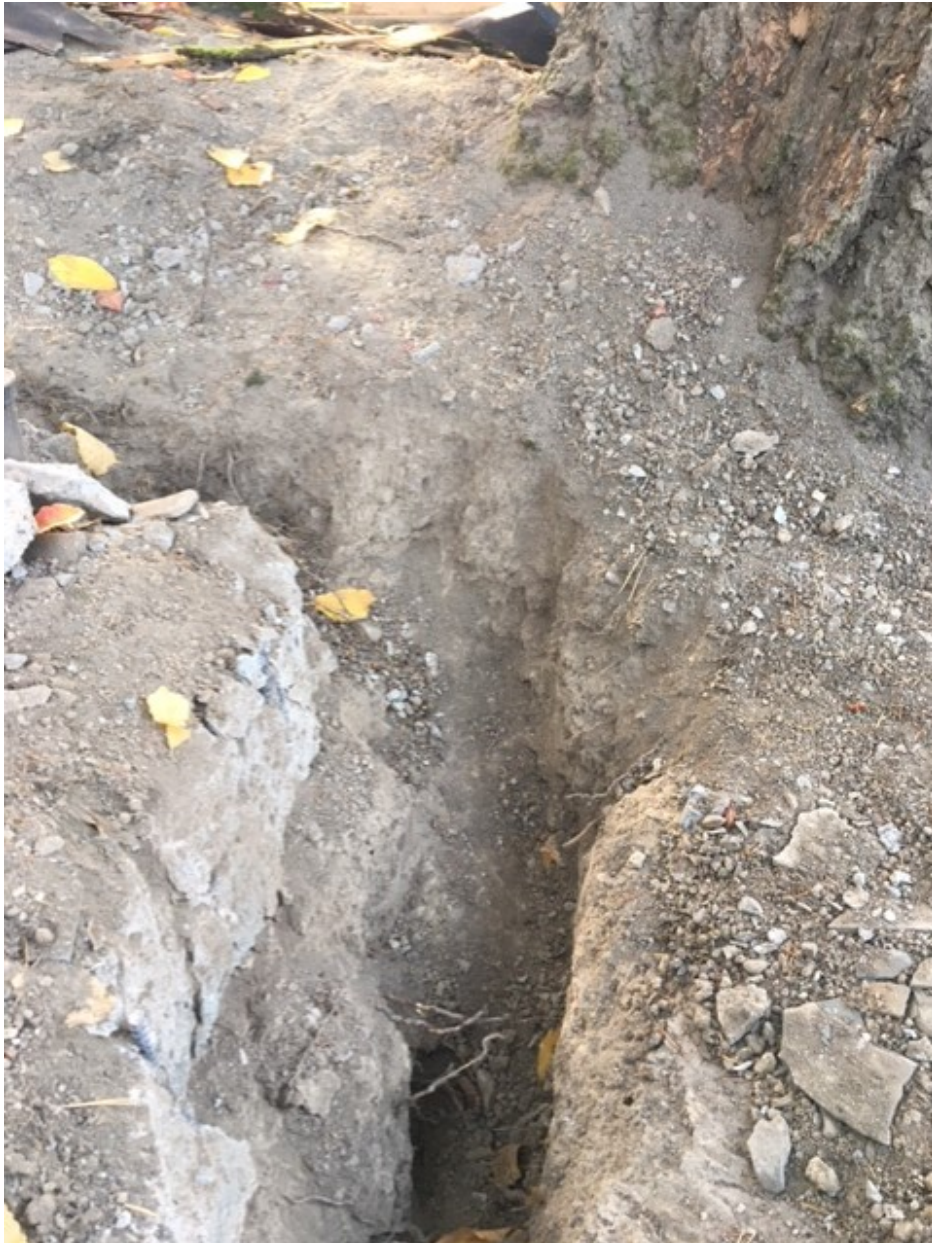
This photo shows air-excavation within 15" of Tree #233. The planned limits of disturbance for this tree is actually 7.35' east of the tree and 5' north. At 5' north of the tree, the air-excavated trench contained very small roots, less than .5" in diameter. The air-excavation trench shown here is the edge of a large underground concrete mass as described in this memo. Even at this close proximity to the subject tree, root mass and size appears very limited, most likely due to the compacted soils surrounding the concrete mass. Complete removal of this mass will not impact the existing roots and may well provide space to backfill with sandy loam soil.

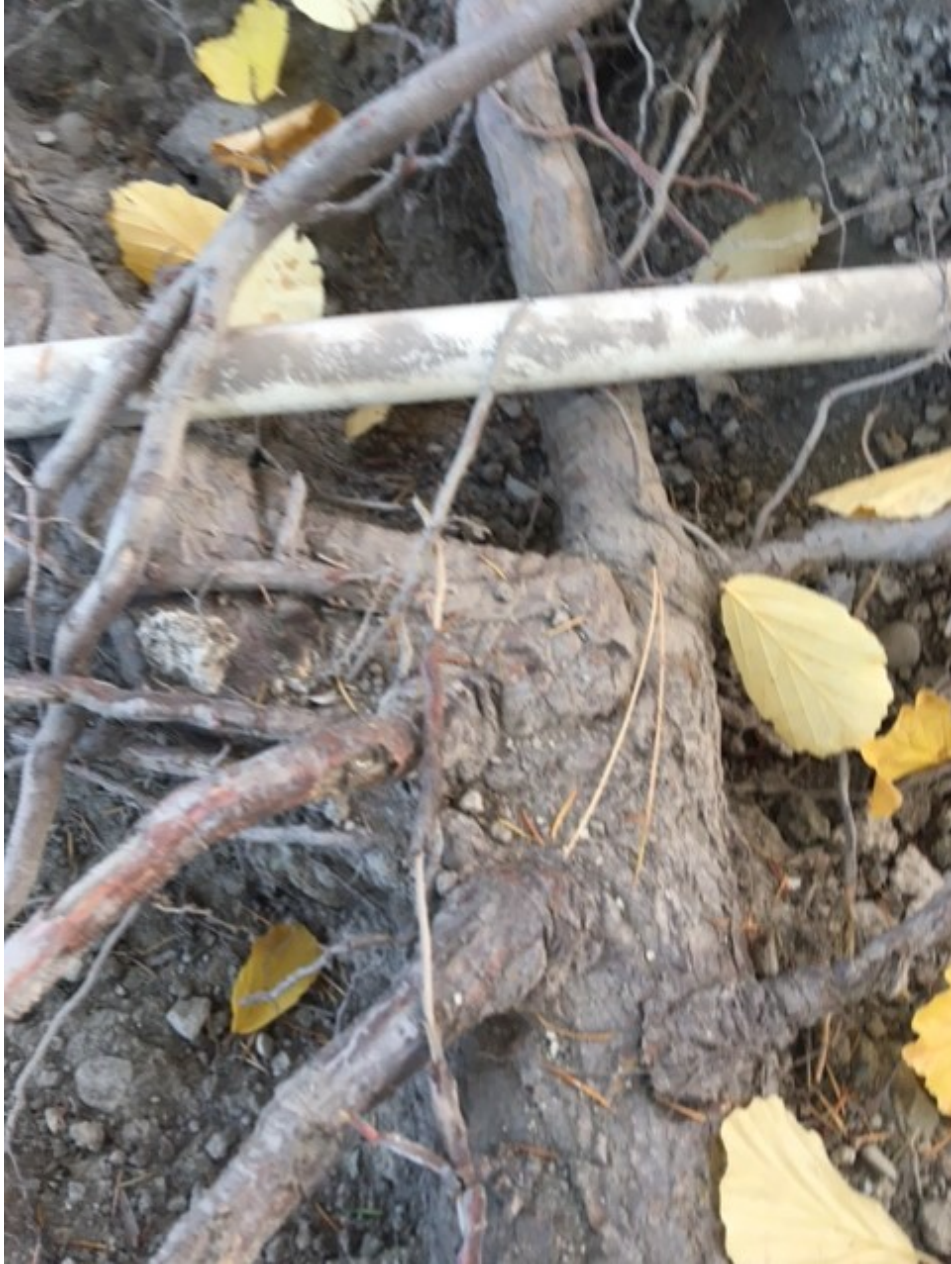
This photo shows the largest of the roots that were exposed by the air-excitation. The largest of these photographed roots is 3.0" in diameter. It appears that this root may have been severed many years ago, resulting in this cluster of smaller roots growing from the previously cut root end. Also present in the photo is a ¾" irrigation line, and less obvious a 4" concrete tile storm drain that is full of soil. It is not known when these systems were installed but it is obvious that there have been root system impacts to this tree in the past.
