Arborist Report

February 22nd, 2021

Chis Luthi
8151 SE 48th St
Mercer Island, Wa

Seattle Tree Consulting
Douglas Smith (Certified Arborist PN 6116-A/TRAQ)
117 E. Louisa St. #731
Seattle, Wa. 98102
(206)457-5706
doug@seattletreeconsulting.com

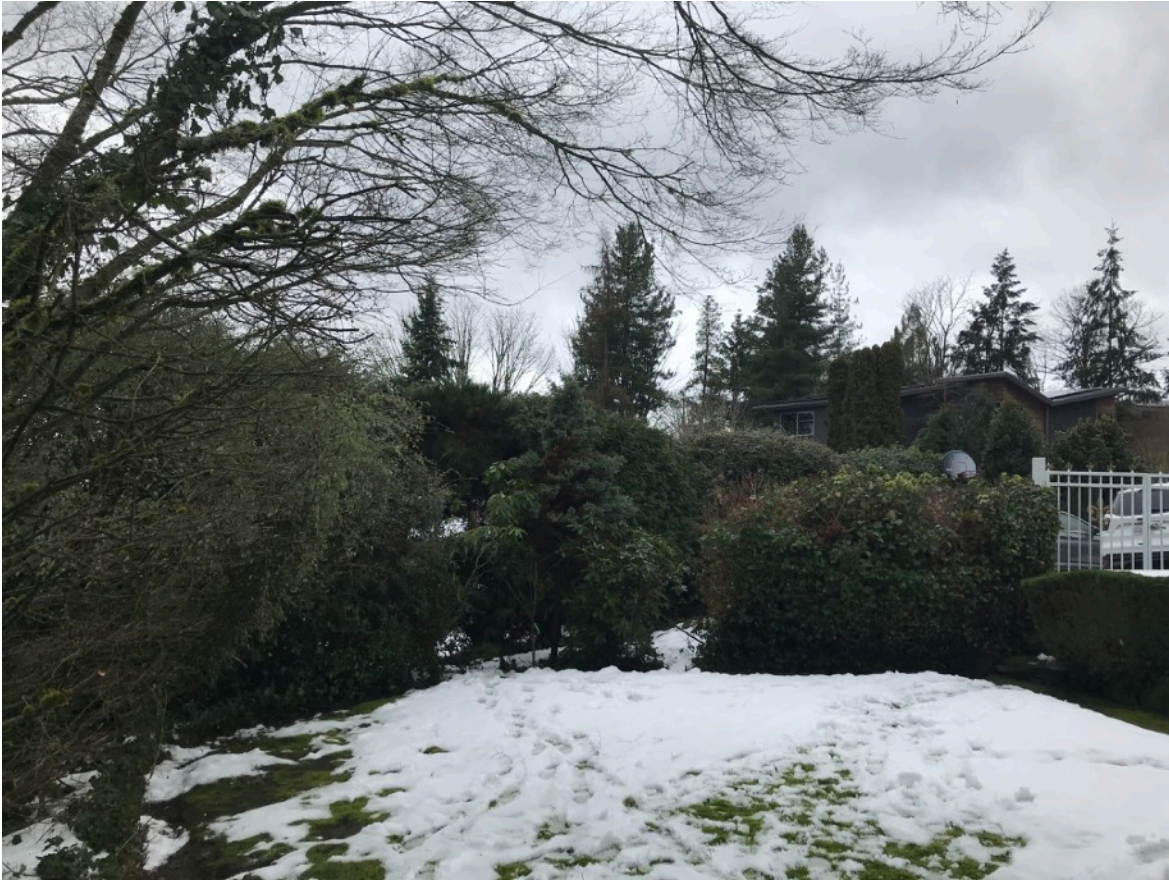
Trees #1-#3 are in this Hedge Row

1. Western Red Cedar. *Thuja plicata*. 10" DSH. 10' DLR. This tree is being maintained at 10 foot above grade. Condition 2/3.
2. Western White Pine. *Pinus monticola*. 10" DSH. 10' DLR. This tree is not tolerating the height reduction as well as the adjacent Cedar. Condition 3.

3. Western White Pine. *Pinus monticola*. 10" DSH. 10' DLR. Tree number three is all the way dead; a standing snag at the time of the site visit.
4. Vine Maple. *Acer circinatum*. 22" DSH. 15' DLR. Condition 1. Tree number four is a Vine Maple with three main stems that have diameters at standard height of 15", 16", and 6". This tree has some English Ivy growing up the stems that could easily be removed. This tree has not had its height reduced and is in excellent condition. This tree is condition one. This tree has a drip line radius of 15' that is based on a day vision of its overall diameter of 30'.

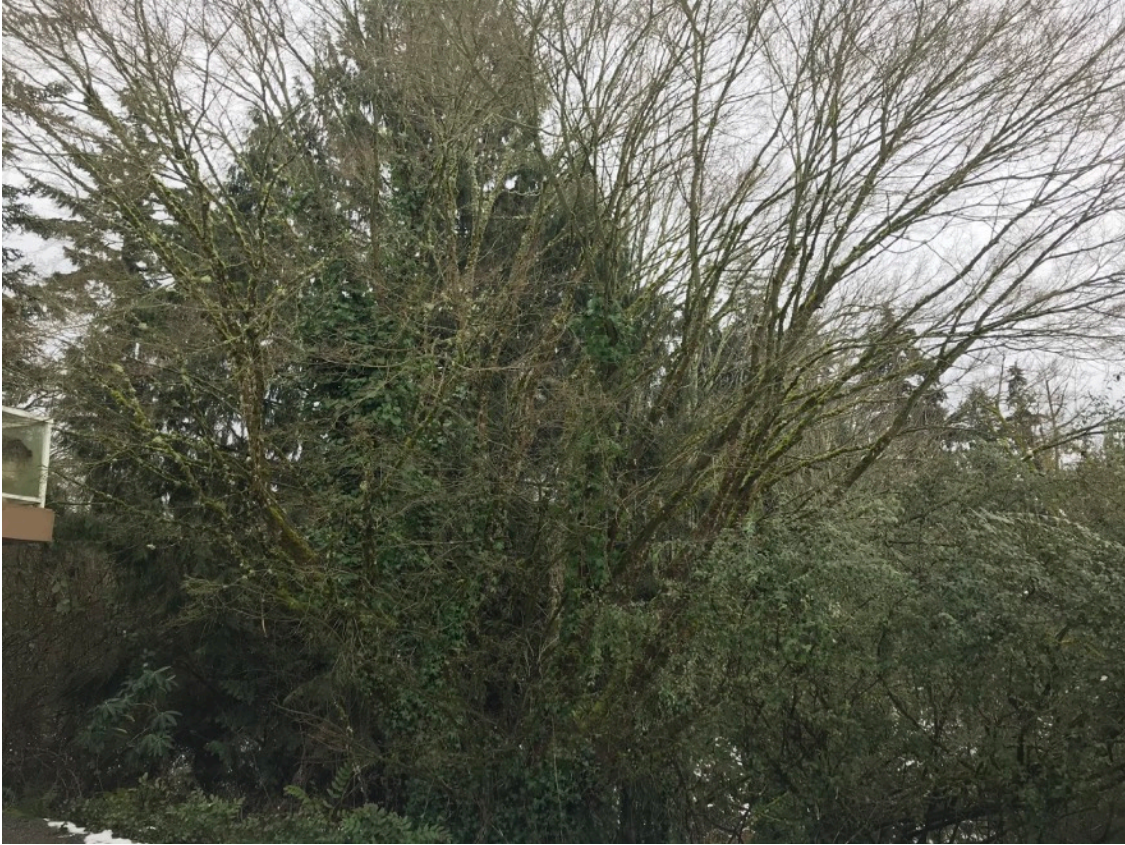
Tree #4 with Tree #5 behind it

5. Western Red Cedar. *Thuja plicata*. 42" DSH. 22' DLR. Condition 1. This tree splits into two leaders that have an included bark union approximately 40' above grade. The new iterations are not tall enough to pose a risk.

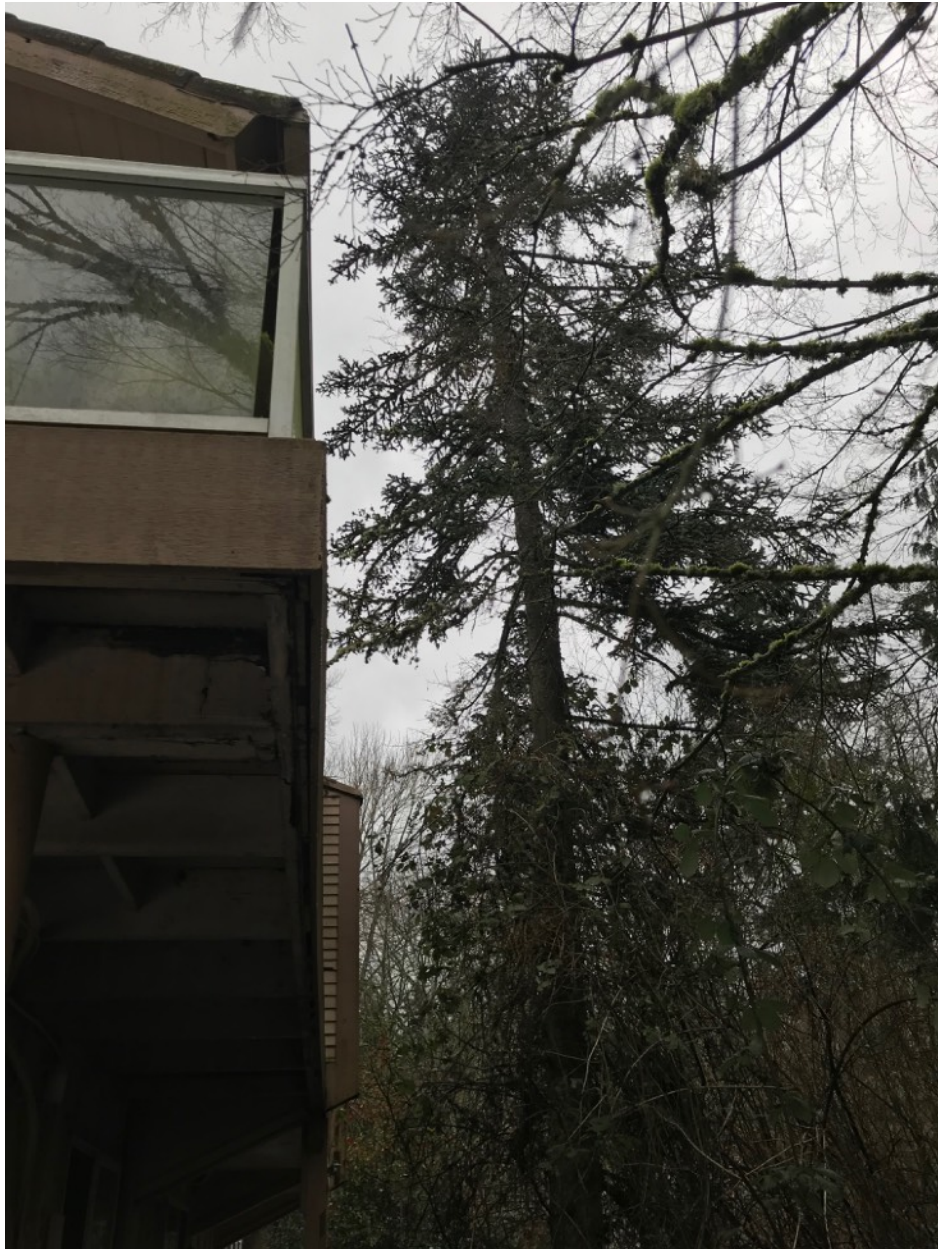
Tree #6

6. Blue Noble Fir. *Abies procera* 'Glauca'. 17" DSH. 15' DLR. Condition 1. This tree is directly south east of the air conditioning unit that is located on the south side of the property. This tree was not located on the survey map that I was initially provided.

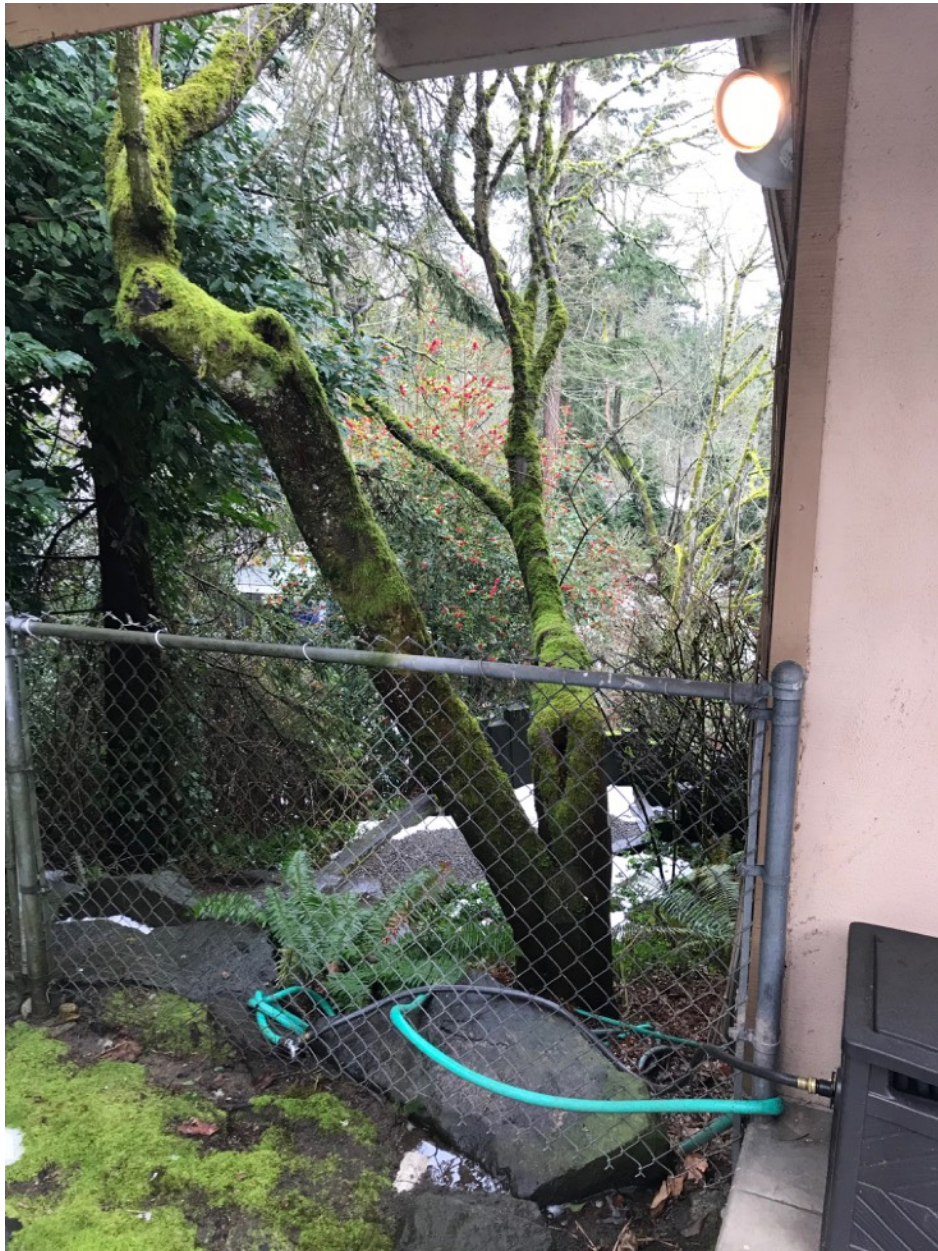
Tree #8

7. Blue Noble Fir. *Abies procera* 'Glauca'. 17" DSH. 15' DLR. Condition 1.
8. Vine Maple. *Acer circinatum*. 15" DSH. 10' DLR. Condition 1. Tree number eight is a vine maple that is located east of the existing structure. This tree has two main stems with diameters at standard height of 11 inches and 10 inches. This tree is condition to because of some defects in the pedestal region and because it is stretching quite a bit for light. This tree has a critical root zone radius of 10 foot that is based on its overall diameter of 20 feet. Because of the existing structure to the west, the majority of this trees root system is likely located to the southeast of the system.

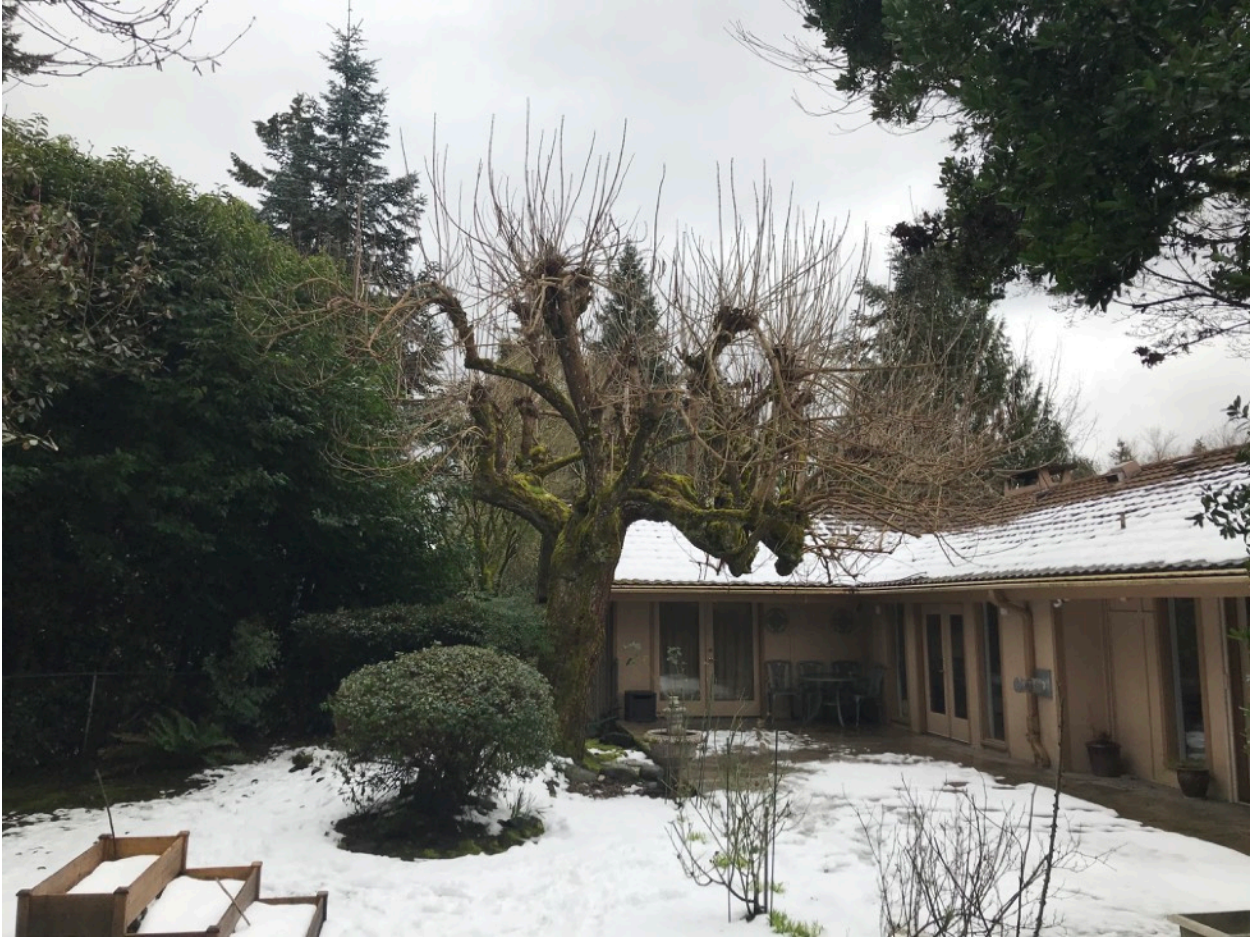
Tree #10

10. Catalpa. *Catalpa bignonioides*. 29" DSH. 12' DLR. Condition 3. This tree is likely acquiring more girth than normal because of the repeated height reduction. The tree is being maintained at approximately 12 to 15' above grade. There are no imminent risks associated with this system but the repeated height reduction is shortening the lifespan of this tree. This tree has a drip line radius of 12', but the extent of its canopy is being reduced with heavy pruning.

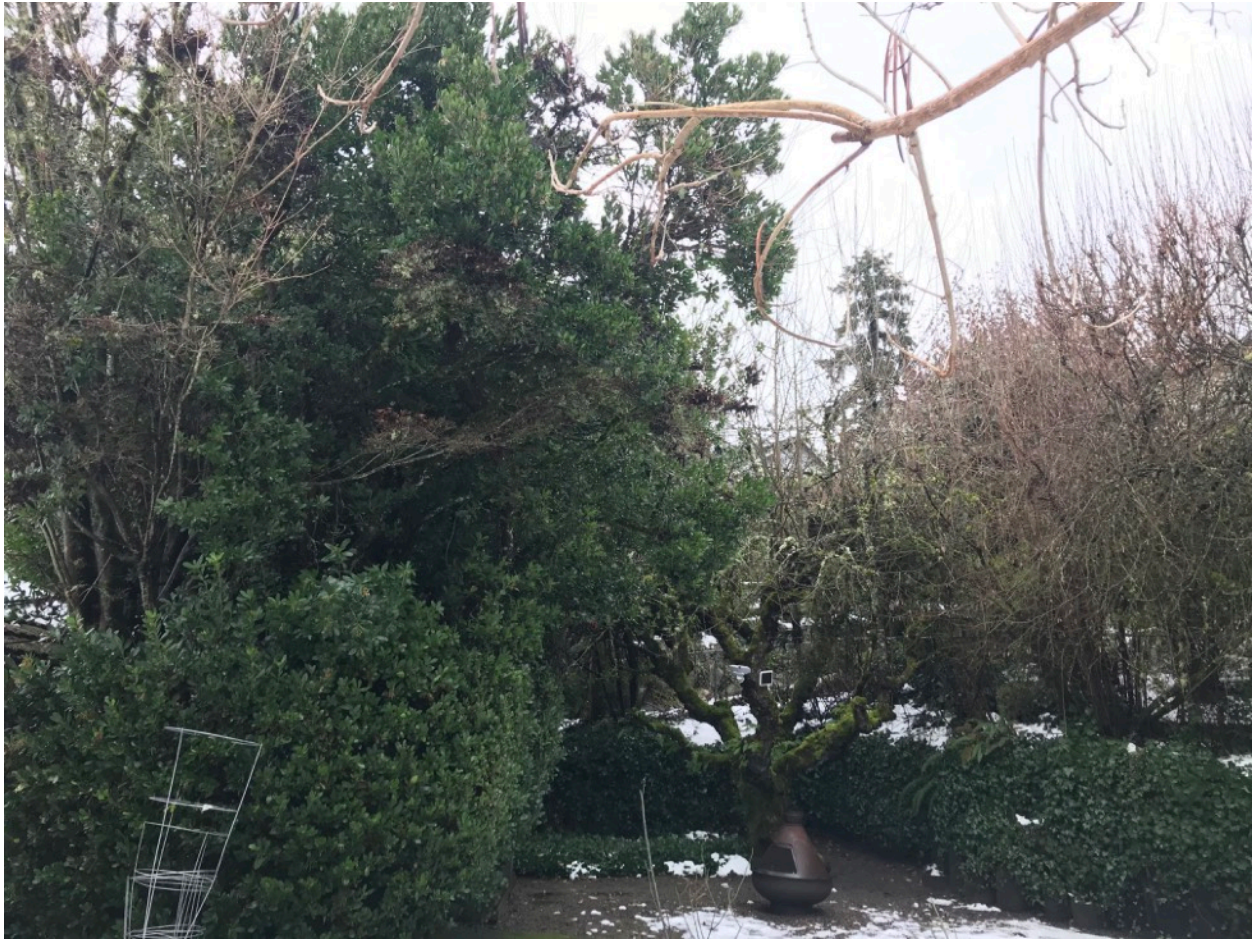
Trees #11-#14

11. Korean Dogwood. *Cornus kousa*. 13" DSH. 12' DLR. Condition 1. This tree is condition one despite the repeated height reduction.
12. Strawberry Tree. *Arbutus unedo*. Multi-stemmed. 12' DLR. Condition 2. Tree number 12 is a multi stemmed specimen of strawberry tree that is also having its height reduced at approximately 12'.

13. Portuguese Laurel. *Prunus lusitanica*. 8" DSH. 12' DLR. Condition 1. There is a small copse of trees that is located close to the northeast corner of the existing structure that was not on

the original site map that I was provided. This is small copse includes trees number 11, 12, and 13.

14. Flowering Plum. *Prunus serrulata*. 18" DSH. 15' DLR. Condition 1/2.
15. Apple. *Malus domestica*. 9" DSH. 6' DLR. Condition 3/4. This tree is condition 3/4 because of repeated height reduction. It is located just west of the chain-link fence in the middle of the backyard.
16. Western Hazelnut. *Cornus cornuta*. Tree number 16 describes a small clump of Western hazelnut that is just to the north of the Apple which is tree number 15. This clump of Western hazelnut includes approximately 20 stems that are between 1-4" diameter.
