# LAYTON TREE CONSULTING, LLC

## TREES & CONSTRUCTION MEMO

To: Matt Glaser, McCullough Architects  
From: Bob Layton  
CC: Bogdan Maksimchuk, Barcelo Homes  
Date: April 12, 2022  
Re: Tree Protection at 7216 93<sup>rd</sup> Ave SE – Tree #18

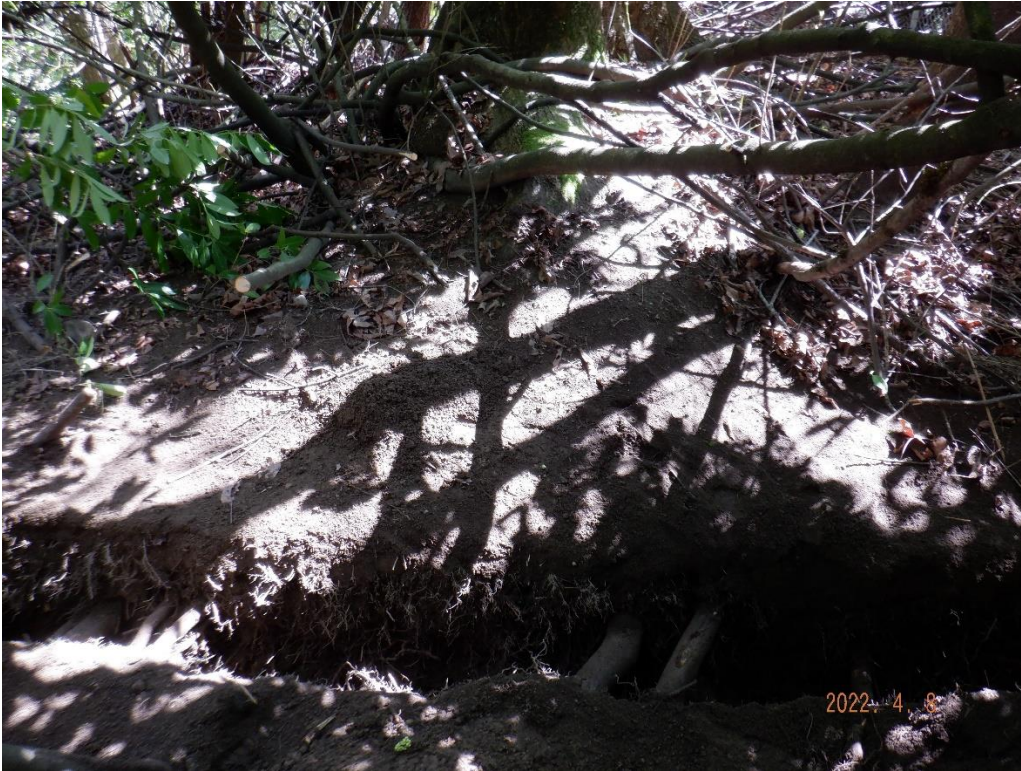
Root crown of Tree #18 in background

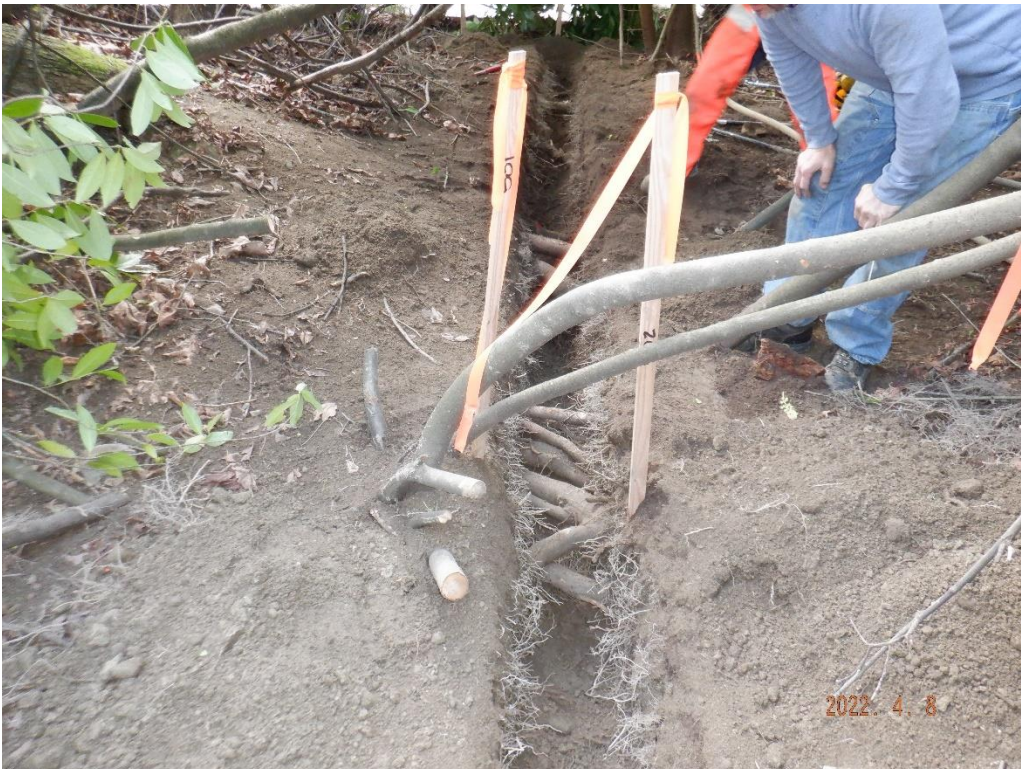
On Friday, a 2-foot-deep trench was air-excavated at 8-feet south of the trunk face of Tree #18 so the presence and size of existing roots could be inspected and ascertained. Eight roots greater than 2-inches in diameter were exposed. The largest root is 4-inches in diameter. There were also 3 – 3-inch diameter roots and 4 - 2-inch. See pictures below. There also a few large roots from the mature English laurel shrubs that cover the area.

Cluster of 2 to 3-inch roots south of root crown

Cutting the roots at this location is not recommended. Long-term tree health is likely to be jeopardized. I would be comfortable allowing an 11-foot Limit of Disturbance from the trunk face as shown on the attached diagram. The roots at this distance would be notably smaller than those exposed at 8-feet from the trunk face. I would not expect any consequential impacts on the long-term health or stability of the tree so long as work is carried out diligently and the tree protection recommendations and guidelines as outlined in the arborist report and below are adhered to. This would also afford 6-feet of clearance between the tree protection zone and the new building at the closest distance to the tree.

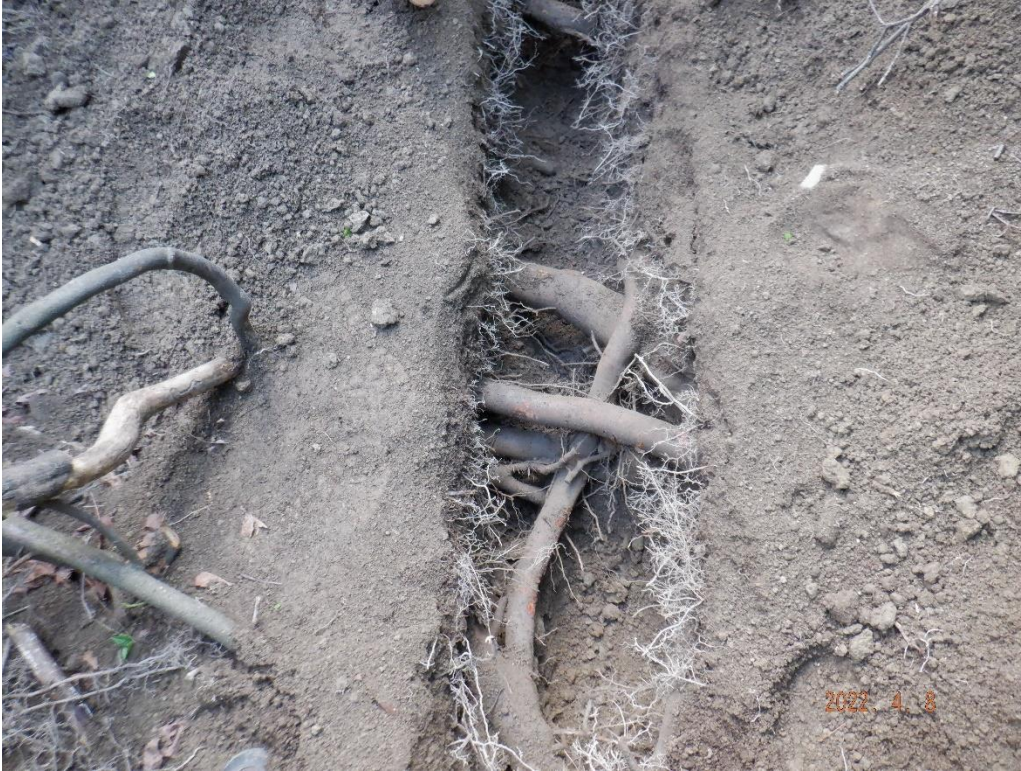
Cluster of 2 to 3-inch roots southwest of root crown

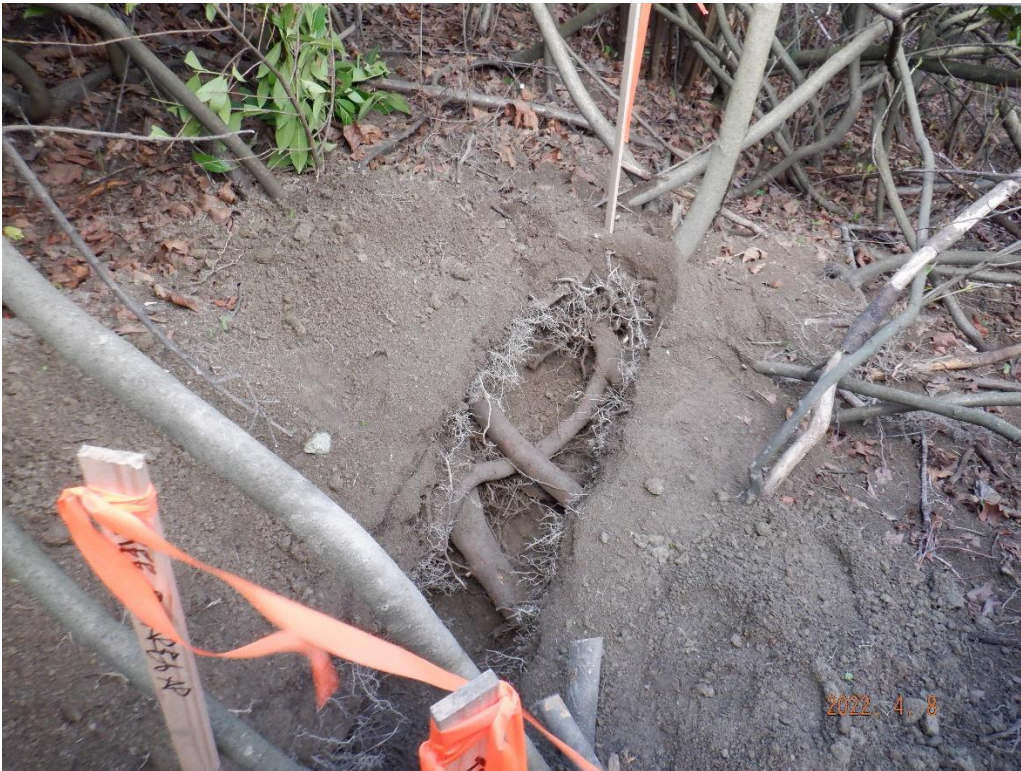
Cluster of 2-inch roots southeast of root crown

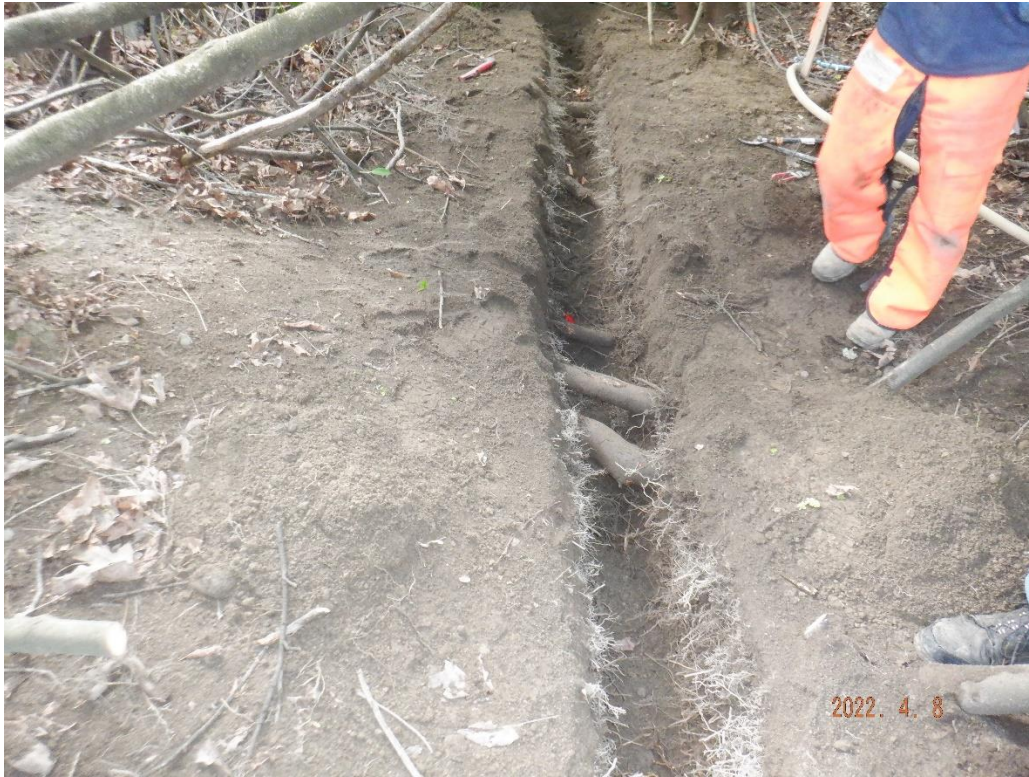
Air-excavated trench

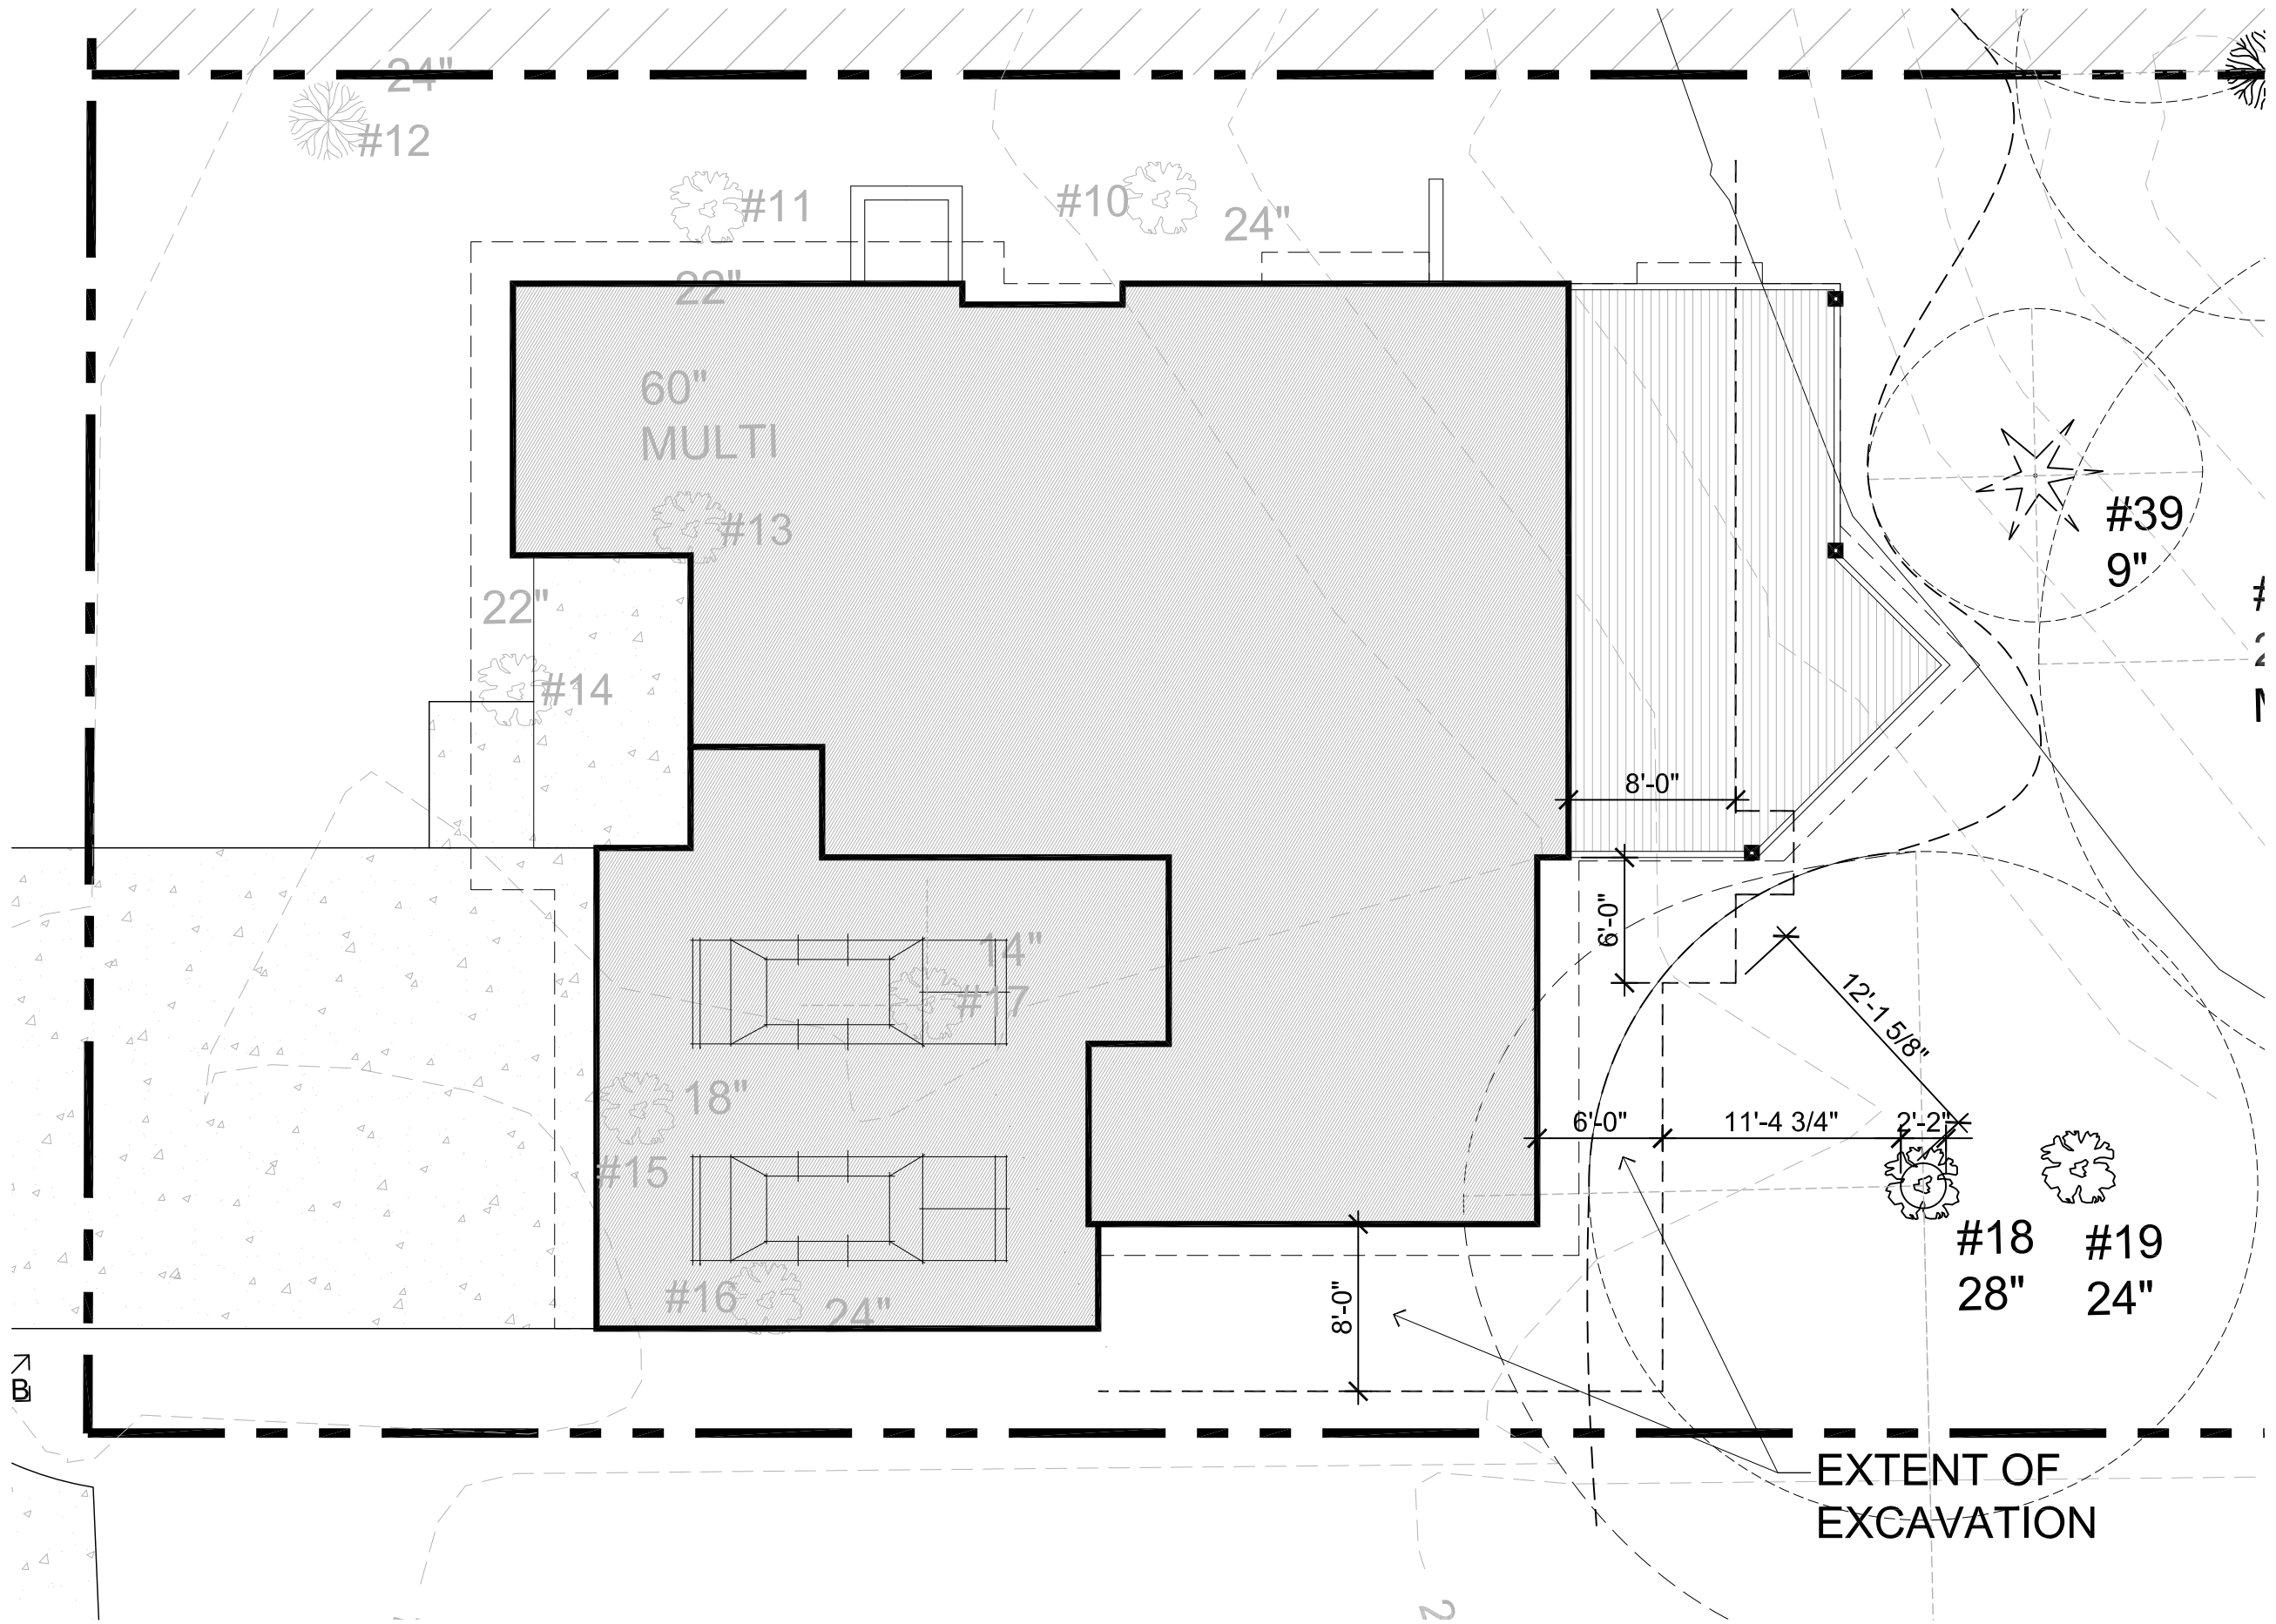
Tree #18 Diagram

EXTENT OF EXCAVATION
