ARBOR INFO LLC

**Tree Assessment
For
Seascape Homes
At
Lot 3, 5208 Forest Ave SE
Mercer Island, Washington**

**Date
2/25/2021**

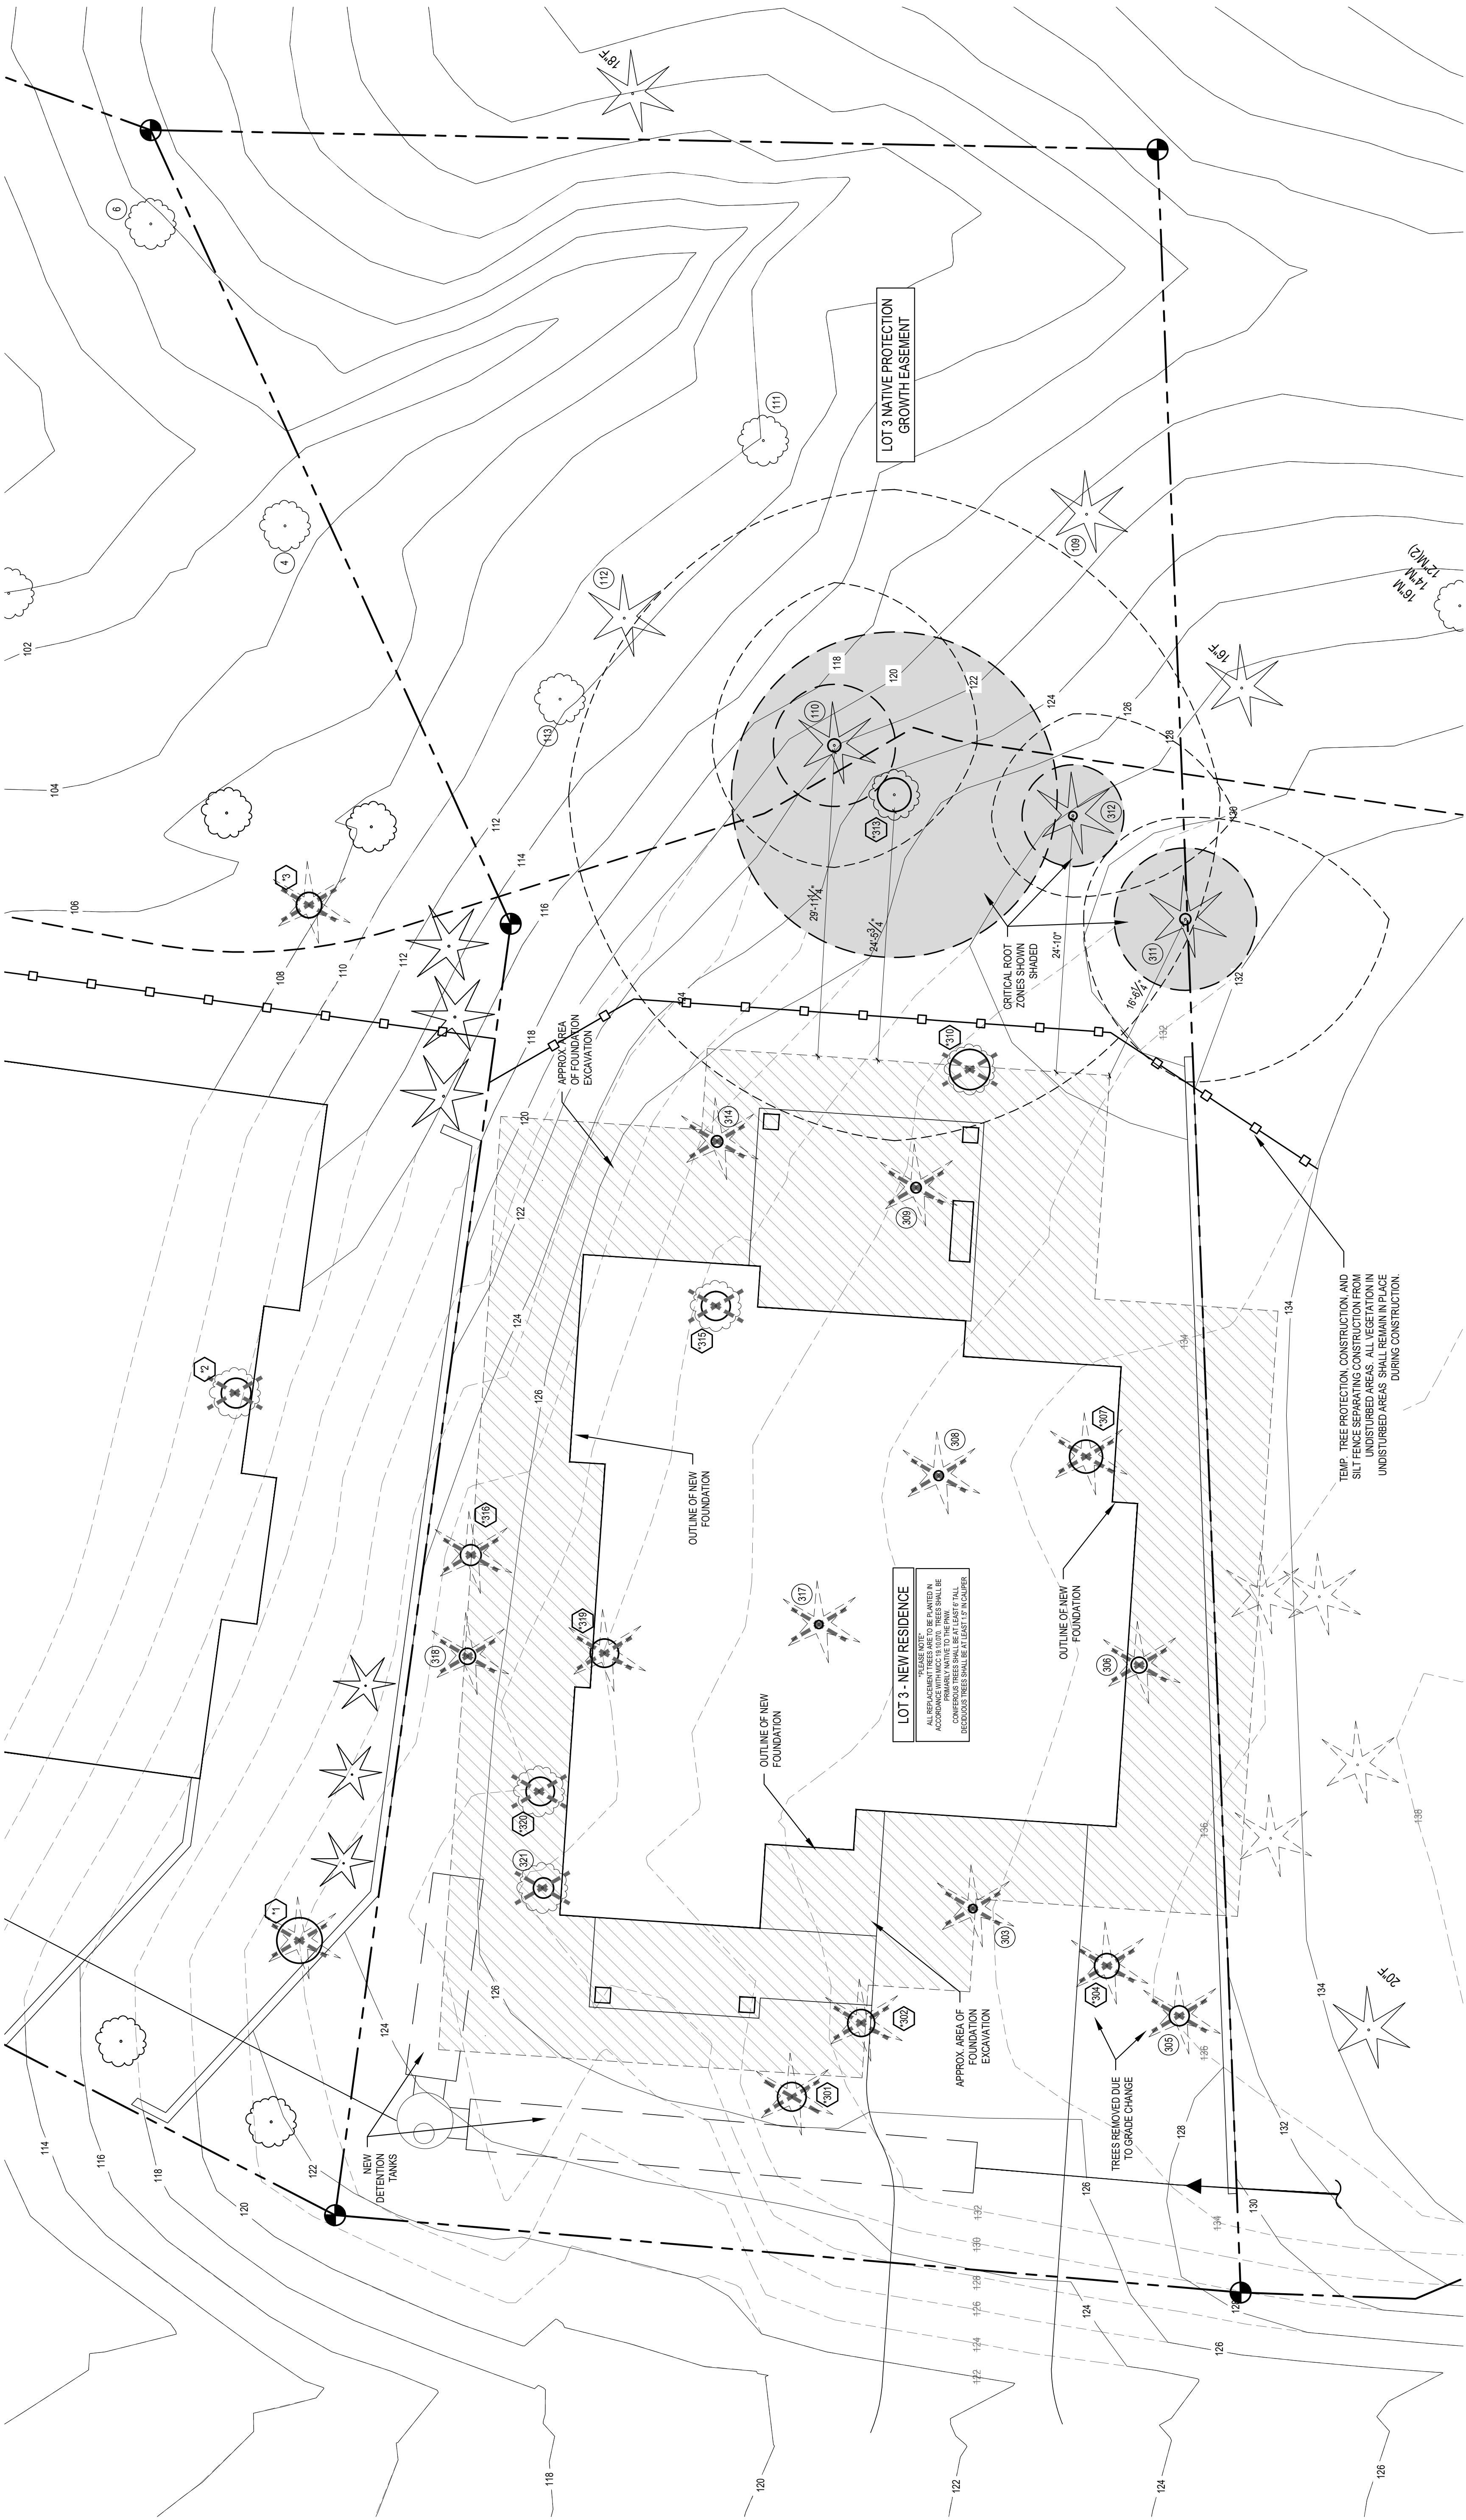
LOT 3
TREE PLAN
SCALE: 1/8" = 1'-0"

All of the on-site trees except No. 310 are within the proposed building footprint and will be removed. The total replacement trees needed is 39.

The limits of disturbance are determined on a case-by-case basis for each tree in consideration of the tree size, estimate of the extent of the root zone and consideration of the planned root zone disturbance per Distances from the face of each tree to the excavation limit were provided by the client. Trees No. 311-313 and offsite tree (NGPA) No. 110 near the footing excavation were measured for dripline (root zone) impacts. As seen following in Table 2, it is unlikely that any impact will occur.

TEMP. TREE PROTECTION CONSTRUCTION AND SOIL PROTECTION SHALL BE INSTALLED IN UNDISTURBED AREAS. ALL VEGETATION IN UNDISTURBED AREAS SHALL REMAIN IN PLACE DURING CONSTRUCTION.
