September 23, 2021

Regarding: Review of Type Ns Watercourse 8557 85th Avenue SE – Mercer Island, Washington

Attachment 1 – Drainage Features

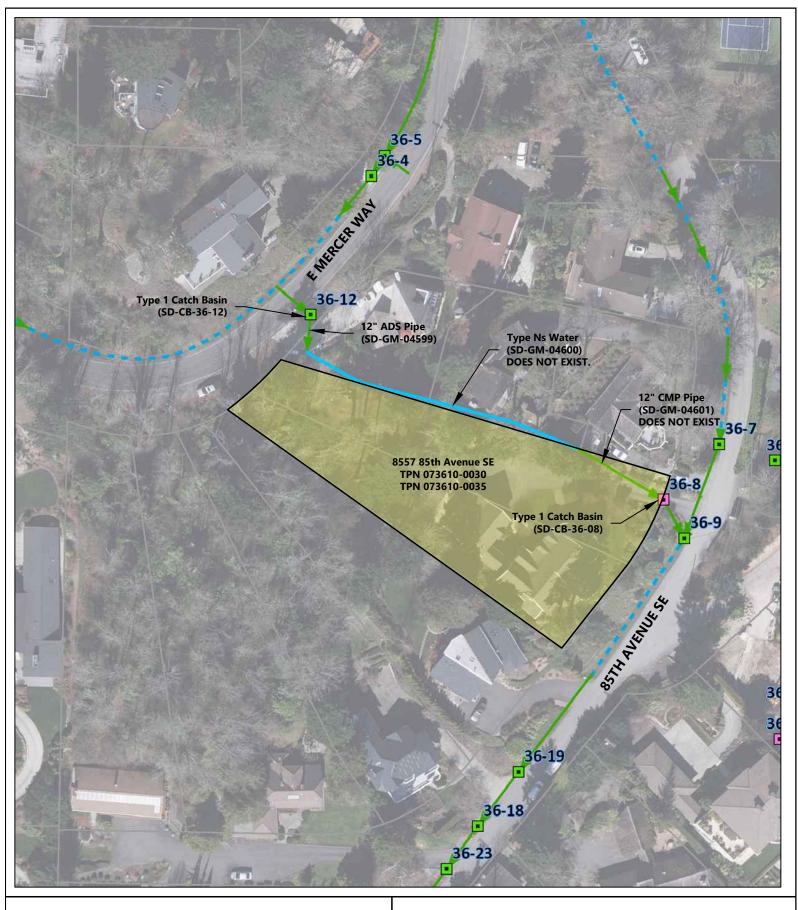
- The mapped channel segment #SD-GM-04600 does not exist. Stormwater outfall #SD-GM-04599 exists near the northwest corner of 8557 85th Avenue SE at the base of gabion retaining wall. Topography slopes to the southeast away from the outfall and comprises a mix of retained native vegetation, landscaping, and residential development. There is no defined channel, swale, or evidence of hydraulically sorted gravel downslope of the outfall within 8775 85th Avenue SE or on the adjoining three parcels to the north.
- The 12 inch diameter CMP pipe #SD-GM-04601 does not exist in the northeast corner of 8557 85th Avenue SE. A 6 inch diameter PVC pipe is the only pipe draining to catch basin #SD-CB-36-8. The PVC pipe is associated with on-site driveway stormwater control.
- 3. Ditches located along E Mercer Way and 85th Avenue SE are shallow man-made roadside ditches

that do not exist within the location of a historic stream. The ditches appear to convey solely stormwater generated by the adjacent roadways. Natural streams, wetlands, or similar aquatic features are not known to drain to either ditch.

4. The project site is not physically connected to Type S, F or Np waters by an above ground channel system. Drainage along 85th Avenue SE is conveyed to Lake Washington by a short roadside ditch as well as a longer series of stormwater control pipes and catch basins.
