Arborist Report

September 6th, 2021

Kumar Residence
4034 85th Ave SE
Mercer Island, Wa

Seattle Tree Consulting
Douglas Smith (Certified Arborist PN 6116-A/TRAQ)
3907 Aurora Ave N.
Seattle, Wa. 98103
(206)457-5706
doug@seattletreeconsulting.com

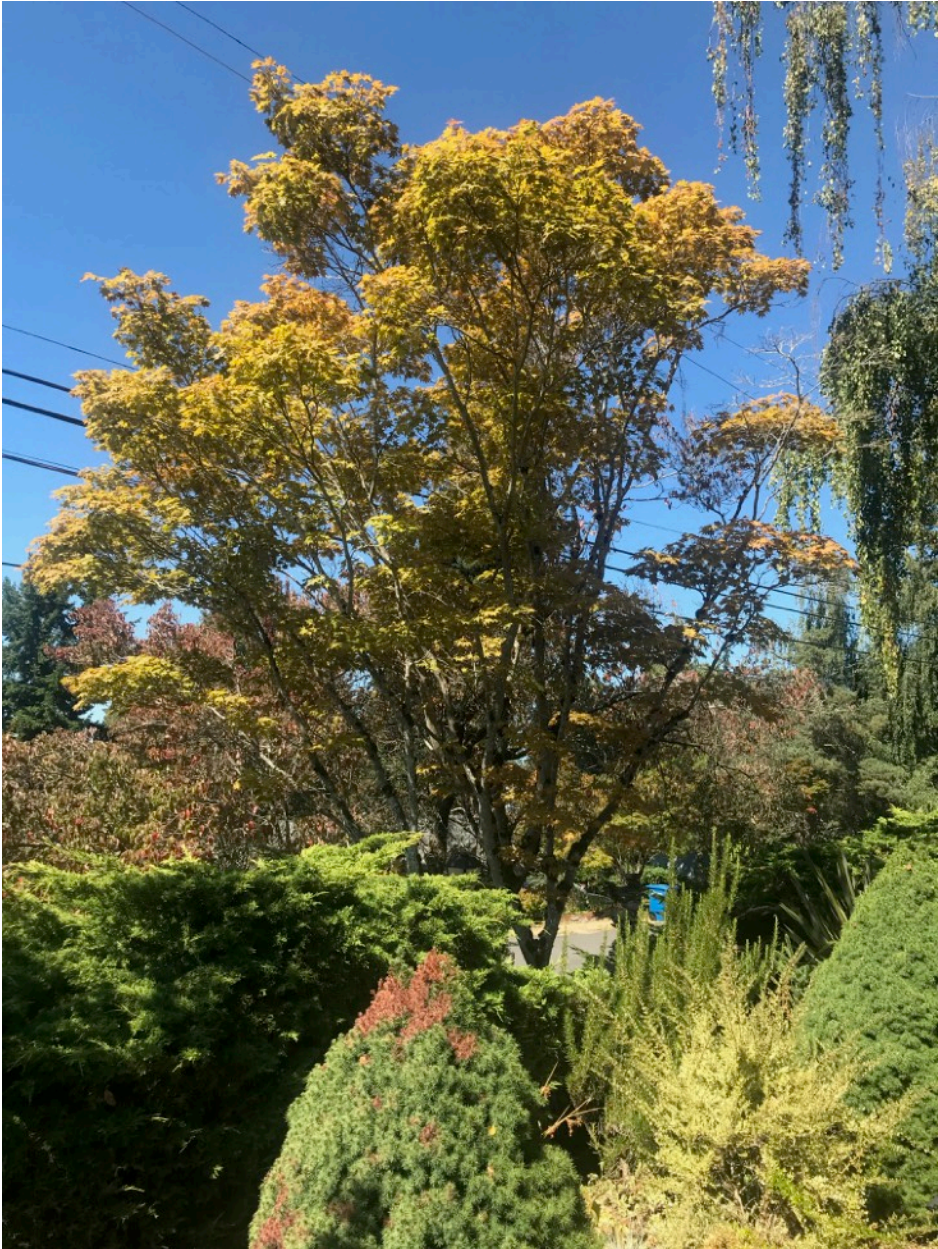
Tree #3

In the southwest corner of the lot there are two exotic trees and that are worth putting on the inventory. One is a three stem Japanese Maple with diameter at standard height readings of 5 inches, 7 inches, and 4.5 inches. This tree is in fine condition but too close to the proposed driveway to retain. Just to the west of the maple is an Eastern Dogwood with two stems that measure 7.5 inches and 6 inches. This tree is also in fine condition.

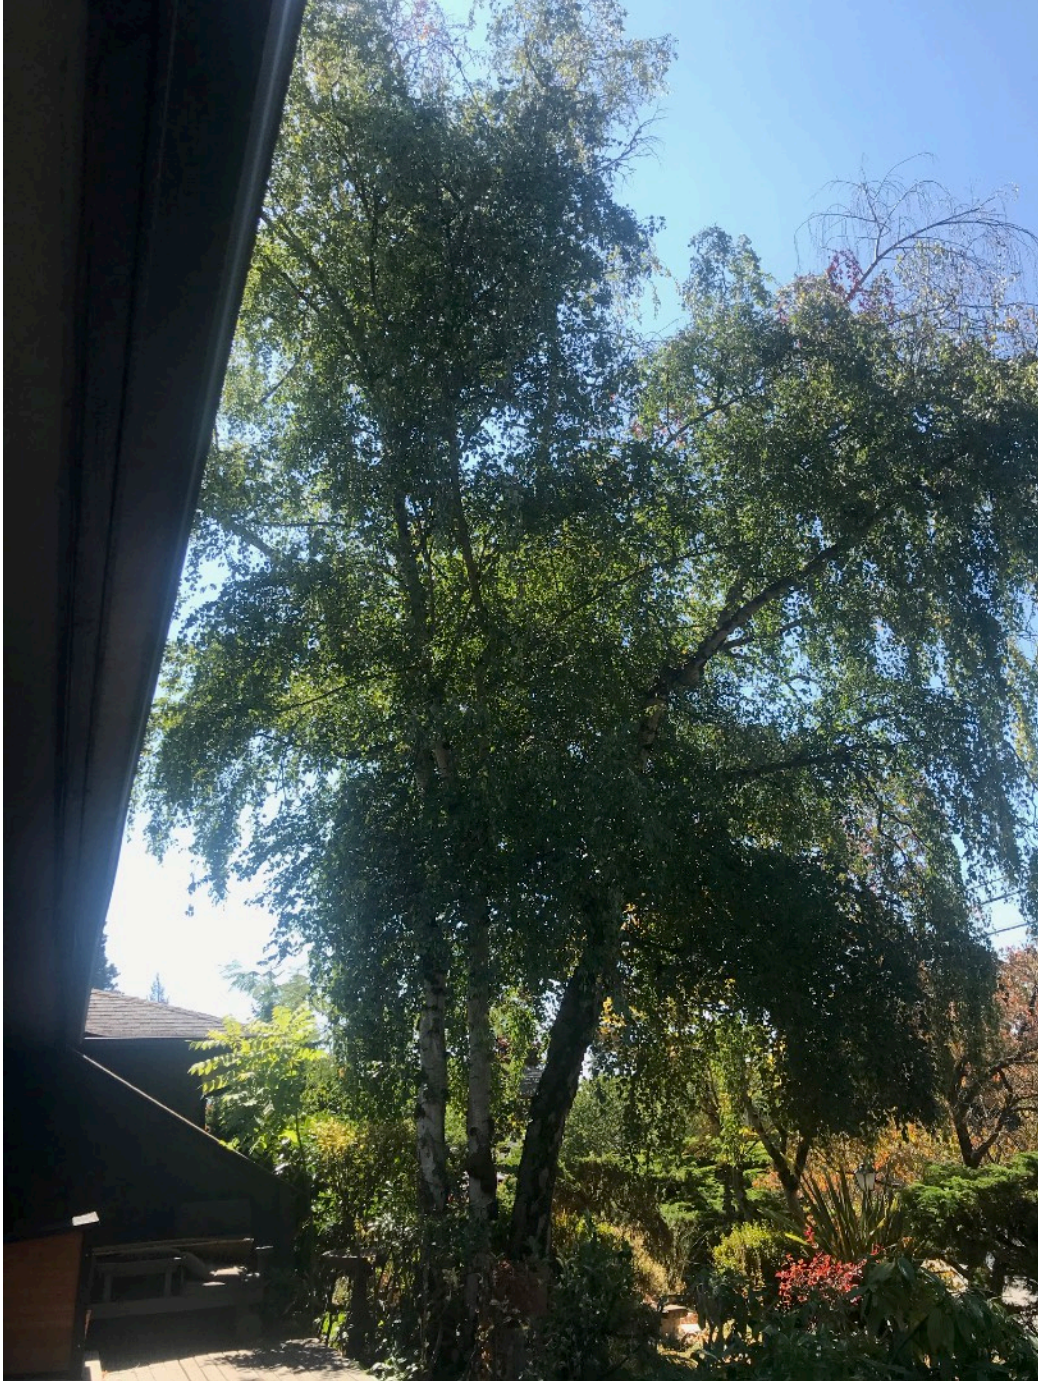
Tree #1

One of the trees that is scheduled to be removed to facilitate the construction process is a three stem European White Birch. The stems have diameter at standard height readings of 7 inches, 9 inches, and 12.5 inches. There is quite a bit of dead material in the upper canopy of this tree and it is apparent the tree is struggling with an infestation of the Bronze Birch Borer. This tree is already in a stressed condition and is not likely to endure significant disturbances to its root zone. Removal of this tree is a good idea as it is close to the existing structure, overlapping walkways, and already presenting hazards because of the declining nature of the upper canopy.

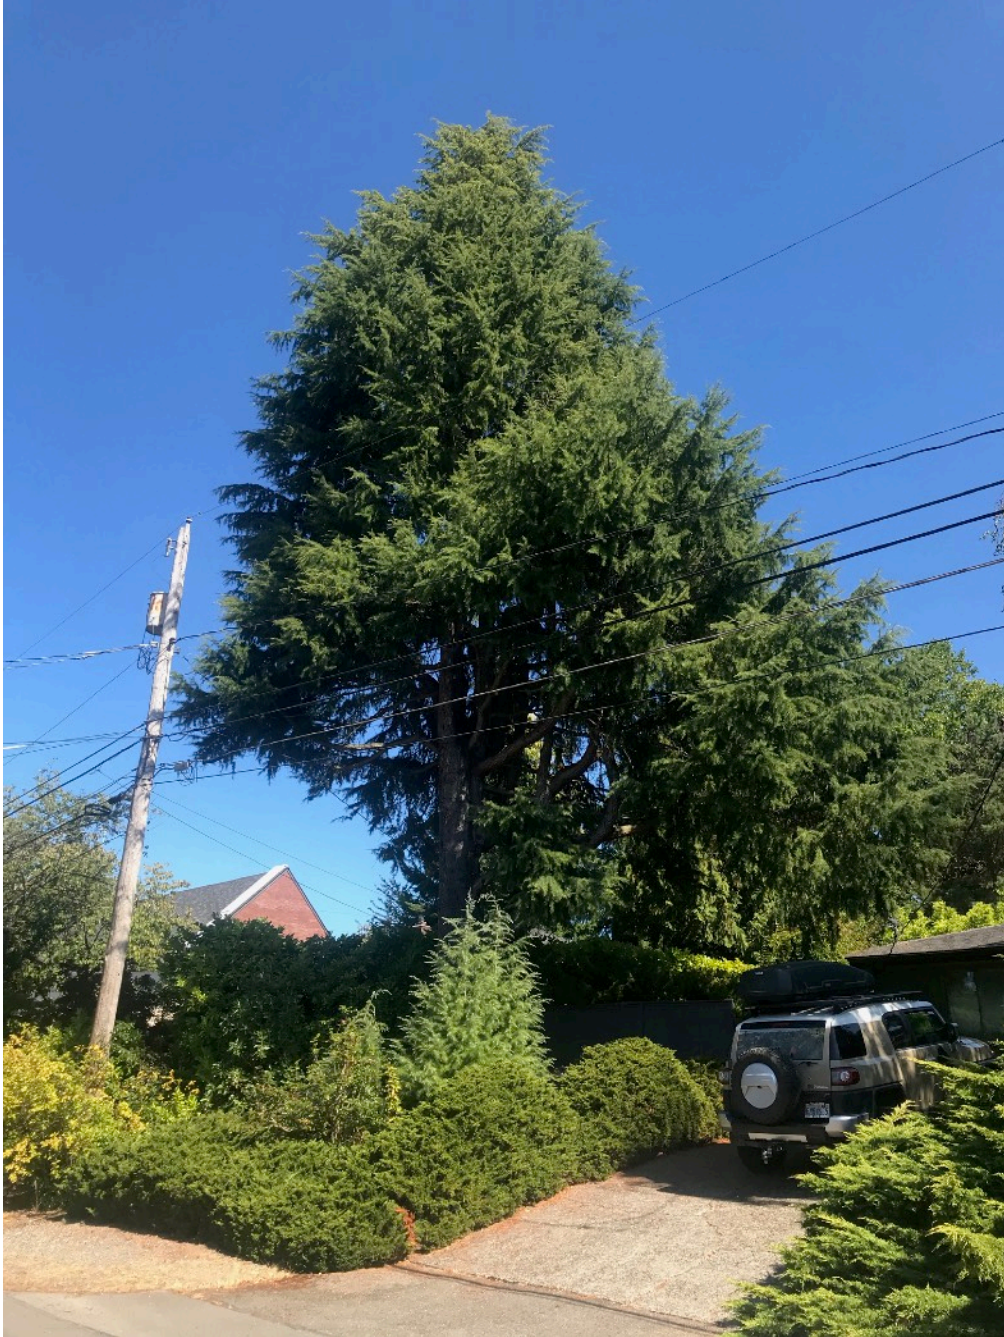
Tree #2

There is a Deodar Cedar in the northwest corner of the front yard with a diameter at standard height reading of 32 inches. The critical root zone of this tree should be protected during the construction process. Instructions for how to protect trees during construction are included at the bottom of this report. This Deodar Cedar does have quite a few stems and some compression

between them. That being said, the tree did not appear to be in need of pruning at the time of the site visit, with the exception of providing proper clearances for the adjacent utility pole.
