## **Arborist Report**

**November 5th, 2021**

Ken Kolbe  
7001 82nd Ave SE  
Mercer Island, WA

Seattle Tree Consulting  
Douglas Smith (Certified Arborist PN 6116-A/TRAQ)  
3907 Aurora Ave N.  
Seattle, Wa. 98103  
(206)457-5706  
[doug@seattletreeconsulting.com](mailto:doug@seattletreeconsulting.com)

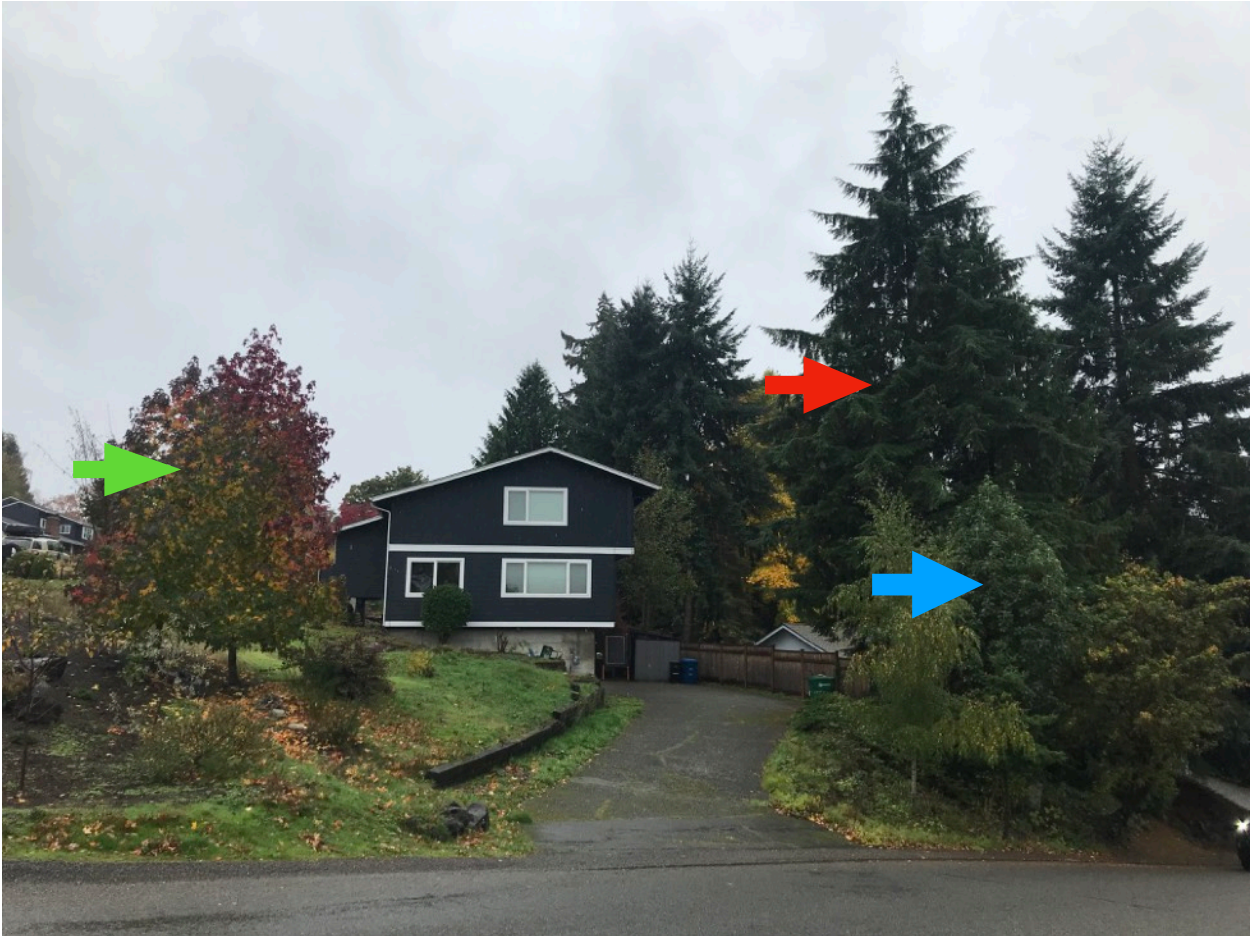
**Red Arrow-Hemlock**  
**Blue Arrow-Madrona**  
**Green Arrow-Sweetgum**

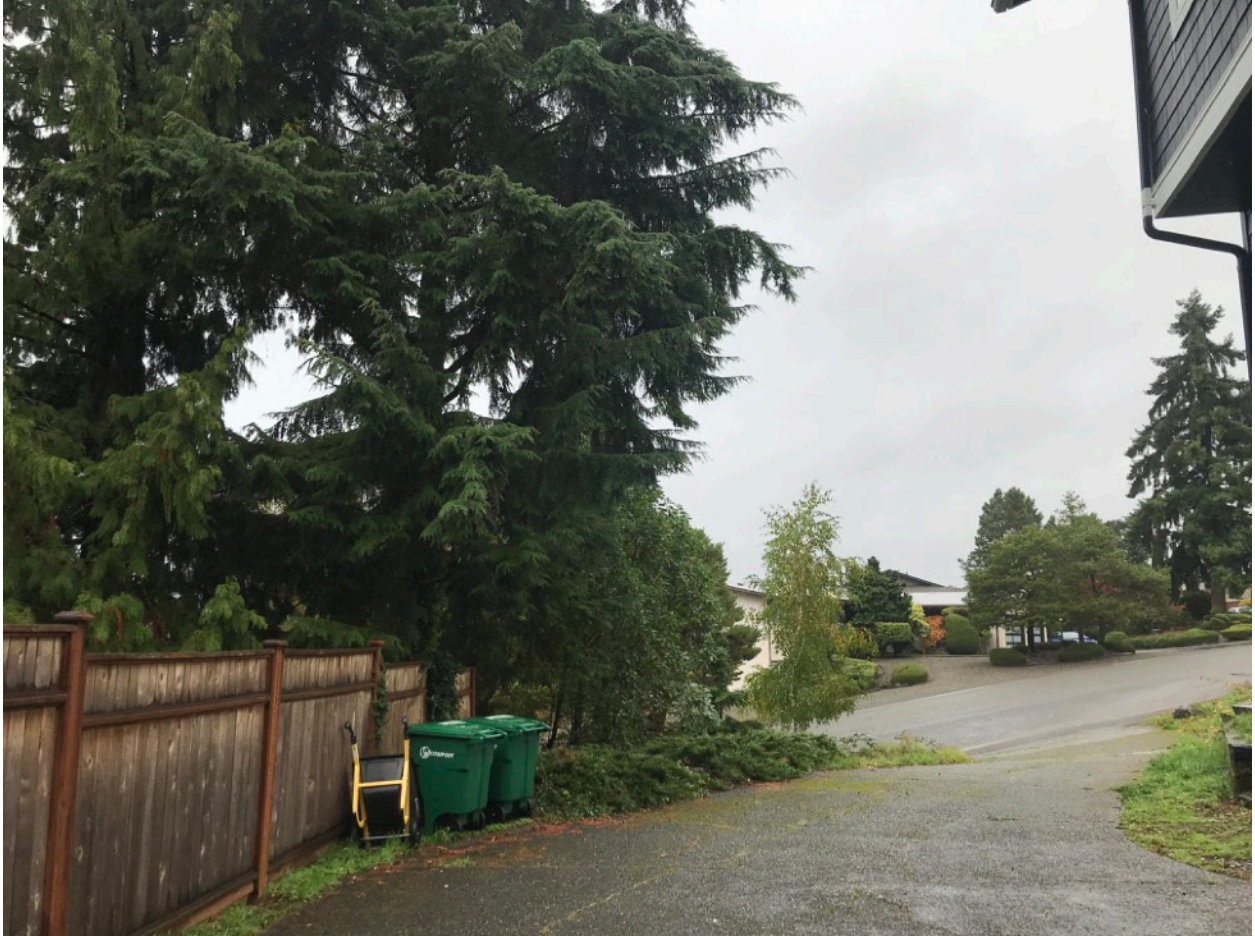
During the site visit, the client told me that there is an intention to redo the existing driveway that accesses the site. This is the only portion of the project that will take place within the root zone of a significant tree. The West neighbor has a Western Hemlock (*Tsuga heterophylla*) that is just over the fence line. This tree has a diameter at standard height reading of 20 inches and a drip line radius of 20 foot that was measured with a laser rangefinder. It is appropriate to assign a critical root zone radius of 20 foot for this specimen. All work that takes place within the critical root zone of this tree should be undertaken with hand tools. The existing driveway should be removed with a jack hammer rather than a piece of large excavating equipment when working in the critical root zone of the hemlock. Once the driveway is removed, the critical root zone of the hemlock should be protected with tree protection fencing so that unnecessary compaction does not occur under the tree.

**Existing driveway, photo taken looking north. The area near the garbage cans should be pulled up by hand and protected with fencing.**

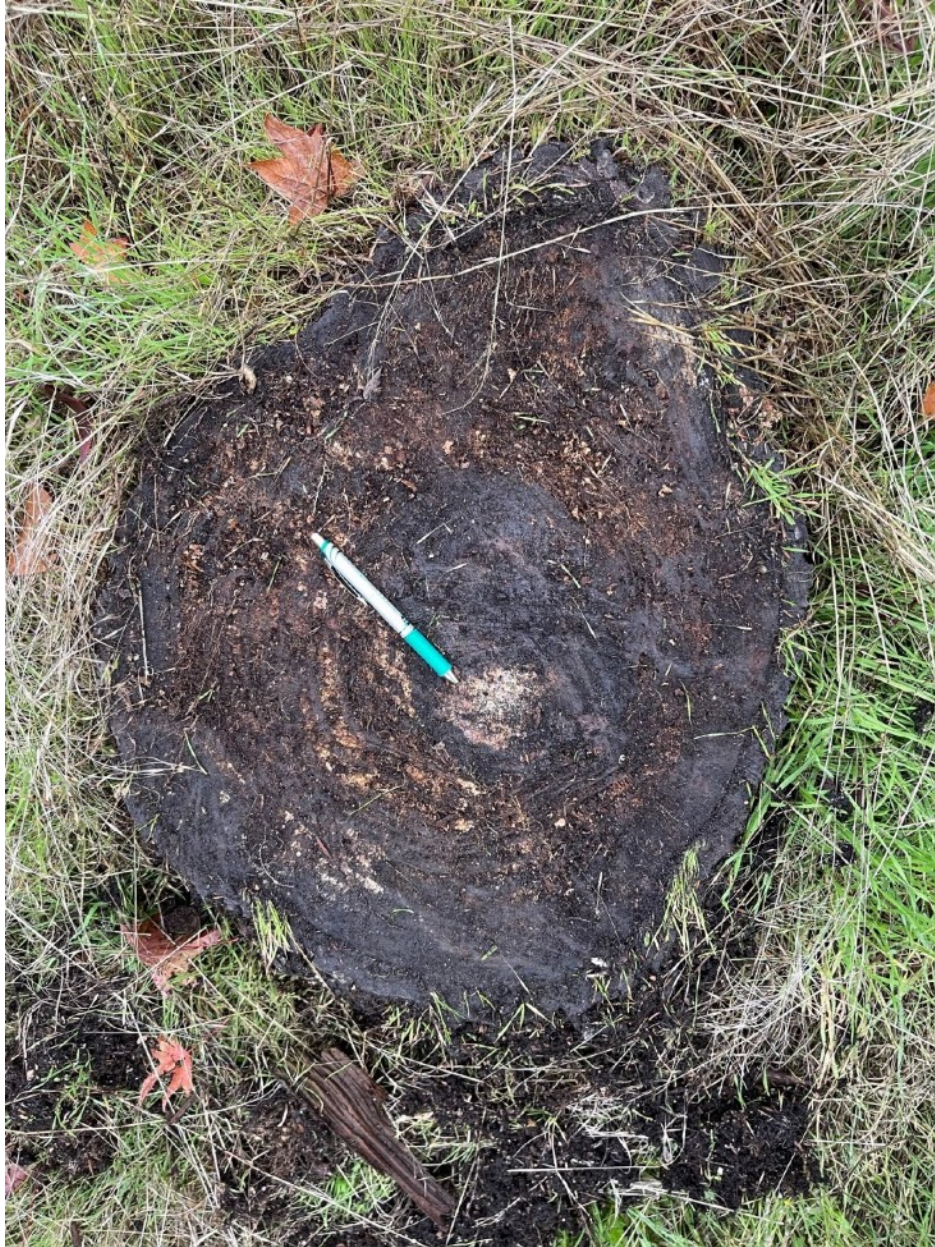
Trees that are larger than 6 inches of diameter at standard height are considered significant. At the time of the site visit, there were almost no significant tree systems on my client's portion of the lot that need to be considered as part of the inventory. The client did inform me during the site visit that there was a significant conifer removed approximately two years ago from the eastern portion of the site because it was suffering from a pathogen, but there was very little evidence left available for me to draw a conclusion about what caused its decline. I have estimated the DSH of this specimen to be 15".

**Picture of the stump of the removed conifer. I have seen several pictures of this tree and it appears to have been a Blue Noble Fir (*Abies procera* 'Glauca'). Diameter of the root flare is 17" and because of the lack of taper in the pedestal region of this species, I am estimating the DSH prior to removal as 15".**
