August 2, 2021

Project: Pre-construction assessment for property re-development at 9611 SE 72nd Street, Drive East, Seattle, WA. Parcel number 2579500040.

Objectives: Evaluate health of existing trees and establish criteria for the preservation of those to be retained.

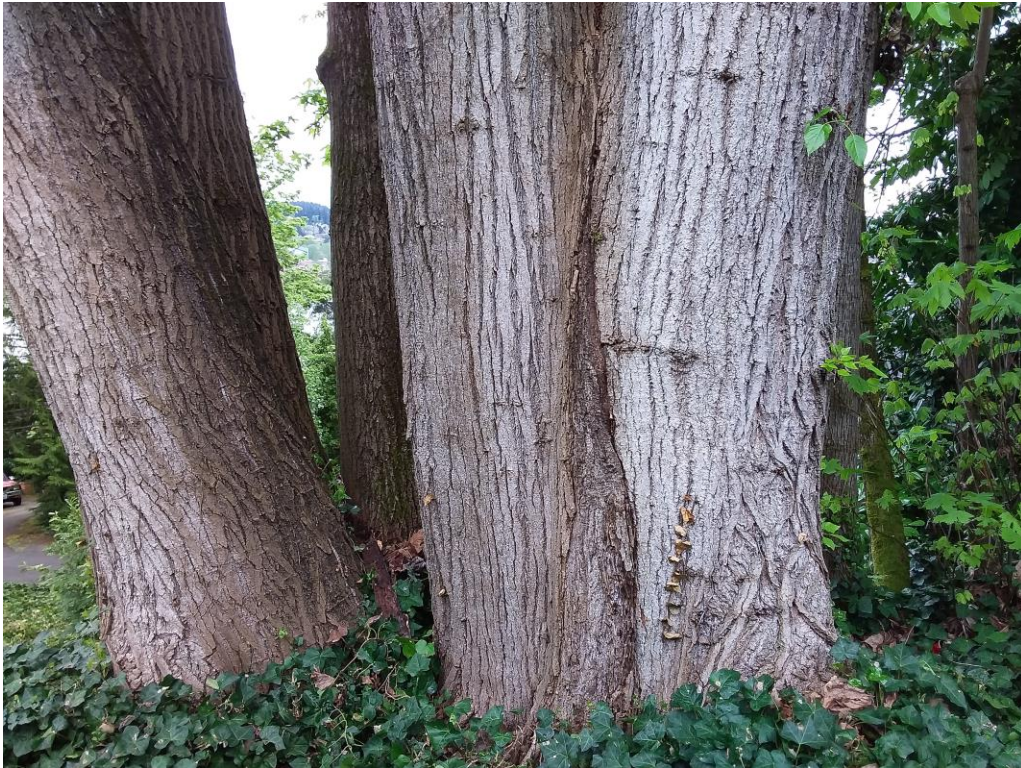
3. Dual stem Black Cottonwood (*Populus trichocarpa*) co-joined from the base and fully separating above the 6' level. An active fracture plane shows on the west face (Figure 9). The east side exhibits better attachment (Figure 10). Tree stands 12' E of the edge of the asphalt and 7' NNW of the #2 maple clump. It measured 54" caliper. The larger stem reaches 100' tall, the smaller about 85' tall. The lesser trunk separates into multiple scaffolds above the 60' level all of which begin to bend over to the west. The scaffolds extend completely over 72nd Street and the tips reach over the power line and ditch on west side of the street. Exhibits average new growth and color. The majority of the scaffolds on the larger trunk extend to the south out as far as 26' and parallel to the street. The top of the tree begins to bend south on a large scaffold. This half of the tree has average color and new growth. The NW quadrant of the base of the cottonwood shows an adverse growth habit indicative of decay in the species (Figure 11). The structural roots on the west side may have been damaged when the street was widened and/or by vehicles parking in the gravel verge between the street and the tree. There are surface roots present showing decay and atrophy (Figure 12).

Figure 9. Looking west at the base of the #3 cottonwood. The #4 is at the left side of the image.

A serious conversation should be had between the owners of the subject property, the 9605 property, and the City of Mercer Island about removing the #3-6 cottonwoods. These trees have been dropping large limbs consistently. There is decay present in the trees, weak unions, and off set canopies.

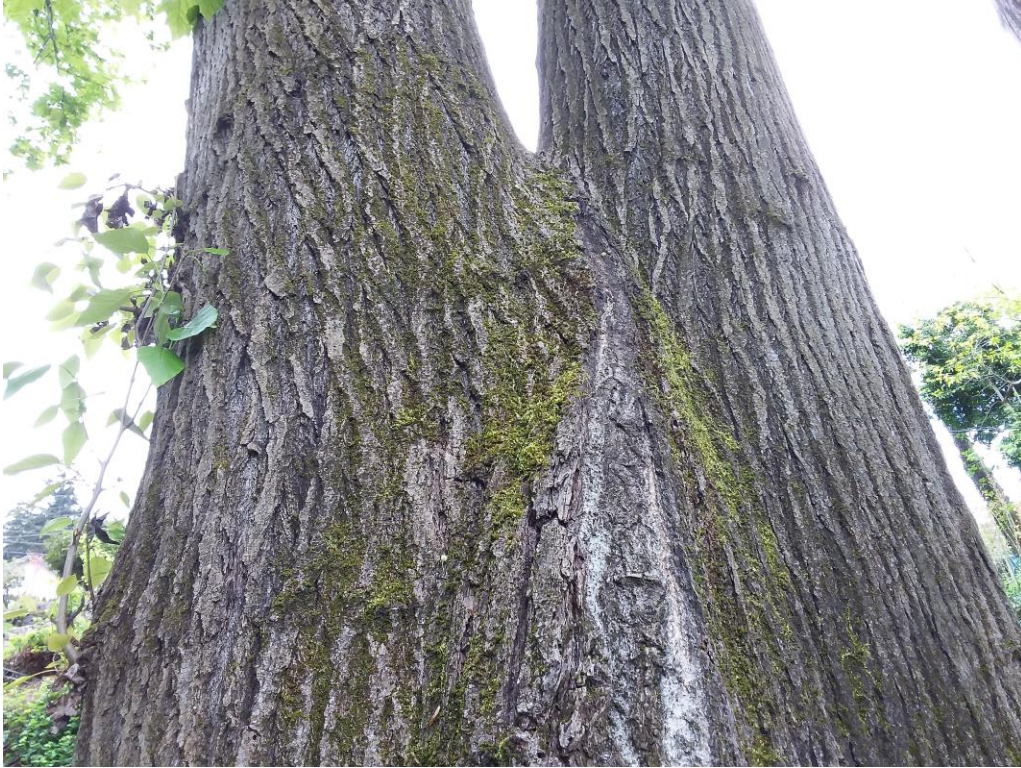
Figure 10. Looking east at the base of the #3 cottonwood.

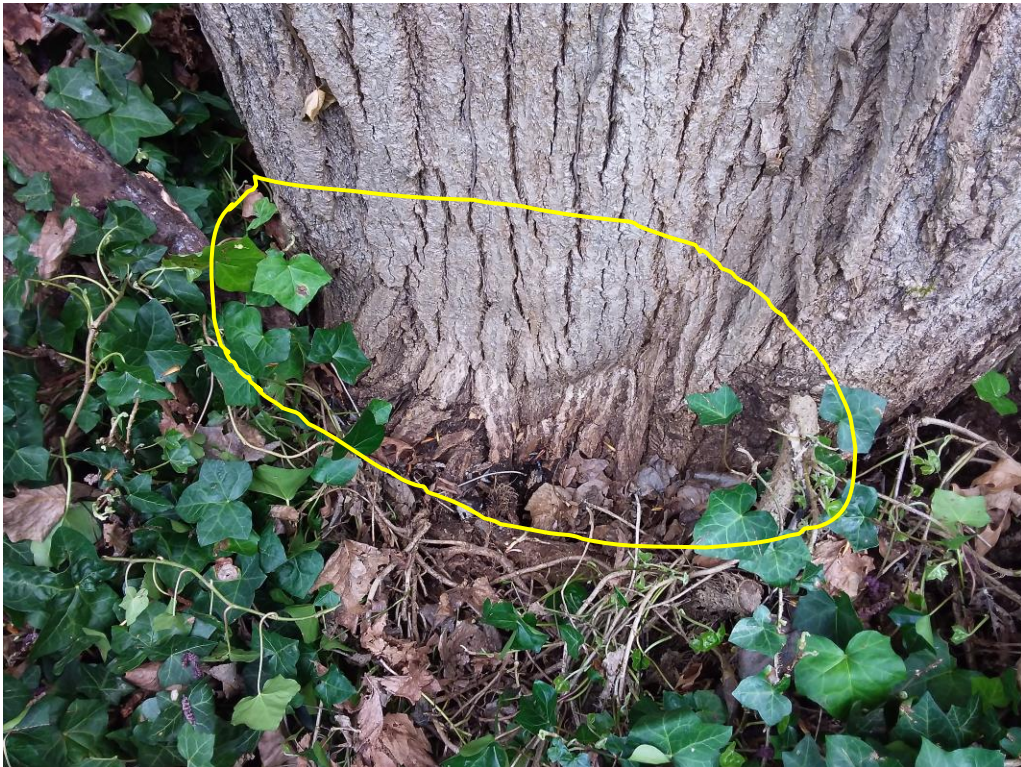
Figure 11. Looking down at the NW quadrant of the base of the #3 cottonwood. Abnormal area is outlined in yellow.

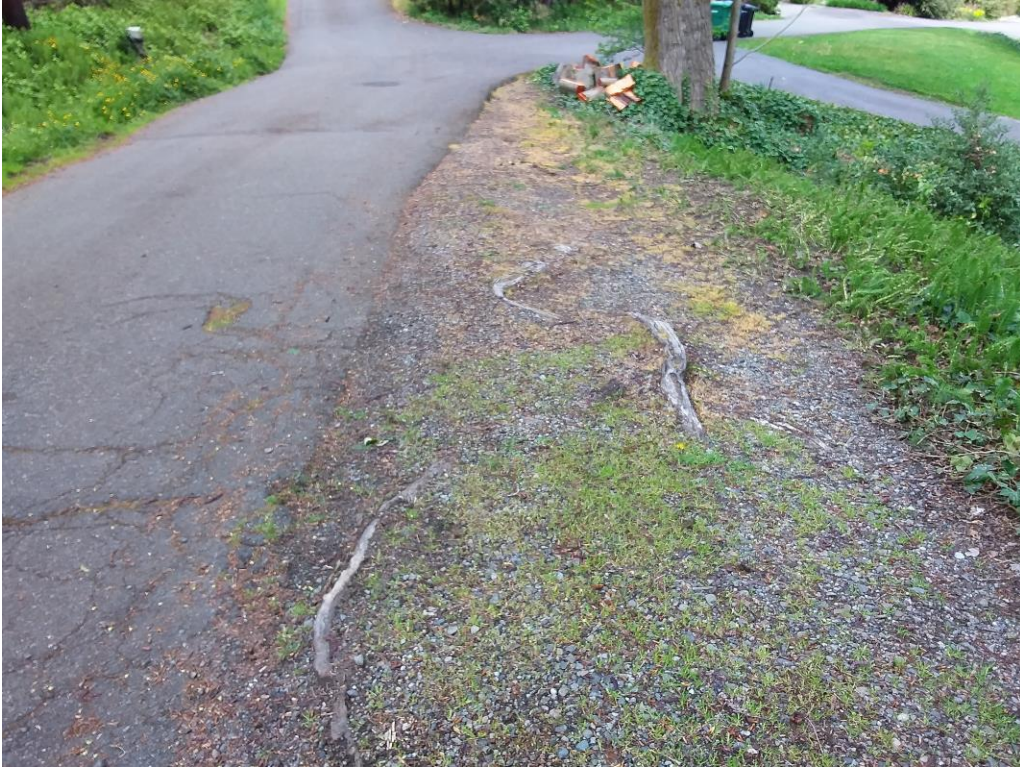
Figure 12. Looking NE down 72nd and showing surface roots from the #3 and #4 trees in the parking strip. Note the cracking in the asphalt indicative of root pressure.

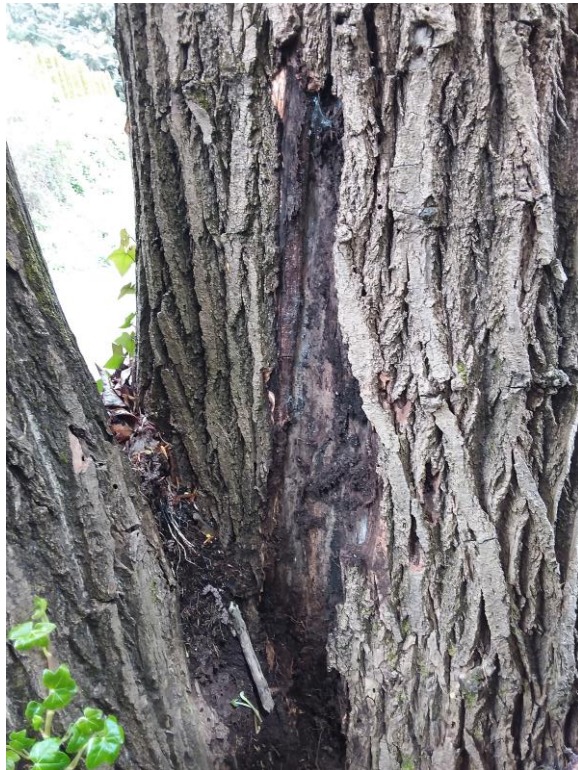
4. Three trunk cottonwood from the base, standing 6' NNE of #3. There is decay and atrophy in the area where the center trunk joins the west side (Figure 13). The NW basal quadrant shows the abnormal growth pattern present in the #3 tree (Figure 14). West trunk is 28.5" DSH, middle stem is 36" DSH, and the east is 20.5" DSH. The smaller stem leans slightly east from the base, bends over in a couple kinks, and goes nearly horizontal 30' out to the east on a couple of scaffolds. The center stem reaches 100' tall, spreads 35' radially, flattens a little on the west due to competition with #3 and its own west side stem. West trunk attains 85' tall, bends into the NW quadrant, reaches 25-30' across 72nd and over the wires. Center trunk is more stunted than the other two and exhibits die back and deadwood. Decay may be more advanced than is readily noticeable.

Figure 13. Looking at the separation point on the #4 cottonwood.

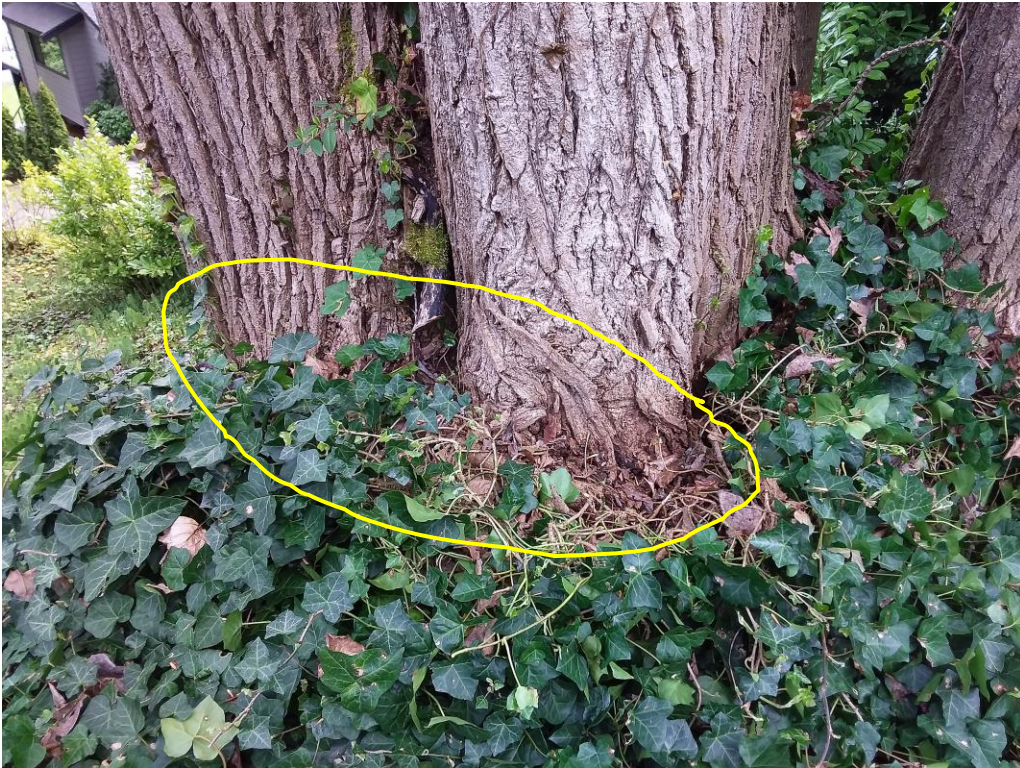
Figure 14. Looking down and east at the base of the #4 tree showing the abnormal basal formation.

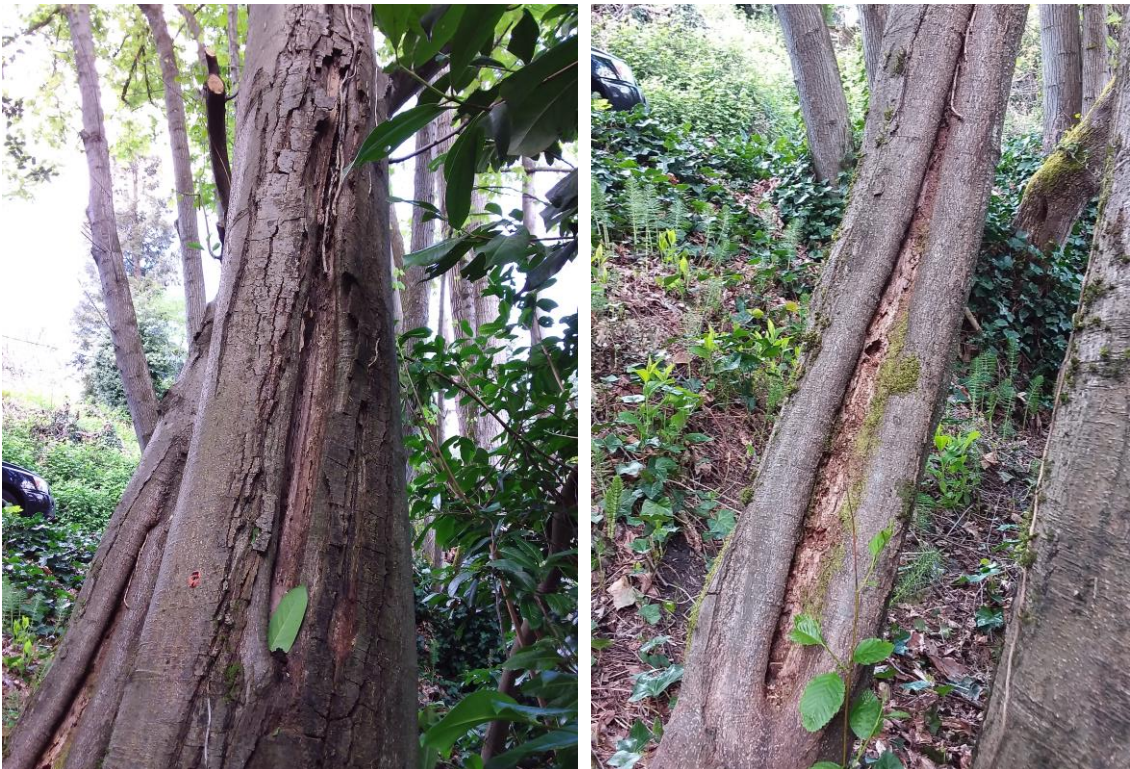
7. Dual stem Red Alder (*Alnus rubra*) standing 6' nearly due east of the NW corner Marker. The tree's small stem is 8" DSH, the larger measured 19.5" DSH, and both have advanced decay running up their SE faces (Figures 15 and 16). The smaller stem leans at 45 degrees from its base, curves around under the larger stem to the northeast, and stretches out to 40' long. Show weak new growth, poor color, and dieback throughout. The larger grows slightly north from its base and doesn't ever return to vertical. Reaches 60' tall, has an 8' spread, and exhibits weak new growth, poor color, and die back throughout.

Figures 15 and 16. The main and smaller trunks of the #7 alder showing the advanced decay running up the column of each.

The #7 alder should just be removed. It has severe decay along the columns of both trunks and alders in this condition break off more often than not. The tree does not offer any redeeming attributes and the maples above and beyond it lock down the slope.

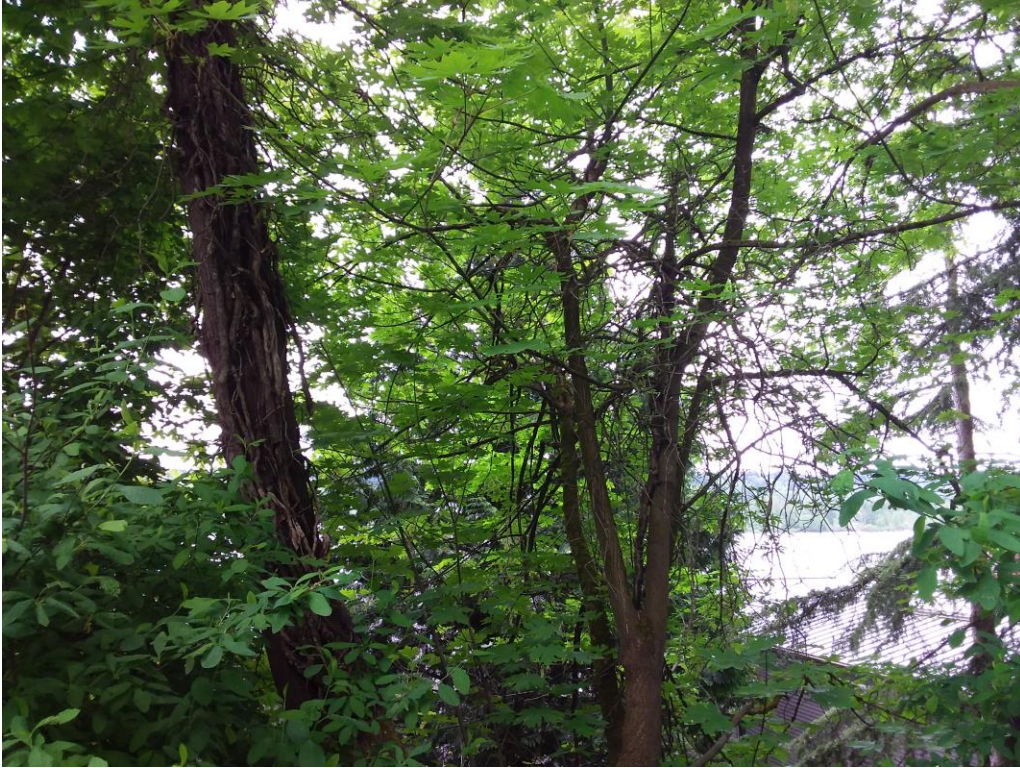
Figure 17. Looking east into the canopy of the #20 maple showing the old ivy.

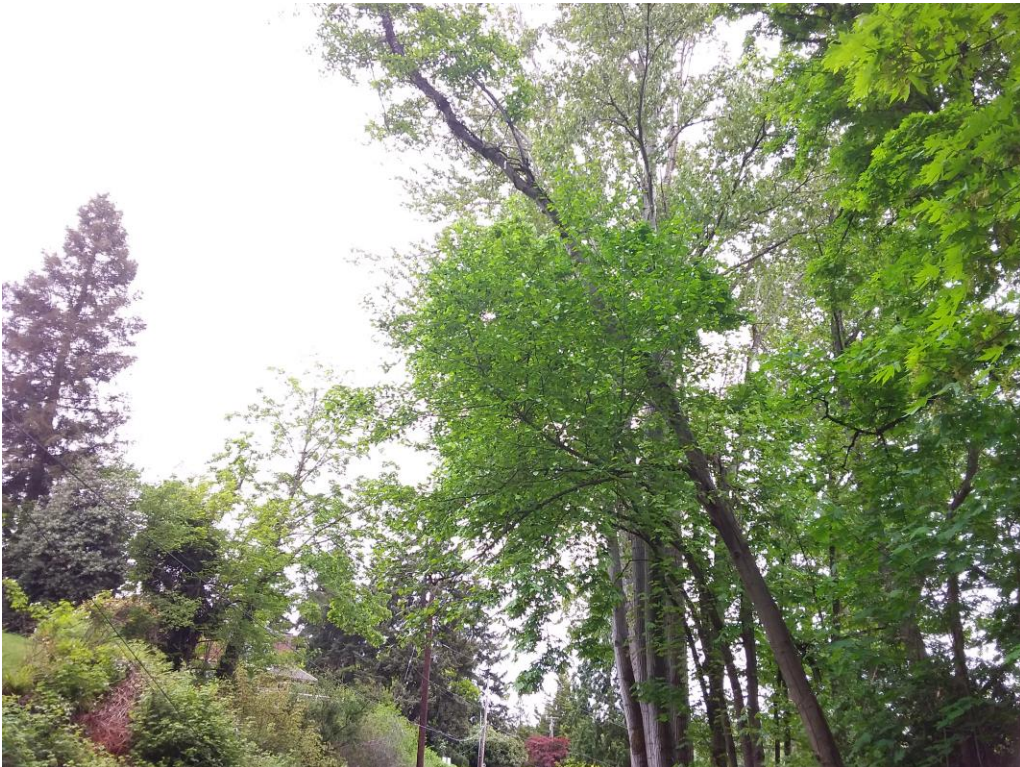
21. Alder 12.5" DSH, 45' tall, leans west from its base and over the road (Figure 18), There are a couple of scaffolds with viable canopy coming off mid column and then short branches in the upper column with sparse foliage and limited new growth. Tree is in weak condition, exhibits stress fracture indications along the lower column, and there is an atrophied area with decay present at the crook near the halfway point (Figure 19). Tree bends noticeably greater above this point. The alder stands 18' N of #20, close to 29' SW of the #1 tree, and 17.5' E of the asphalt edge. It is fully in the ROW. Based on the alder's growth profile it is retrenching below the weak spot in the column.

Figure 18. Looking north at the #21 alder leaning over the road.

The #21 alder is in quite poor condition and hangs over the parking and street. As the tree is fully in the City ROW they should probably make the decision as to take care of it or not.

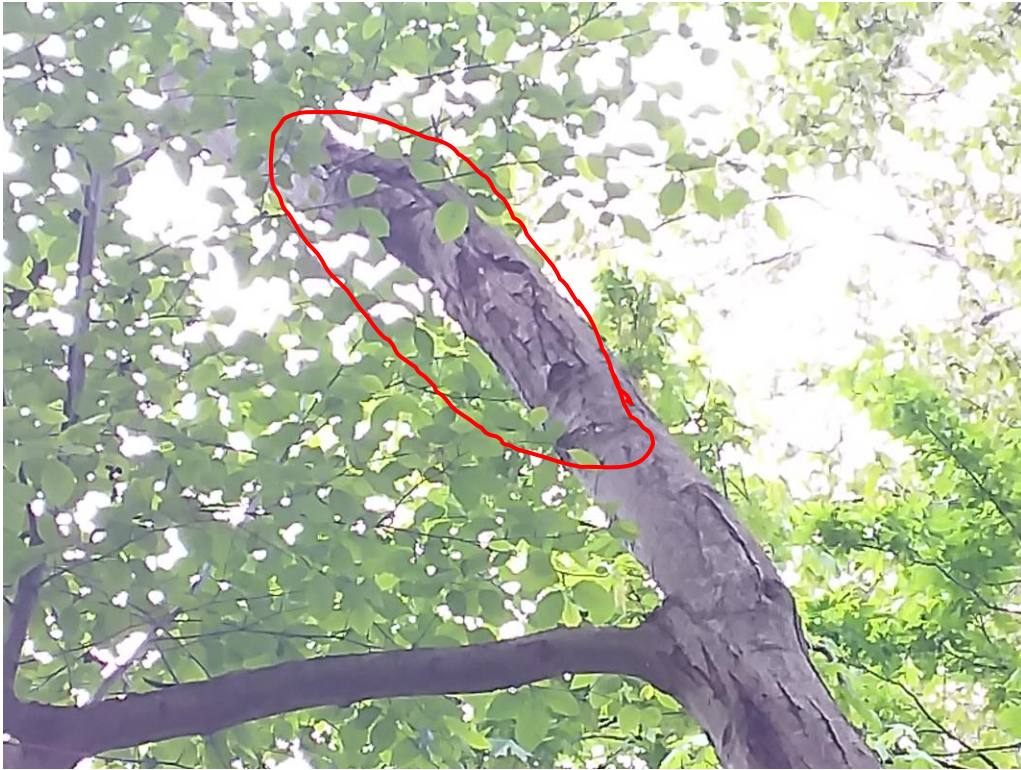
Figure 19. Area of advanced decay in the #21 alder.

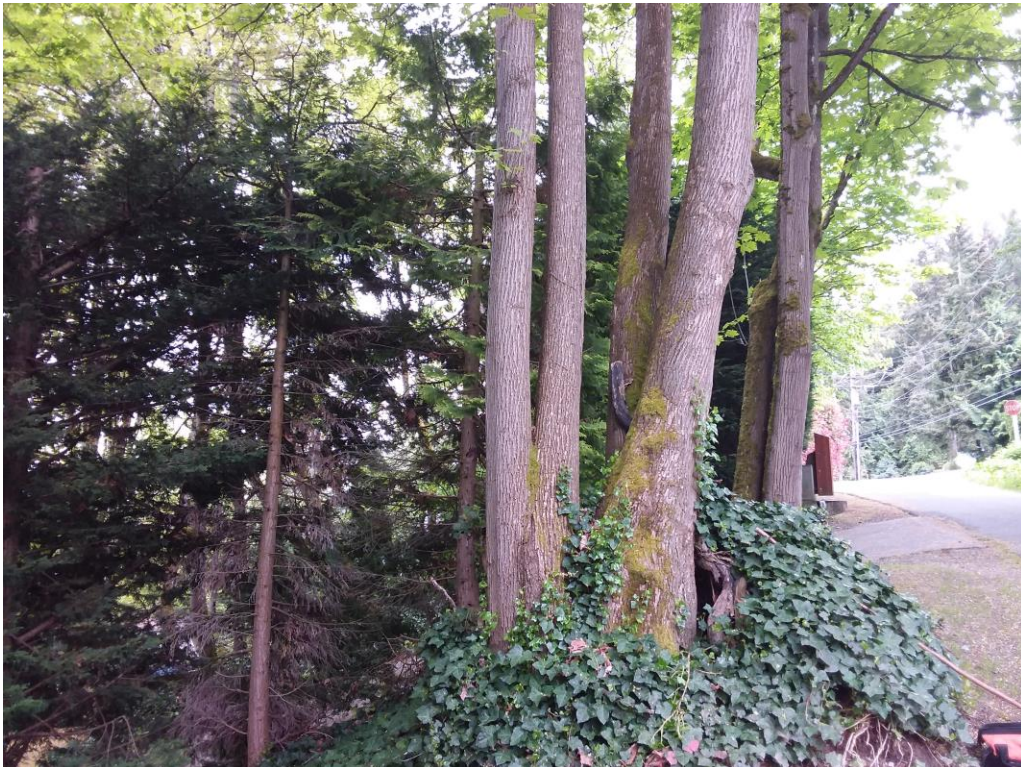
23. Big Leaf maple, bifurcates at the base and then each stem splits again around the 5' level. This tree grew over or out of an old stump that is covered with ivy (Figure 20). Tree is in below average condition, has some larger deadwood present, some over elongated branches especially over the neighbor's driveway, and it has been pruned for power line clearance in the mid canopy on the west side. No sign of active fracture planes at the junctures. Tree has been crown cleaned not too long ago. It stands 17' SW of #22, 16' NW of the SW corner marker, and 10' E of the edge of the asphalt.

Figure 20. Looking south at the base of the #23 maple.

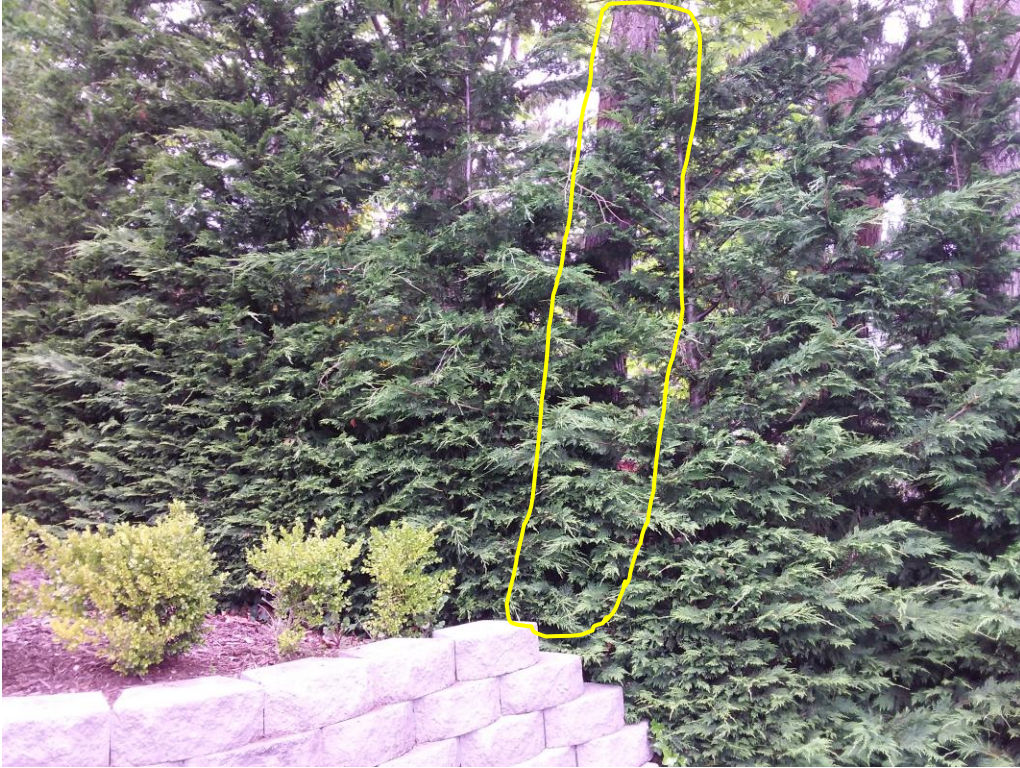
26. Scots pine (*Pinus sylvestris*) 11.5" DSH, broke over in 30' range. Tree stands 3.5' N of the keystone wall end by the lower patio (Figure 21). Tree is in below average health.

The 11" DSH #26 pine has a 6.5' SRP according to Figure 27. According to the proposed plan and field measurements the pine sits just 3.5' back from the end of the brickwork at the NE corner which is slated to be demolished. While the survey shows the wall curving south of the pine (Figures 8 and 28) the photo in Figure 21 shows the end of the wall pointing directly at the base of the pine. There is a high likelihood that the pine has structural roots reaching into the soil above the wall.

The #26 pine should theoretically have an 11.5' radial CRZ but it has matured with the retaining wall carving out more than 50% of its south side space. So its root system distribution is in an area roughly 70% of normal which should result in a higher concentration of roots in its available space. The east end pile post will be set right at the outer margin of the pine's expected spread.

The cubic volume of soil between the keyblock wall, the property line, and the shoring wall cut could contain 30% or more of the #26 pine's functional roots.

Figure 21. Looking north at the base of the #26 pine at the end of the keystone wall.

The island of orphaned soil in the SW quadrant of the #26 and #27 pines will have to be carefully considered. There may be a means of preserving all, most, or at least enough of it to prevent significant impacts to the two pines. The section could be air spaded or it could just be scratched back carefully and inspected in real time by the arborist.

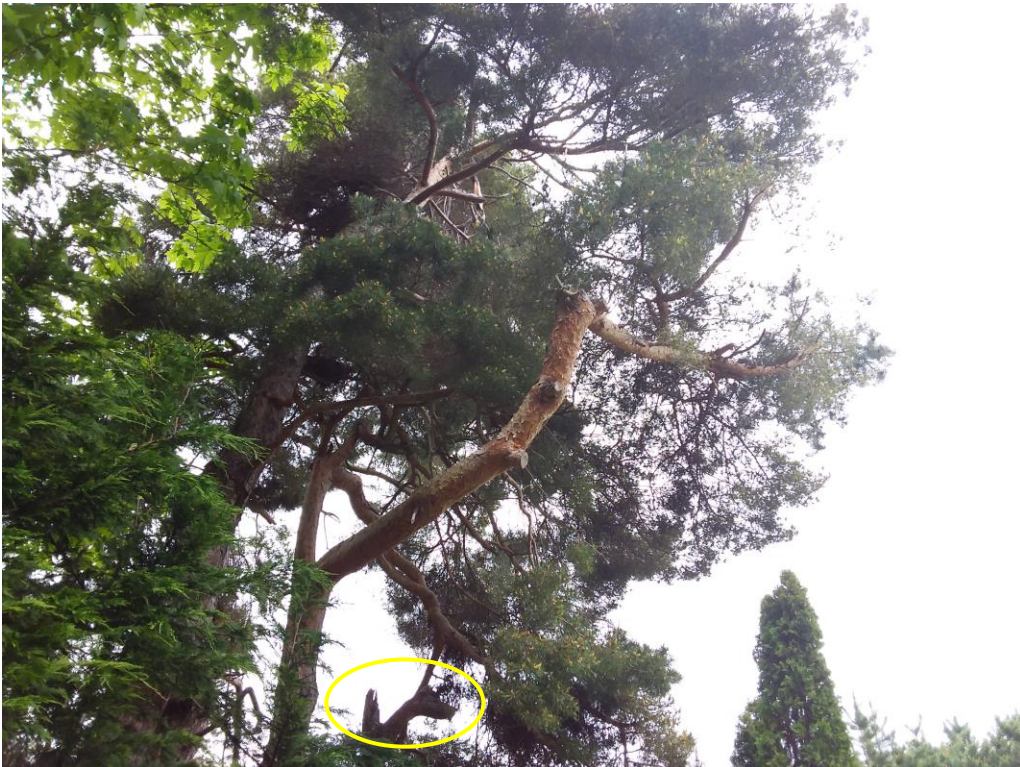
Figure 22. Looking up and NE and the south spar on the #27 pine. Note the top of the #28 stub (circled).

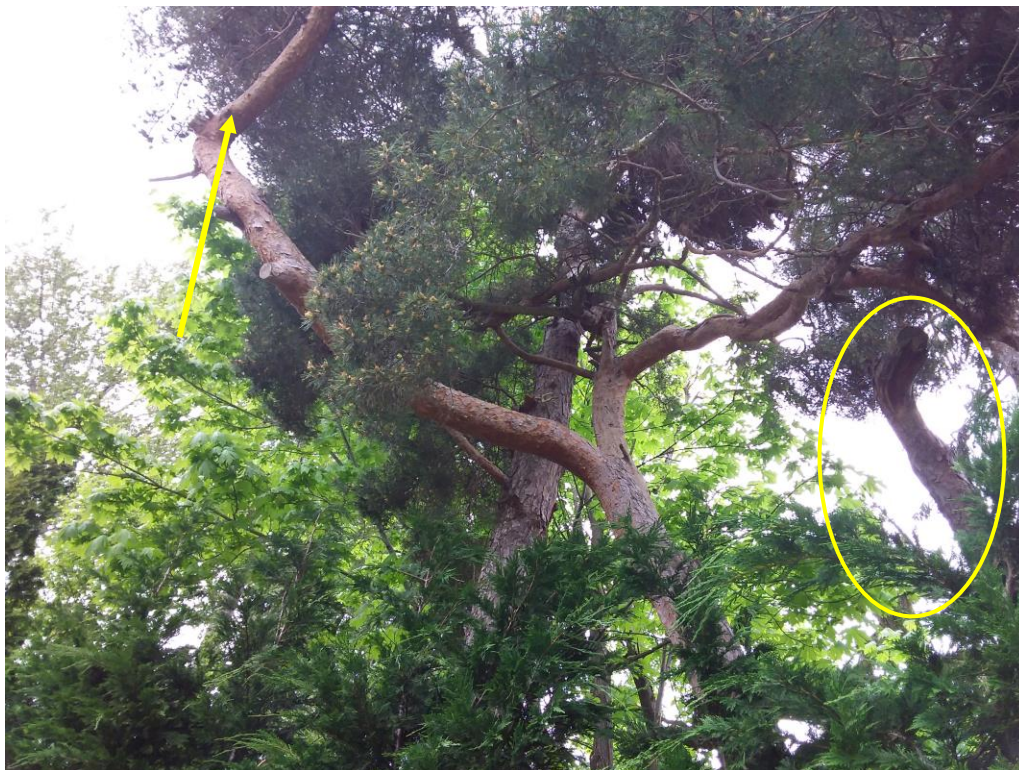
Figure 23. Looking up and NW at the #27 south spar showing how it turns back over itself. Note the 328 peeking in from the right side.

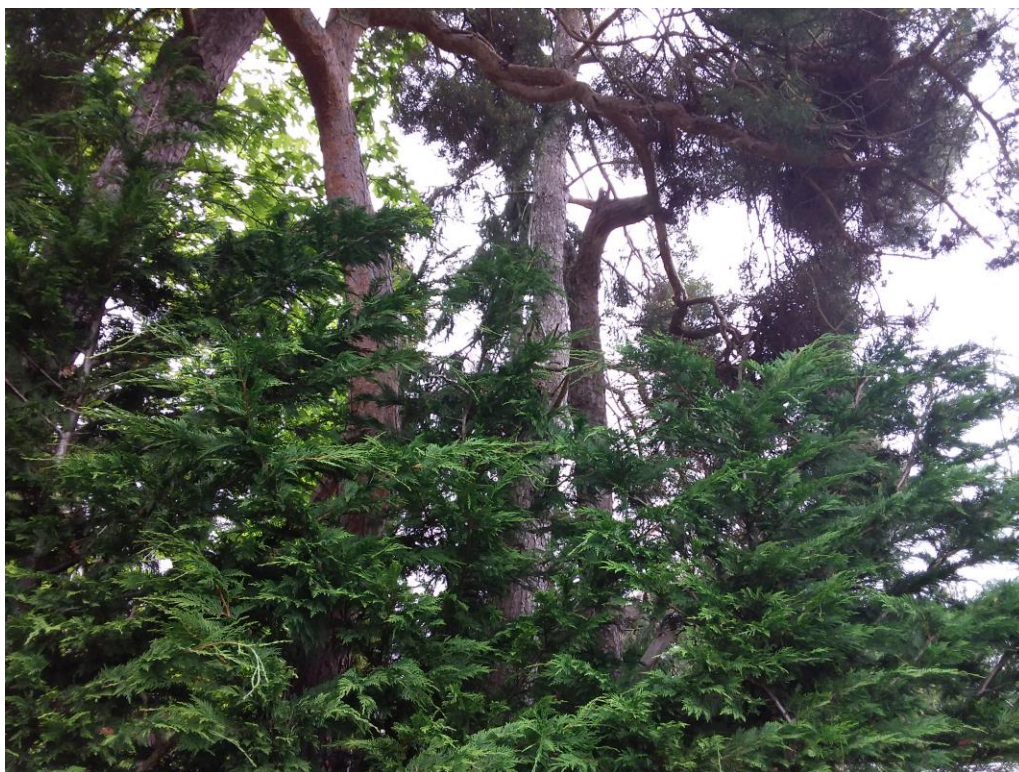
28. Dead Scots pine stub, 7.5" DSH, 18' tall, standing 5' ESE of #27 (see Figures 22-24).

Figure 24. Looking up and north at the east spar of the #27 pine showing its unique conformation. The #28 stub is at the center.

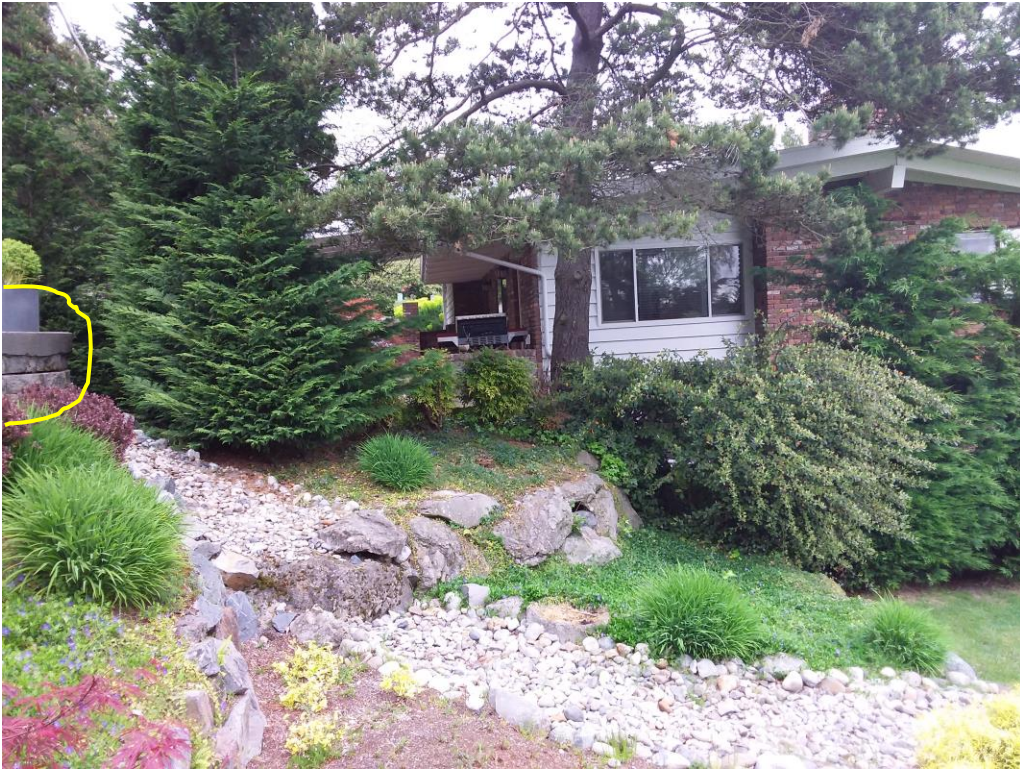
30. Black Pine (*Pinus thunbergii*) 14" DSH standing at the north end of the rock retaining wall that runs north to south in the lower yard (Figure 25). Tree has been pruned to maintain an average 18' height. Branches are becoming overextended especially on the south and east sides and could be susceptible to snow load damage. Just on neighbor's side based on survey.

The #30 pine, with its limited rooting space to the north and layer cake shelves of available space to the south, is in a rather precarious situation. If the stone walls are removed within 14' of the tree, as shown in the plans, and the area is regraded it is more likely than not that the tree will lose more than 50% of its Critical Rooting Space.

Figure 25. Looking north at the #30 pine showing its location at the north end of stone retaining wall (west). The east section of the #24 hedge is left of center. The lip of the patio is just visible at the left edge of the image.

All things being considered it probably makes the best sense to figure out an acceptable redesign of the area around the #30 pine that incorporates at least 10' of the two stone walls. Removing the walls and grading in the area will result in the demise of the tree.

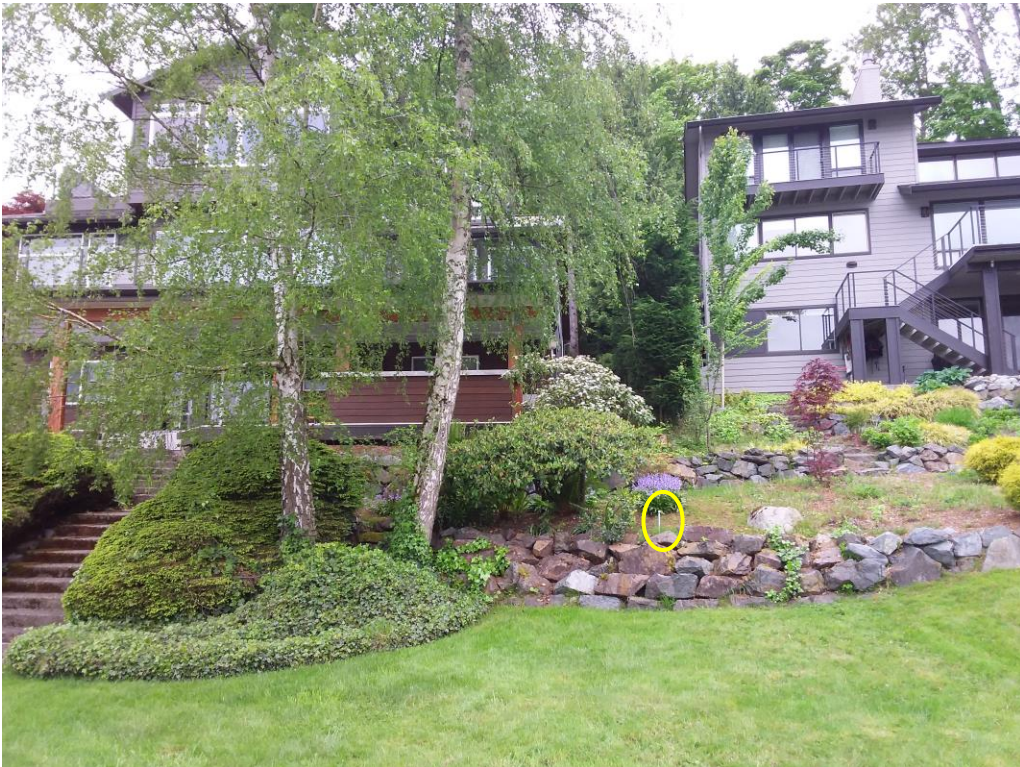
31. European Birch (*Betula pendula*) 11" DSH, 45' tall, 9' spread standing at the base of the stone wall on the south side of the lower yard (Figure 26). Showing signs of light dieback in the upper canopy that could be due to beetle attack. Below average condition. Birch stands somewhere between 12' and 16' south of the south property line.

Figure 26. Looking west at the #31 and #32 birch trees. Note the property line stake (circled) and the #33 hedge at the center of the image.
