ARBOR INFO LLC

**Tree Assessment
For
Sturman Architects
At
Mounger Residence
4006 E. Mercer Way
Mercer Island, Washington**

8/28/2020 (rev 12/29/2020)

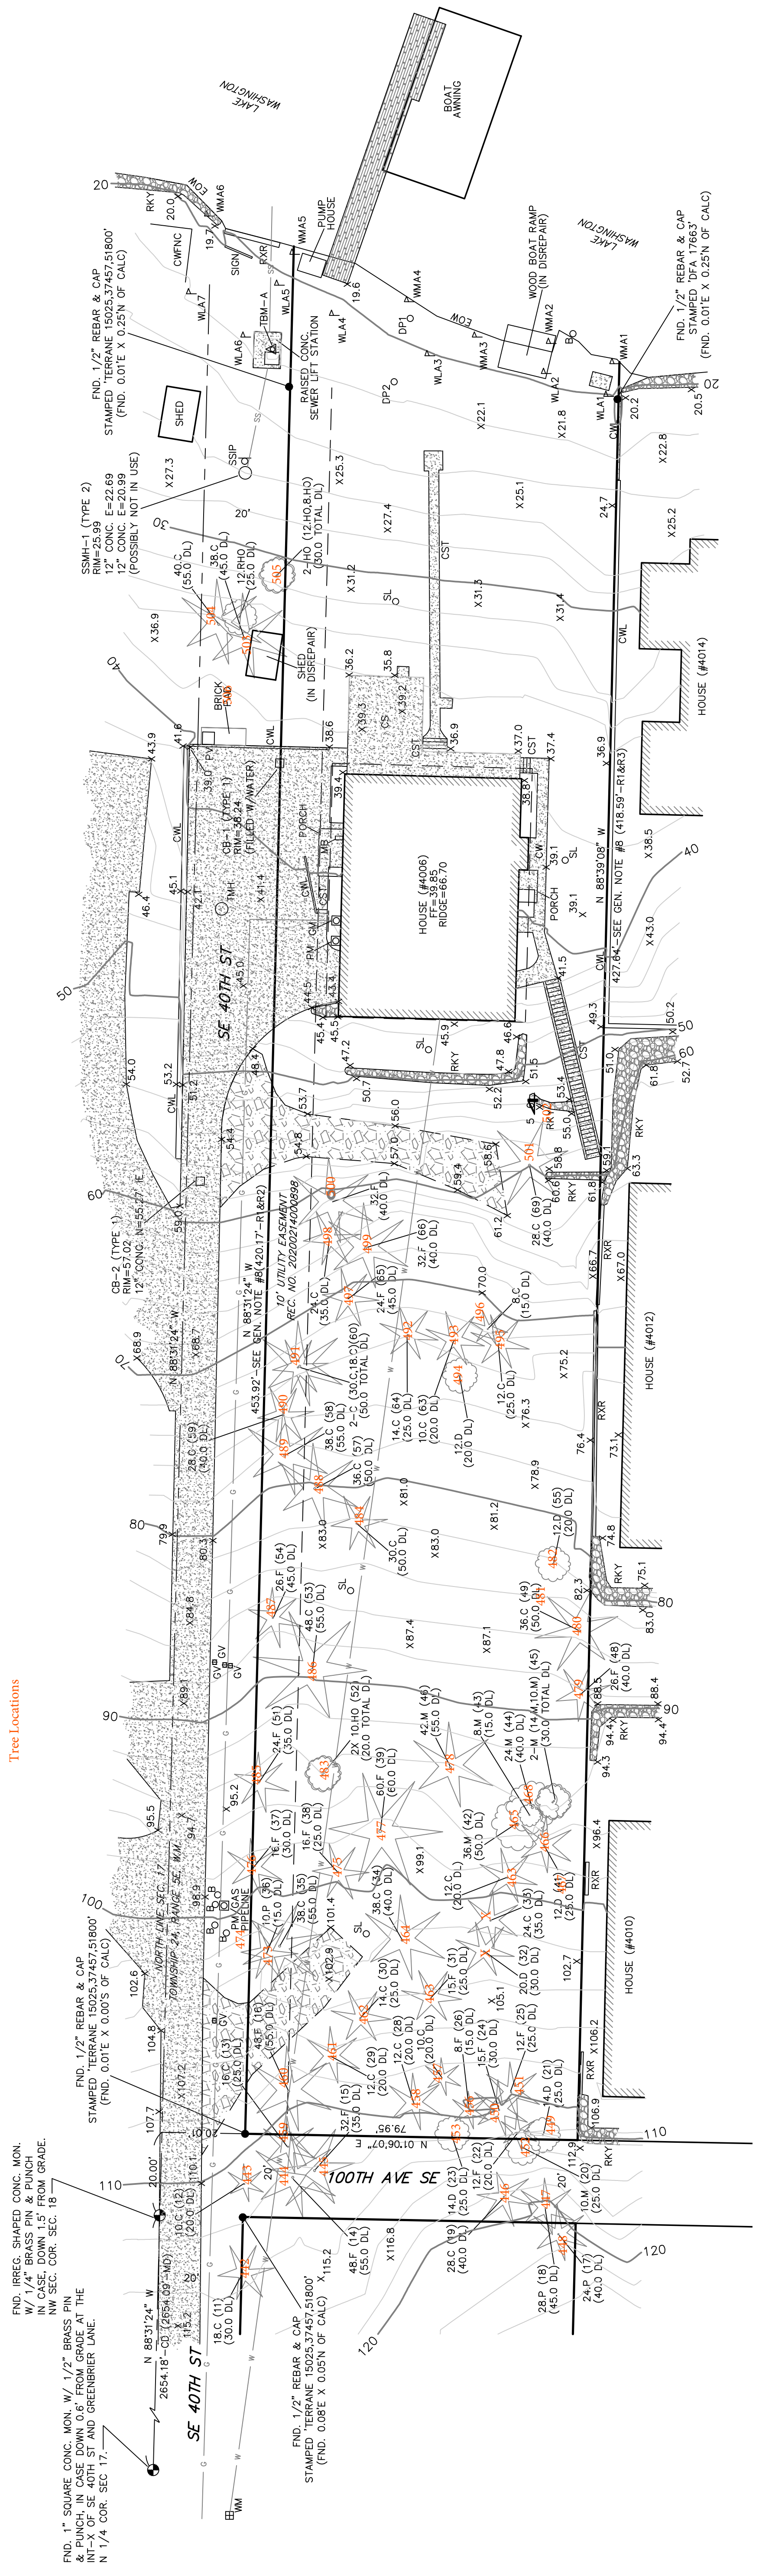
Tree Locations

The root zone of Tree No. 500 is within the proposed access excavation area. Excavation, down-hill from the tree will remove 93 square feet of the total 462 square feet or about 20-percent. Considering the down-hill location and the subsequent rebuilding of the retention wall, in my opinion this tree will not be significantly affected.

- Certified Arborist on site during excavation activities within the defined root zone of all trees.
- All trees to be retained are to be fenced at the edge of the recommended tree protection zone with 6-foot high cyclone type fencing.
