ARBORIST REPORT/TREE PLAN

73XX SE 38th Street
Mercer Island, WA

February 23, 2021

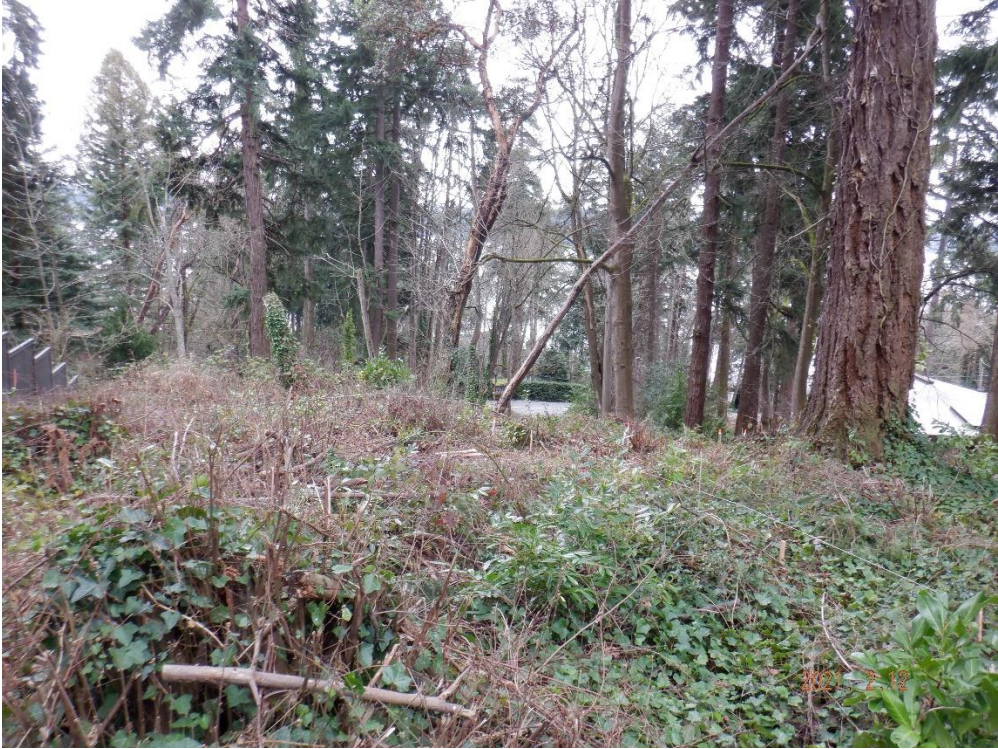
Proposed building footprint, Tree #23 on right

The owner desires to retain as many healthy trees as possible. Tree #23 is close to the proposed building footprint but can be successfully preserved if measures are taken to protect the root system. It is my understanding the garage floor will be floated above the existing grade to minimize root disturbance for Tree #23 and the neighboring trees. Only small footing pads shall be excavated within the defined LOD boundary. Footing pads within the LOD boundaries shall be hand-excavated only. Heavy equipment shall be limited to only those areas that are outside of the fenced protection areas and defined LOD. Exposed LOD areas outside of the fenced protection area shall be protected by covering the ground surface with a protective covering of a 6 to 8-inch layer of arborist wood chip mulch or hog fuel, rubber mats or plywood to prevent damage from equipment.

The proposed walkway to be constructed next to Tree #23 is to be elevated above the existing grade. Care shall be taken when working near trees to protect soils and surface roots that likely extend beyond the dripline. Cover areas with a protective 6 to 8-inch layer of arborist wood chip mulch or hog fuel to protect soils from compaction and damage to surface roots.

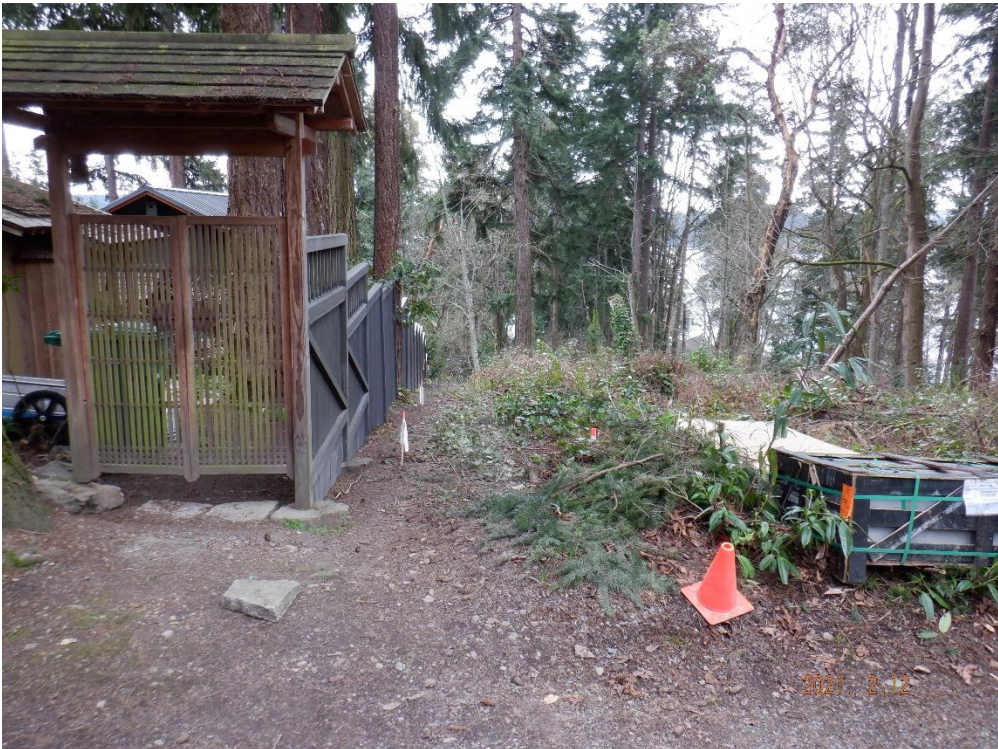
East property line adjacent to proposed building footprint, neighboring trees on left

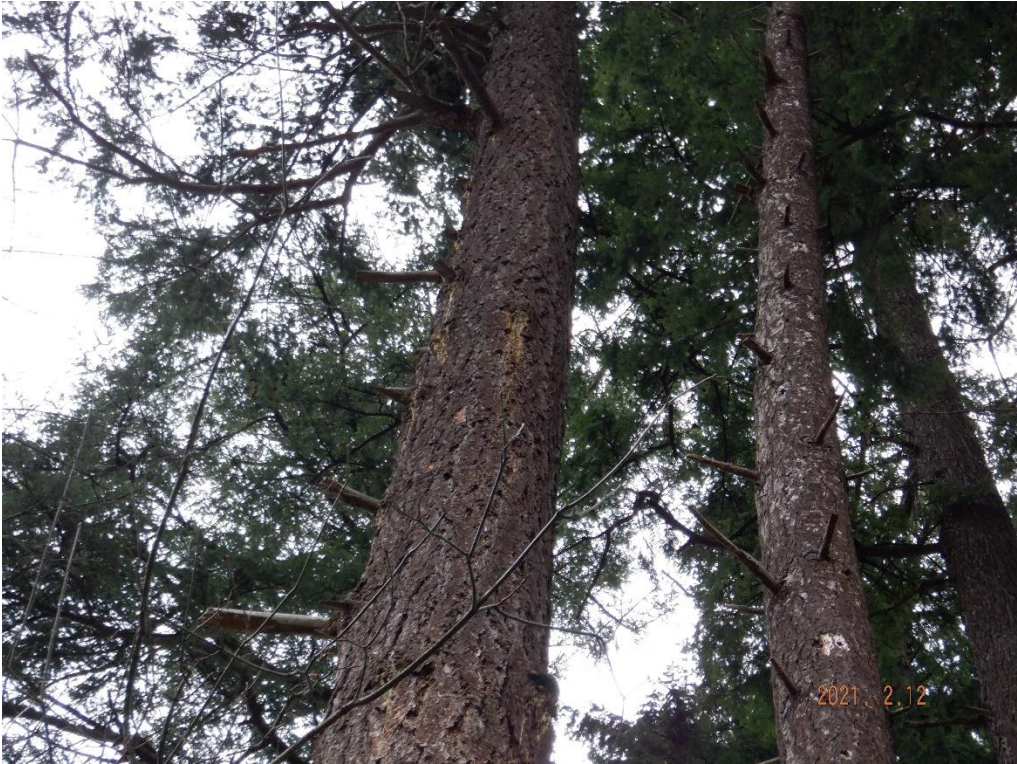
Tree #33 and F have advanced decay within the lower and mid-trunk caused by *Porodaedalea pini*, red ring rot. Multiple fruiting bodies of the fungus can be observed on all sides of the main stem of #33. On Tree F, there are multiple conks on the south side of the lower trunk and mid-stem. Tree F has a lean to the neighbor's house. Tree #30 has an incipient infection.

Tree #33 is high-risk, given its condition and proximity to the proposed building footprint. Multiple conks or fruiting bodies of the white rot fungus (red ring rot) suggest advanced decay within the lower

and mid-trunk. In the early stages of infection, pockets of decay can be expected behind each conk¹. In its advanced stage, there may be more extensive columns of decay and significant loss of wood strength. Trees with extensive heart rot are considered to have a high likelihood of failure. Tree #33 is recommended for removal to abate the hazardous condition.

Tree #33 (advanced pini infection), dead Tree #2 on right

The cut stumps of #32 and #33 shall be grinded down to the existing grade and not pulled, or simply cut at ground level. Pulling or excavating these stumps would cause damage to the roots of nearby trees as the root systems are likely entangled or intertwined.

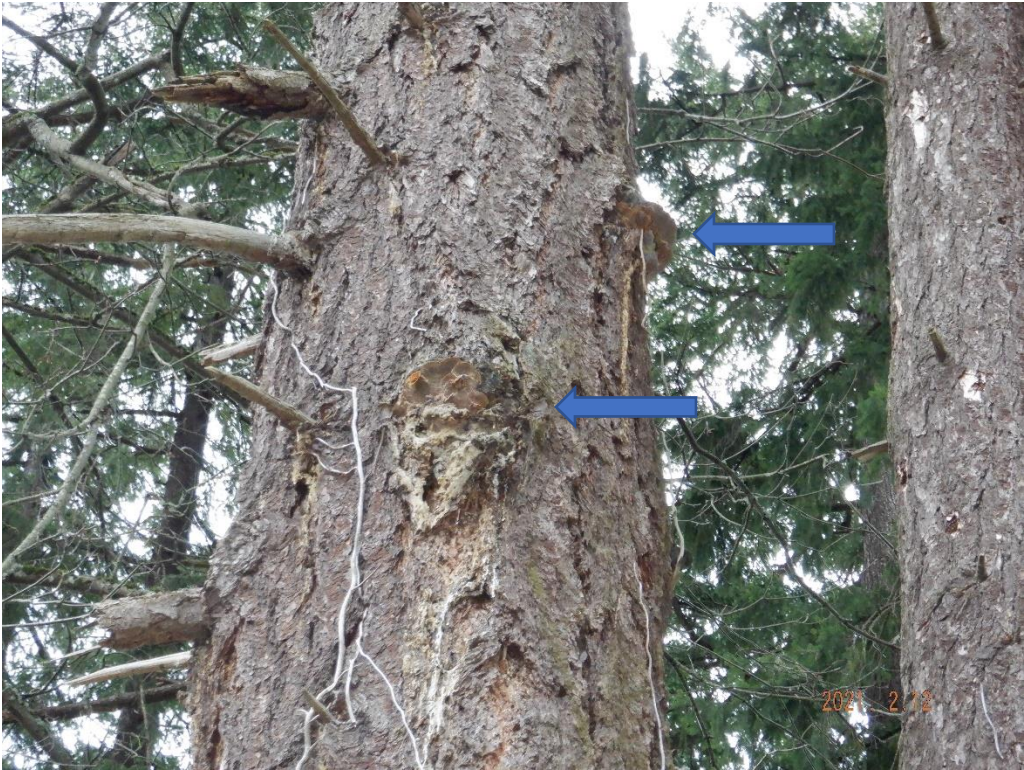
Tree #33, pini fruiting bodies on lower trunk (arrows)

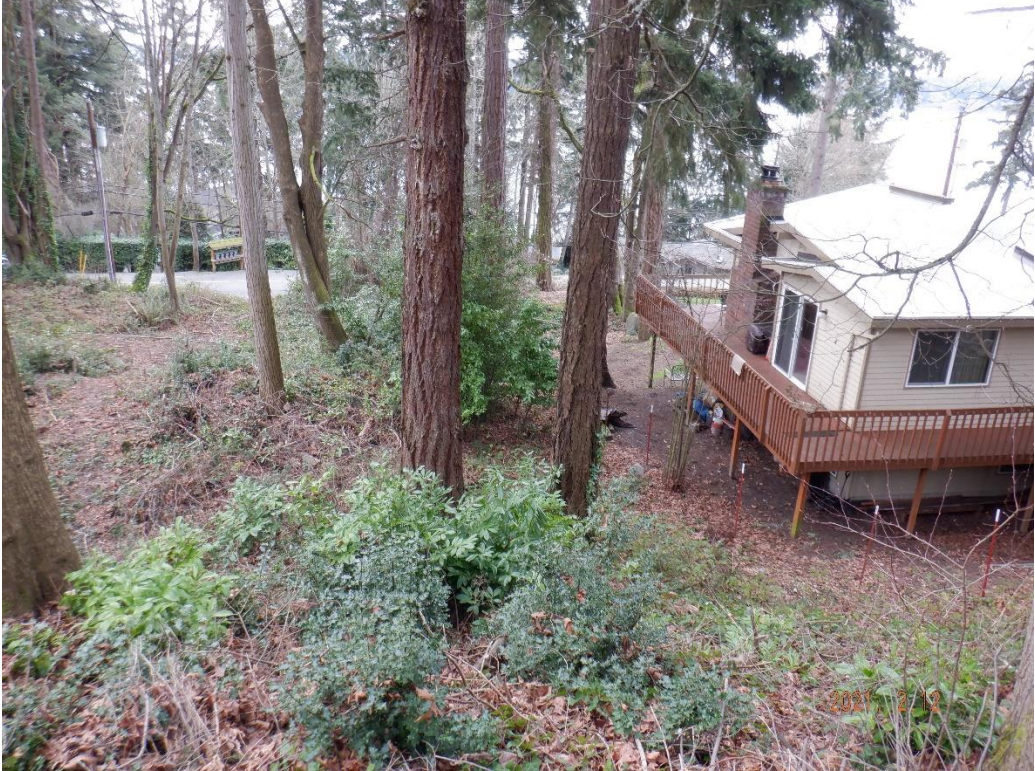
Tree F also has an advanced red ring rot infection. The tree has a slight lean towards the neighboring house. Trunk failure would result in severe damage to the neighbor's house. Removal is recommended to abate the hazardous condition. Tree #30 has an incipient infection. Continued retention appears appropriate at this time. Periodic follow-up assessments of tree condition and risk are warranted for this property in the future. Recommend having trees assessed at least every two years.

West property line below proposed building footprint, Trees #36 (center) and F (right)

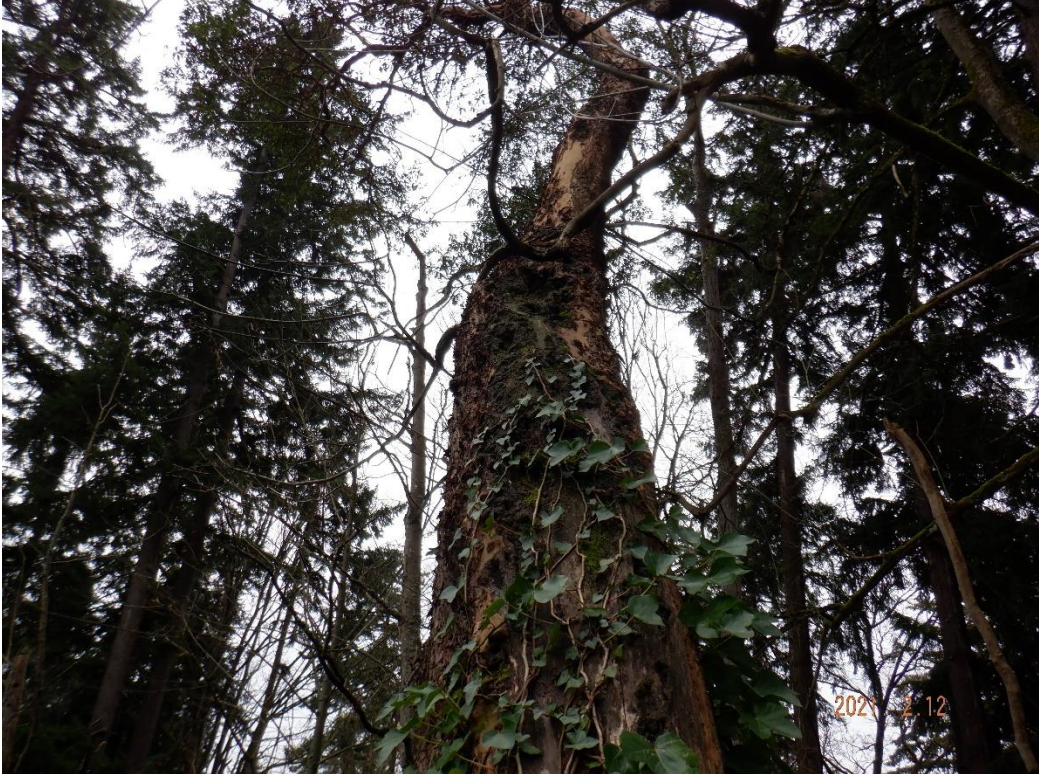
Tree #21, a mature Pacific madrone is located just south of the proposed building footprint. It is heavily diseased and has a major lean downhill to the south. The subject is in a general state of decline as evidenced by the decline and mortality of most of the madrone trees in the vicinity. Ground disturbances south of the tree on the uphill side are likely to compromise structural stability. Removal is recommended.

Tree #21, diseased, major lean south

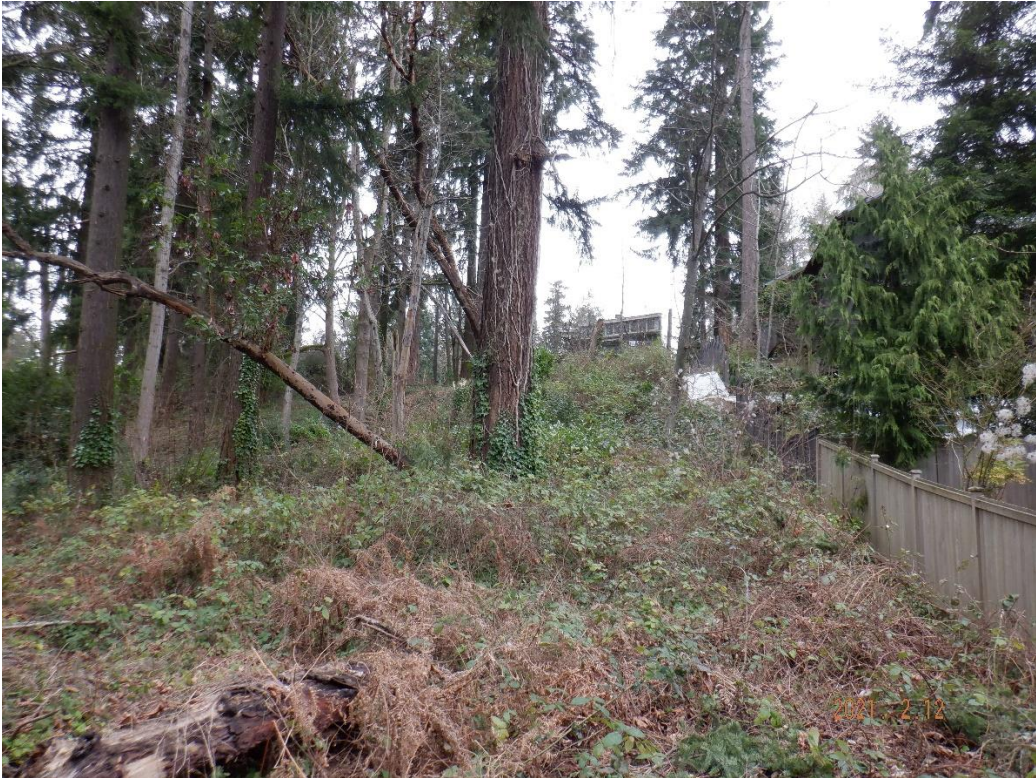
East property line, looking north, Trees #12 and #13 in foreground

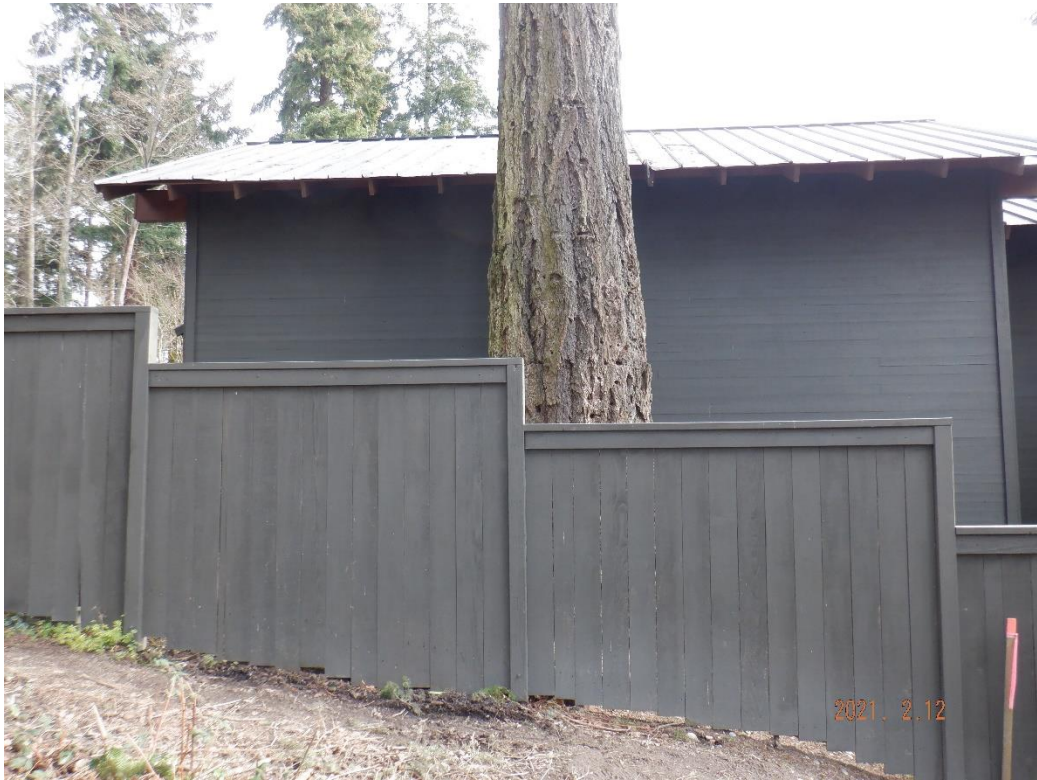
Neighboring Tree E

Off-site or neighboring trees are in fair to good condition. No overly concerning issues were observed from the street or from the subject property. Tree E has been impacted to some degree in the past. Foliage appears somewhat sparse. Overall condition is fair.

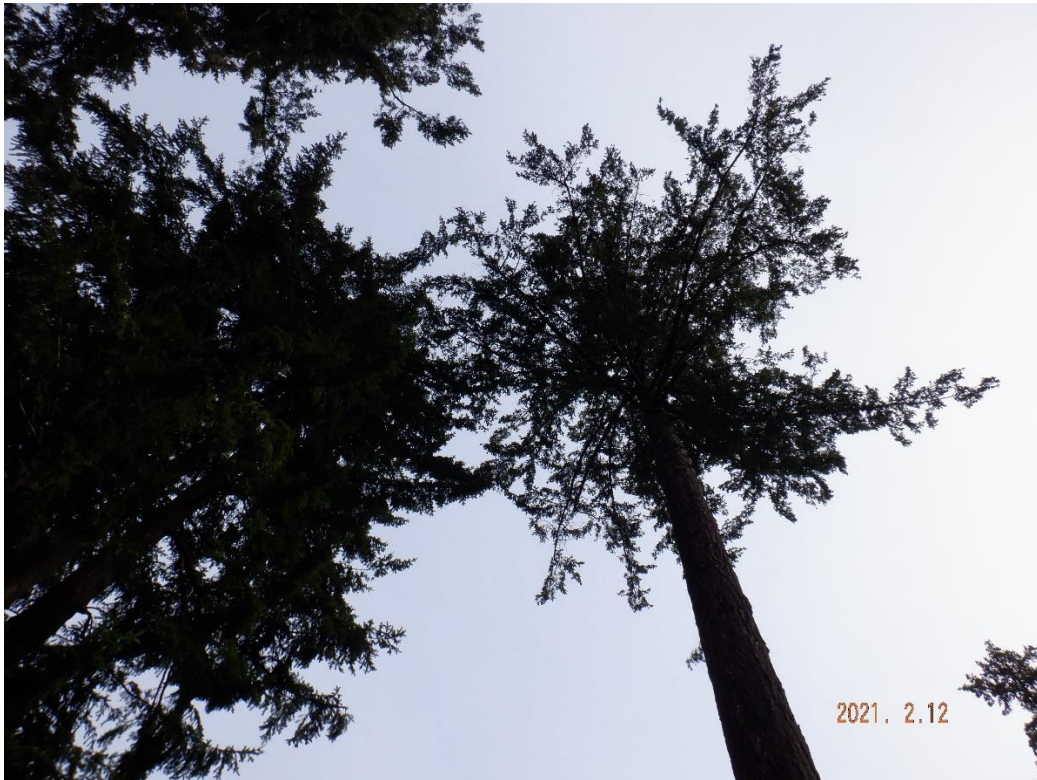
Neighboring Tree E – upper crown, foliage somewhat sparse

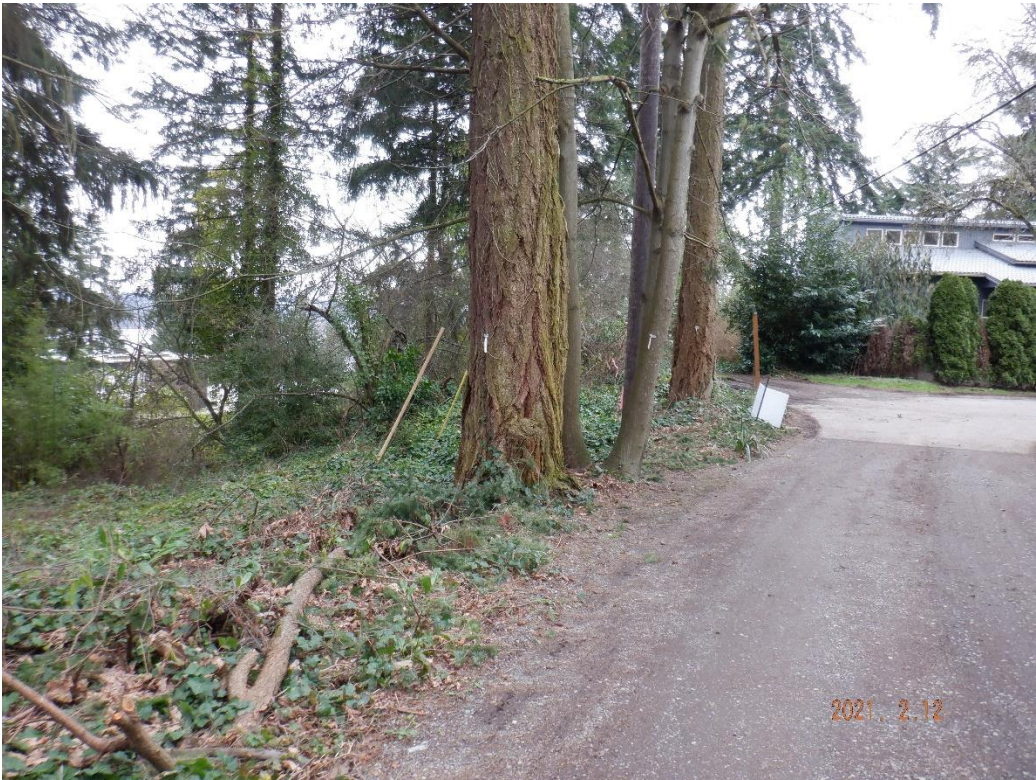
Trees in ROW of SE 38th Street – no impacts expected
