# LAYTON TREE CONSULTING, LLC

## TREES & CONSTRUCTION MEMO

To: Paul Bosveld  
From: Bob Layton  
CC: Heather Crain, Matt Wittman  
Date: March 31, 2022  
Re: Tree Protection at 38XX W Mercer Way

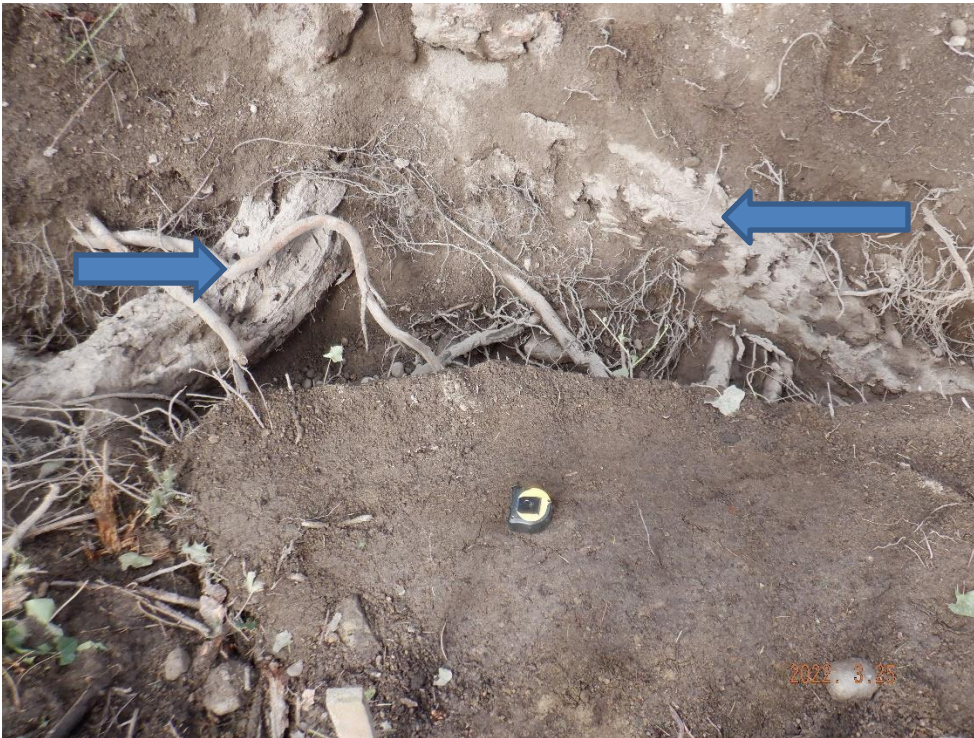
Trees requiring the most attention include Tree #23 and the neighboring Trees B, C and D. These are closest to the proposed site work. The buttress root locations of Tree #23 were air-excavated. See pictures below. The concrete footing proposed directly 4-feet east of the trunk face sits between the two exposed buttress roots which radiate away from the footing location. The footing may need to be slightly shifted north to avoid the south buttress root.

Root crown of Tree #23, 10-inch diameter buttress on left, 12-inch diameter buttress on right (arrows).

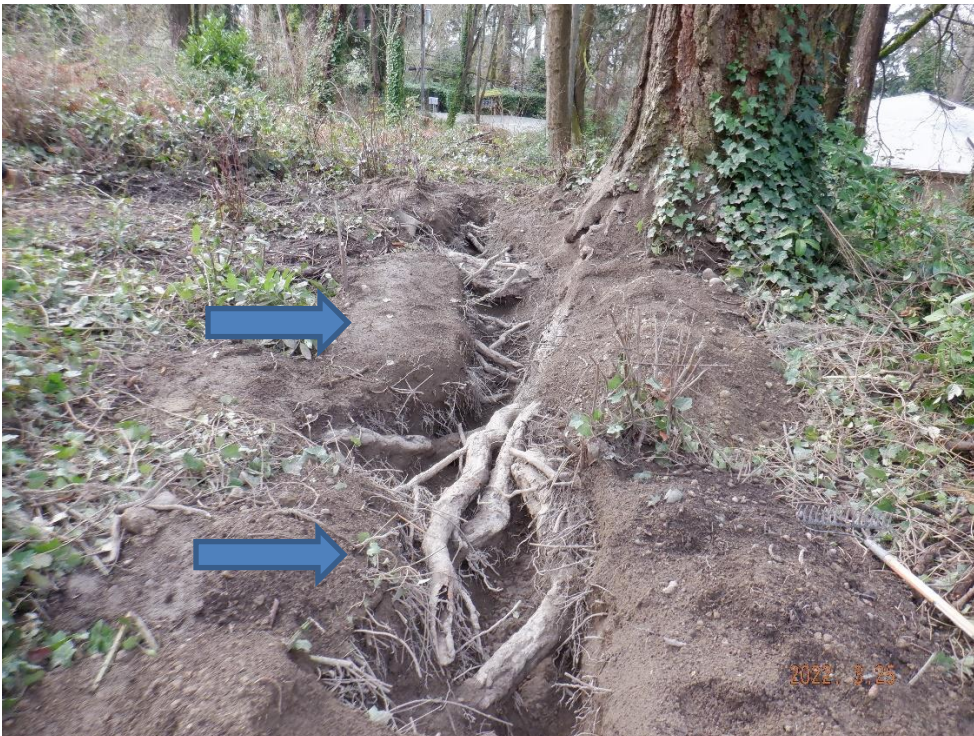
Exposed roots east of #23, proposed footing locations (arrows), north buttress root runs farthest west along edge of trench and would not be impacted

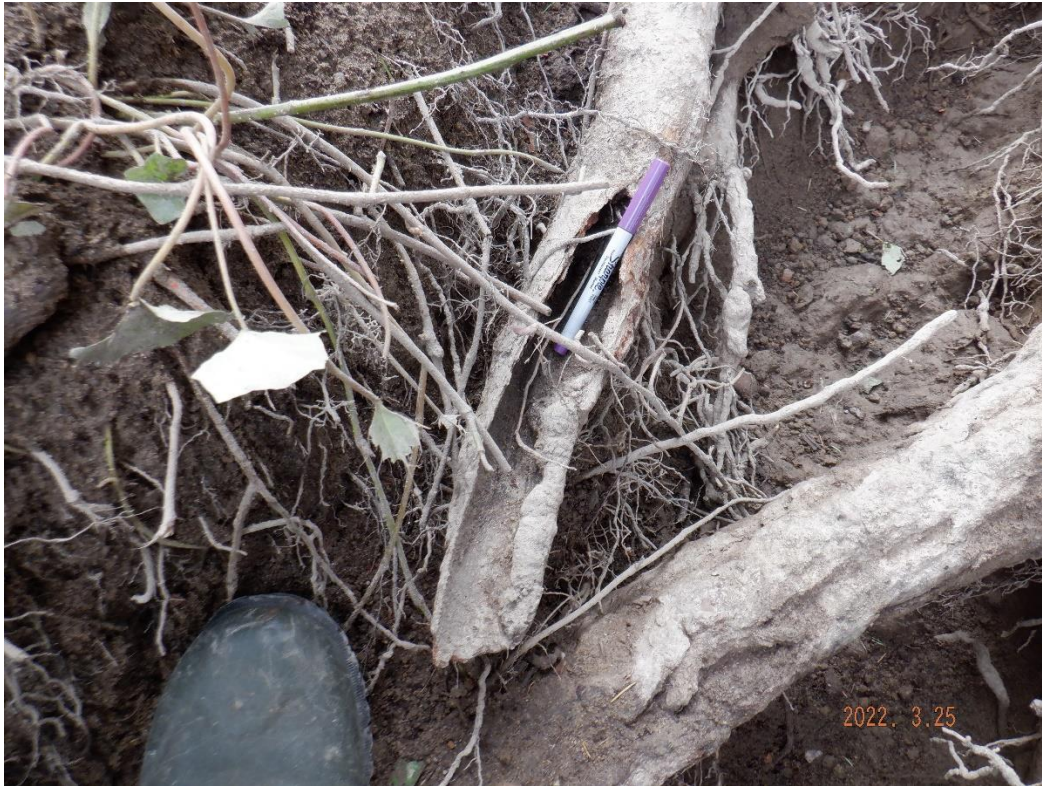
Decayed root pictured above at edge of proposed footing, can be pruned away

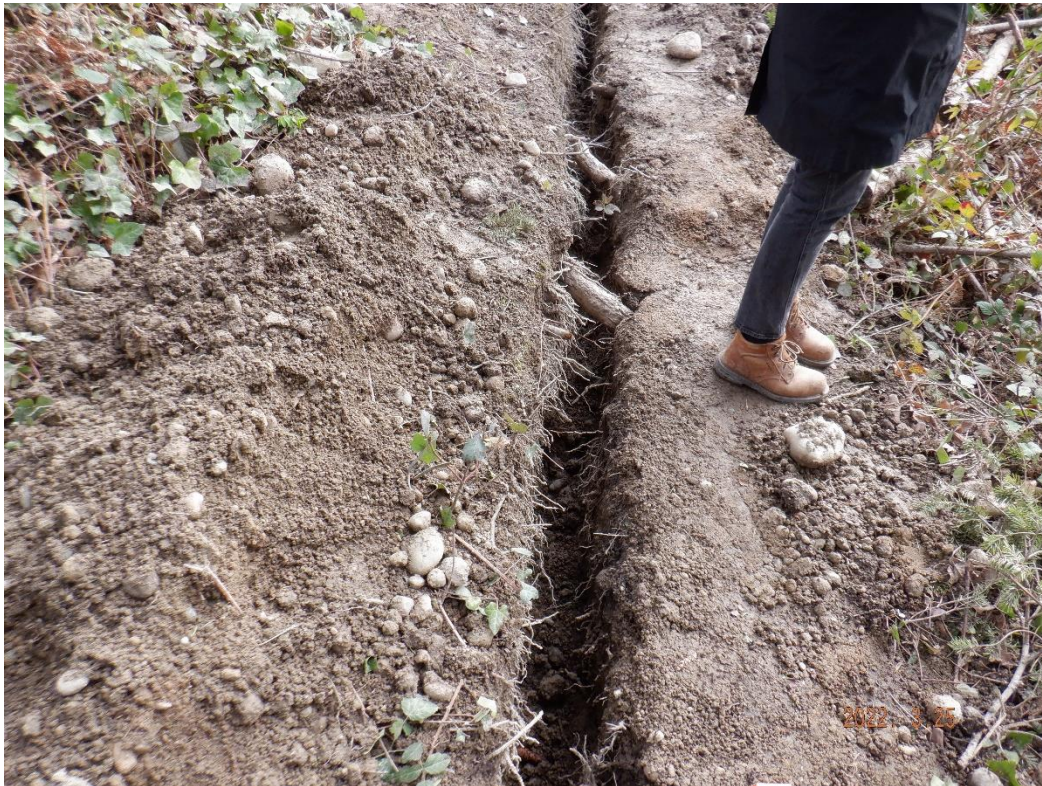
A trench was also air-excavated at 14 ½-feet south of Tree #23 at the proposed cut in grade for the new house. Only one 2-inch diameter root was exposed. See picture below. This root can be cut at the excavation limit without having any impact on the health or stability of the tree.

Trench air-excavated south of #23 at proposed cut in grade

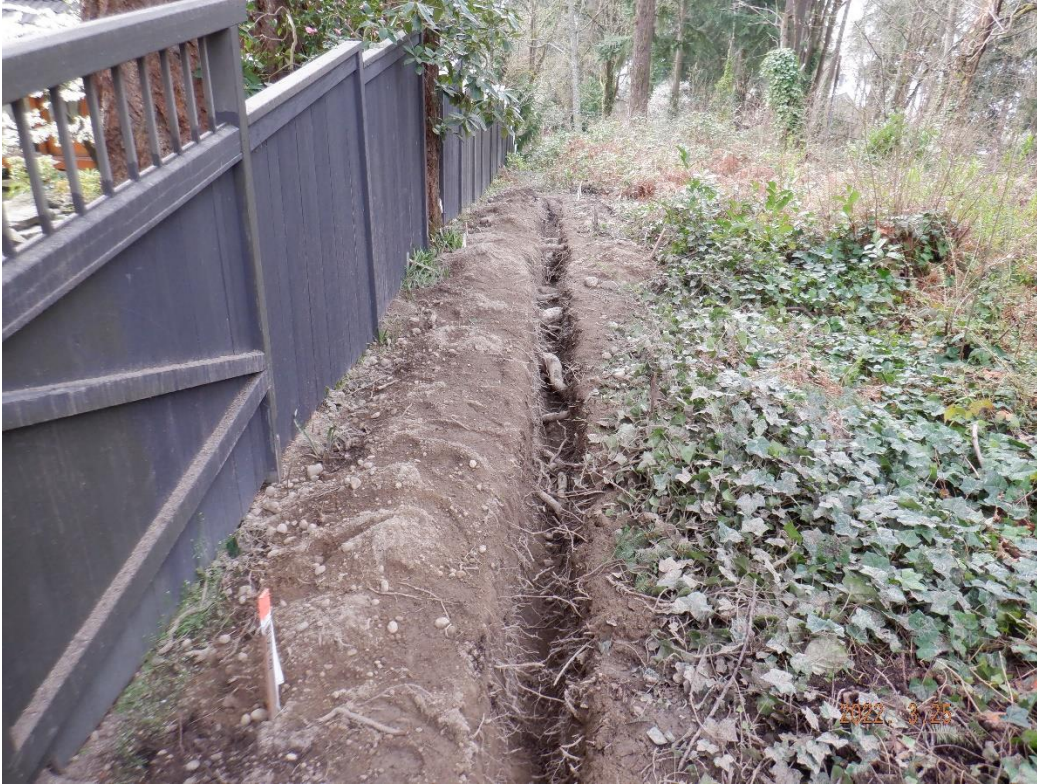
Another trench was air-excavated adjacent to the east property line at the proposed excavation extents. A cluster of +/- 5 structural roots exist directly west of Tree B. See the attached map. These will need to be protected. A continuous concrete footing at this location is not possible.

Trench air-excavated at excavation extent along east property line

Footings can be poured at the northeast and southeast corner, and mid-span of the garage to support the floating garage floor. Excavation for a below grade storage compartment west of Trees B and C is not recommended. A smaller storage compartment at the northeast corner of the garage could be excavated out without having any significant impacts on neighboring trees.

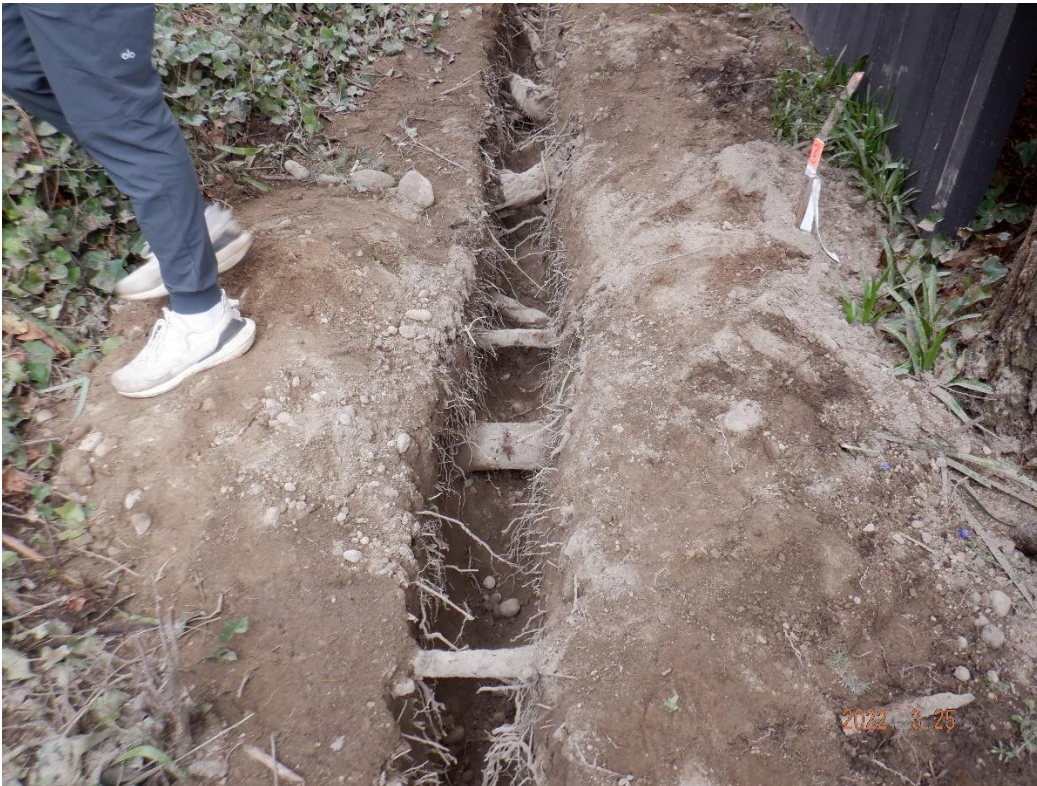
Cluster of structural roots exposed west of Trees C & D

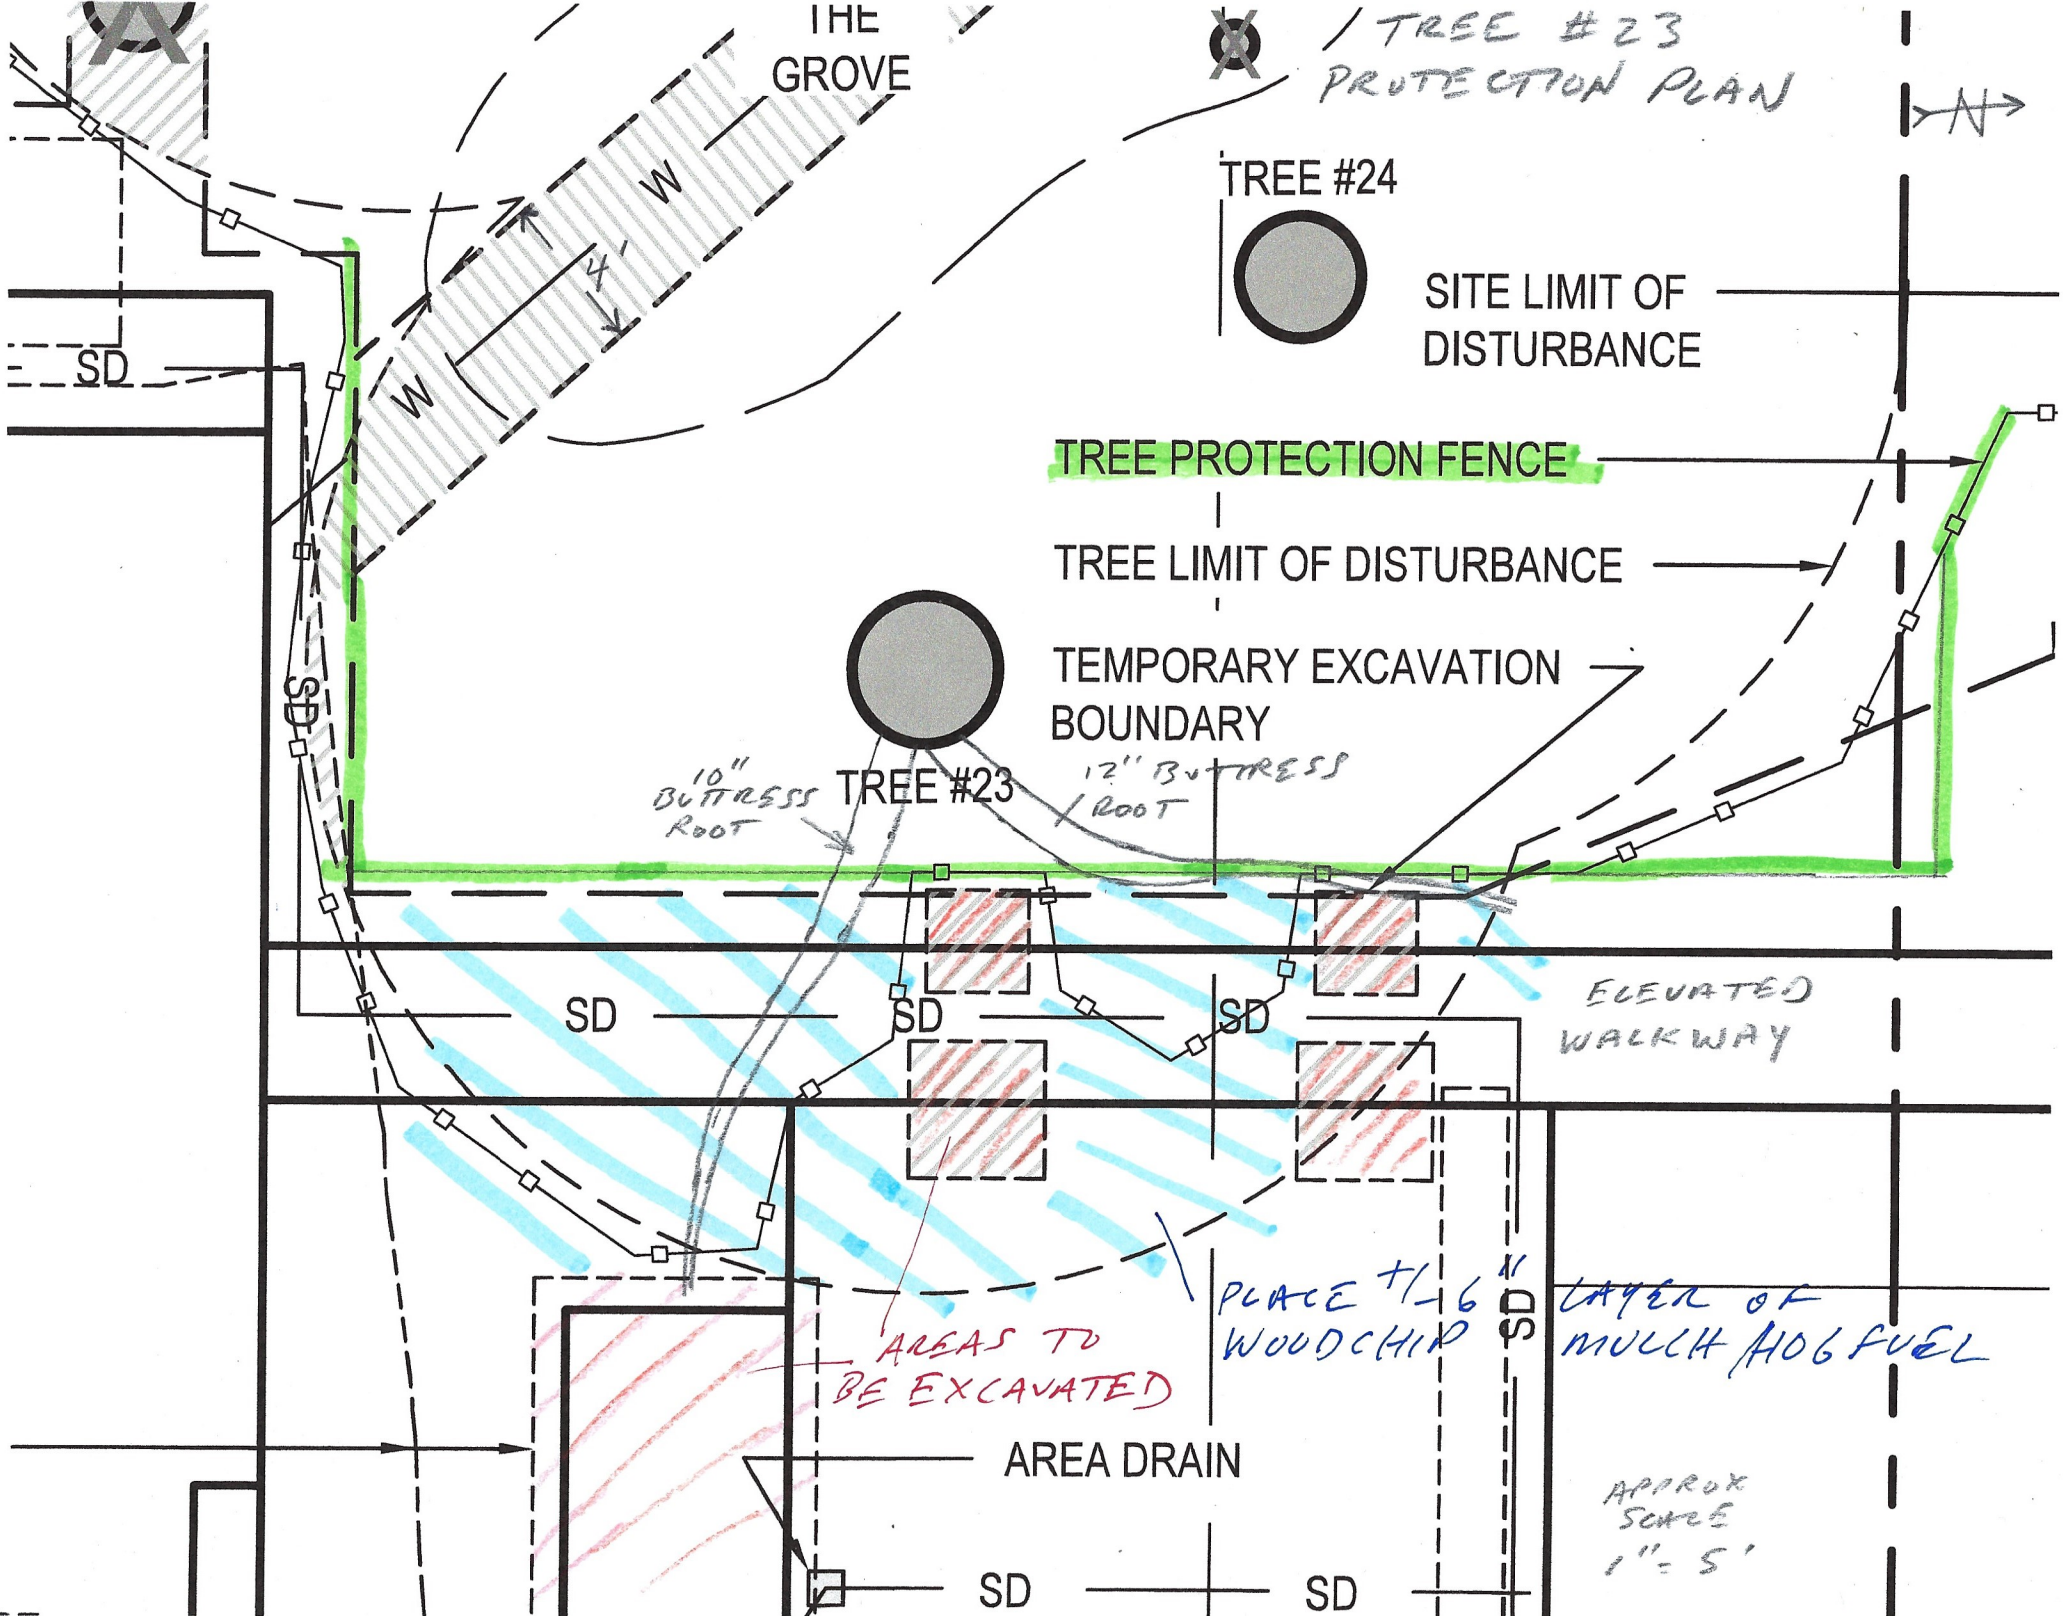
TREE #23  
PROTECTION PLAN

It is the intent of the owner to retain Tree #23. 5-feet of clearance between Tree #23 and the proposed improvements is not possible, given the size constraints of the area to be developed. One of concrete footings necessary for the garage and elevated walkway construction has to be within a proximity of the tree, which will not afford the 5-foot clearance. The recommended location of tree protection fencing is shown on the attached map.

PLACE +/- 6"  
WOODCHIP

LAYER OF  
MULCH HOG FUEL

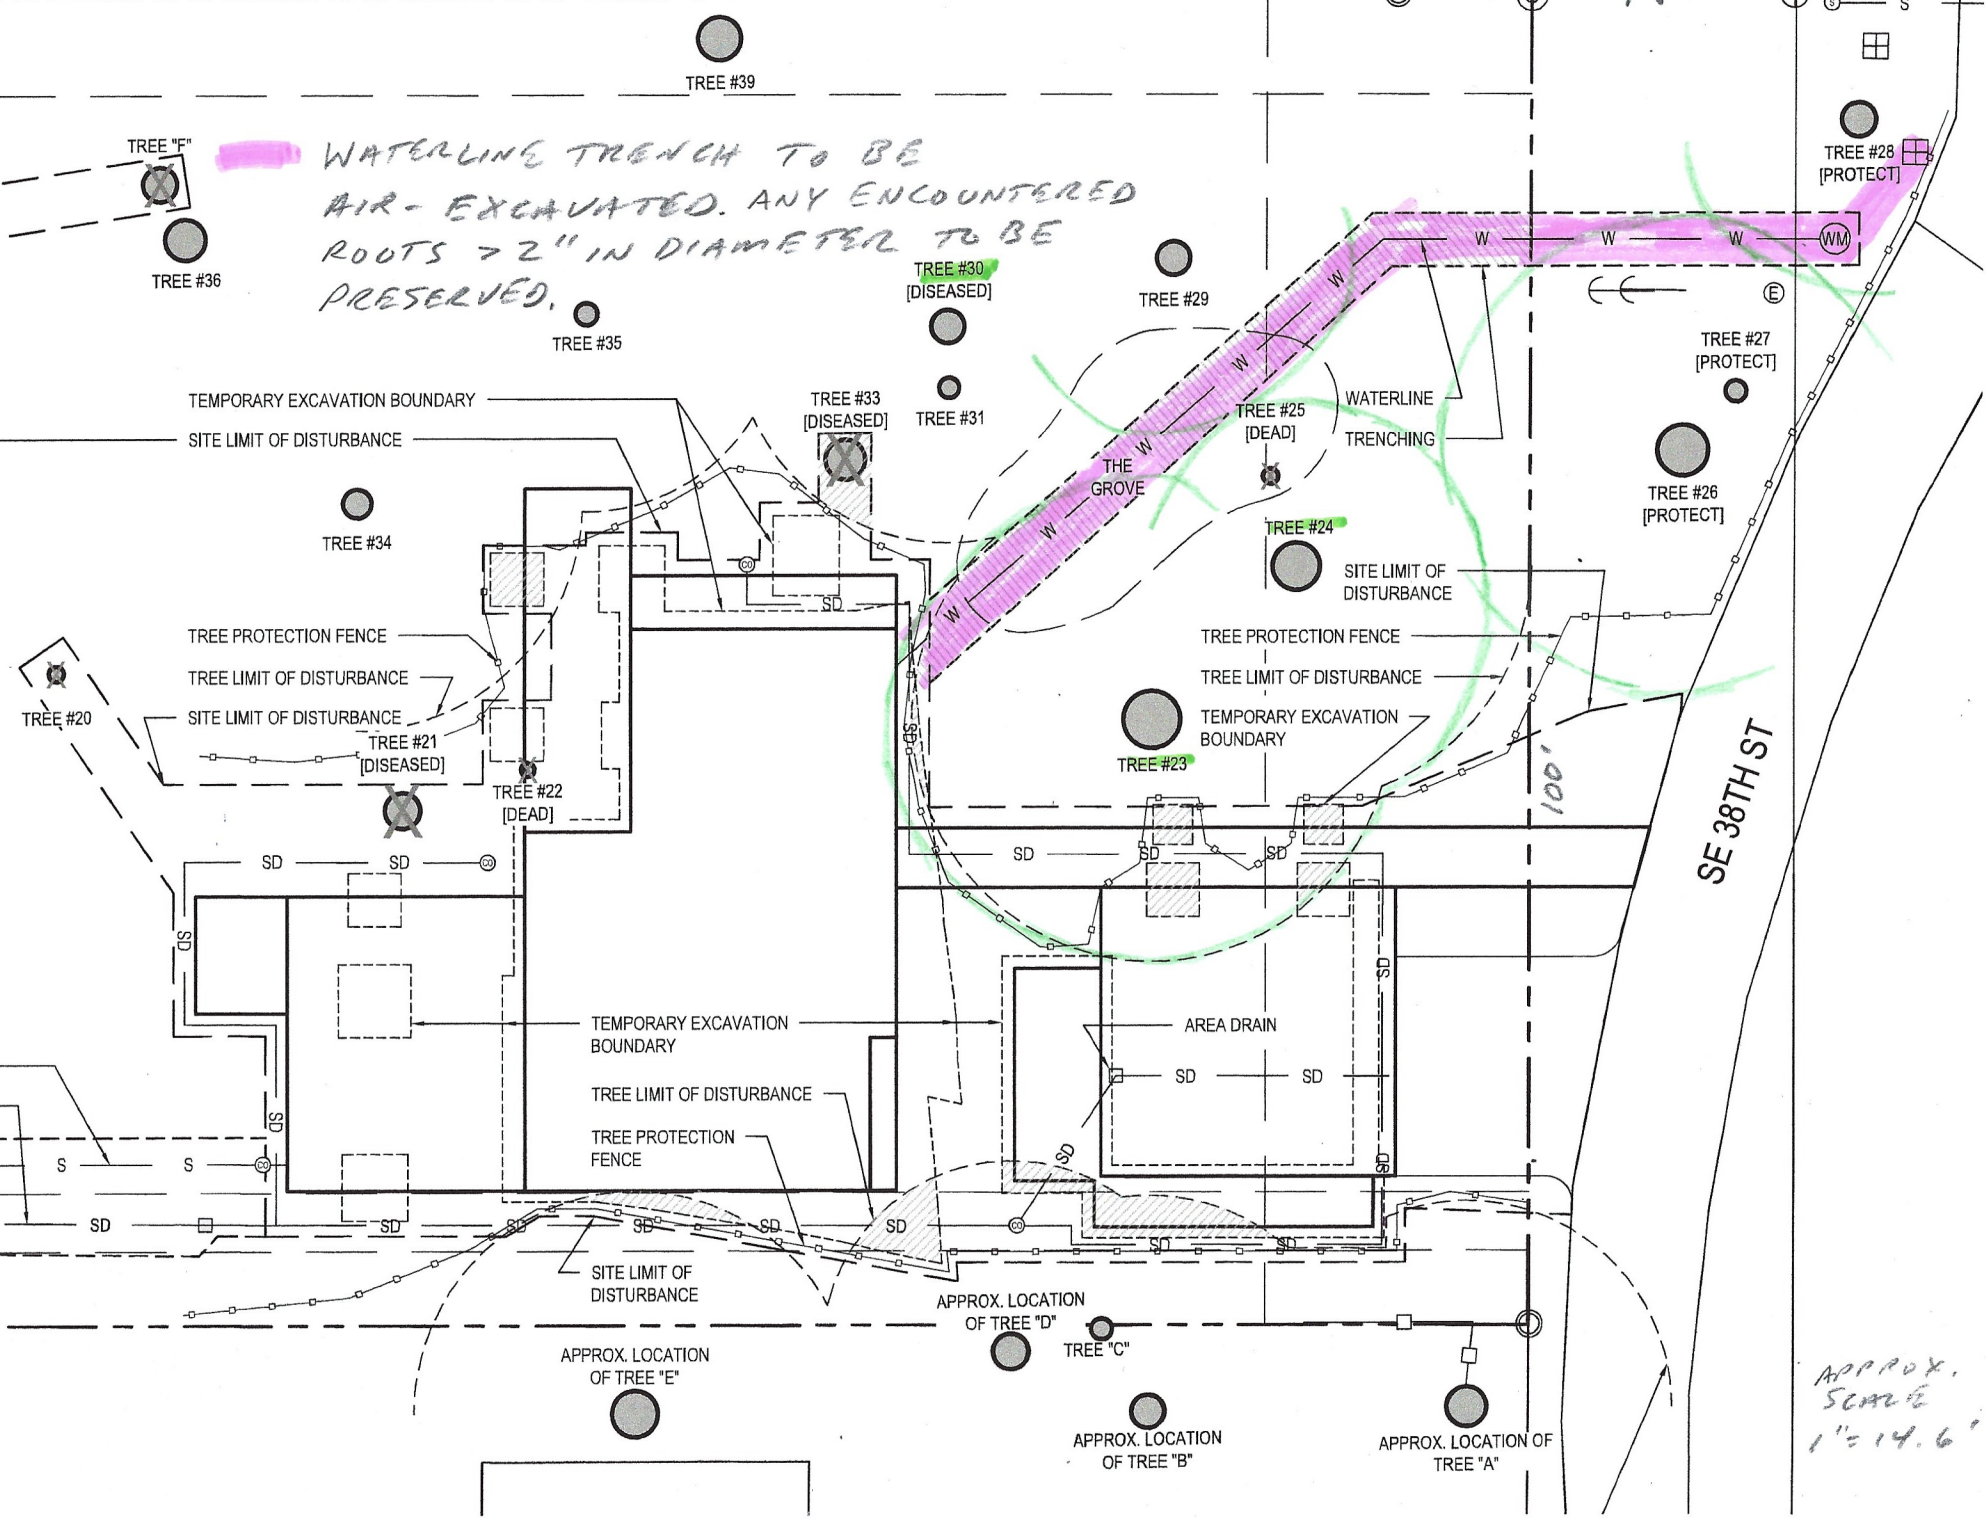
# WATERLINE PLAN

Given the number of exceptional trees to be retained within the vicinity of the water line utility, it is not possible to stay at least 12-feet away from all exceptional trees. The location of the trench will ultimately be field-located to be as far from exceptional trees as possible. The entire length of the water line trench will be air-excavated. All roots greater than 2-inches in diameter will be preserved and the utility/pipe routed beneath them. The trench location on the attached map is shown as 4-feet in width. Realistically, the trench would only need to be a foot to a foot and a half wide to install the plastic waterline.

WATERLINE TRENCH TO BE AIR-EXCAVATED. ANY ENCOUNTERED ROOTS > 2" IN DIAMETER TO BE PRESERVED.

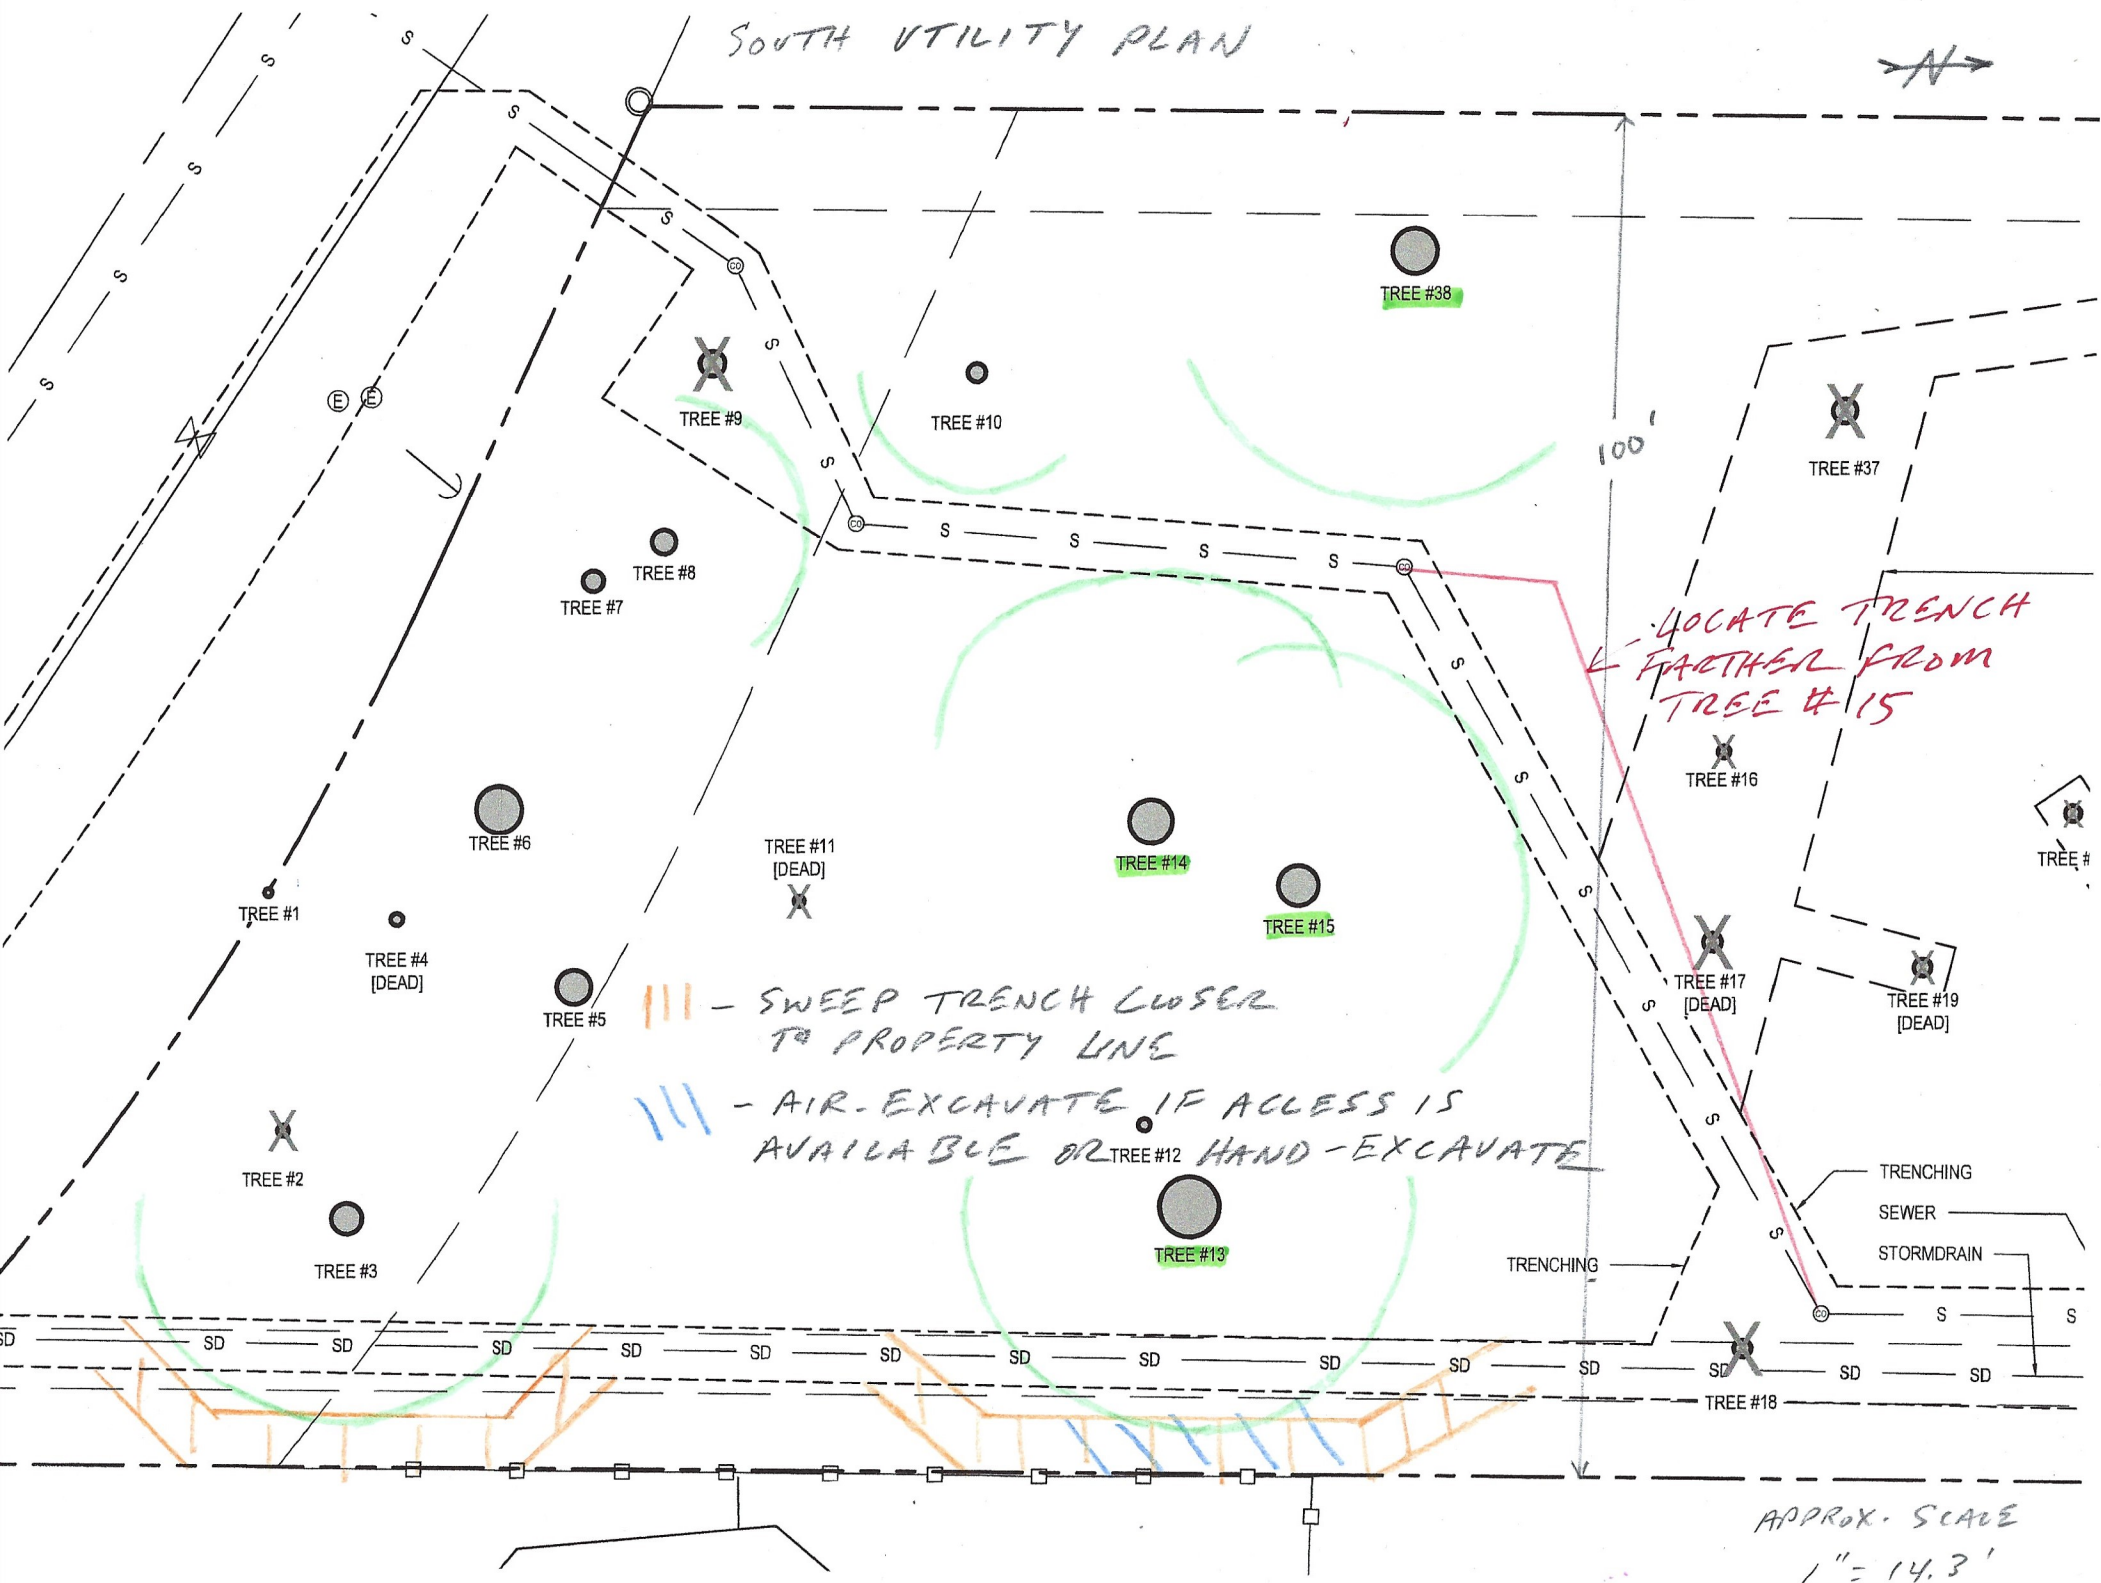
# SOUTH UTILITY PLAN

The sewer utility has been designed to avoid the driplines of adjacent trees. The storm drain utility on the south perimeter shall be moved closer to the property line to the farthest extent allowable to reduce the impact to Tree #13 and Tree #3. See the attached copy of the site plan. Slightly move trench north away from Tree #15. The majority of trenching can be accomplished with a tracked mini-excavator. Air-excavate adjacent to Tree #13 if access available or hand-excavate to preserve any roots greater than 2-inches in diameter.

LOCATE TRENCH 1' FARTHER FROM TREE #15

||| - SWEEP TRENCH CLOSER TO PROPERTY LINE
||| - AIR-EXCAVATE IF ACCESS IS AVAILABLE OR TREE #12 HAND-EXCAVATE

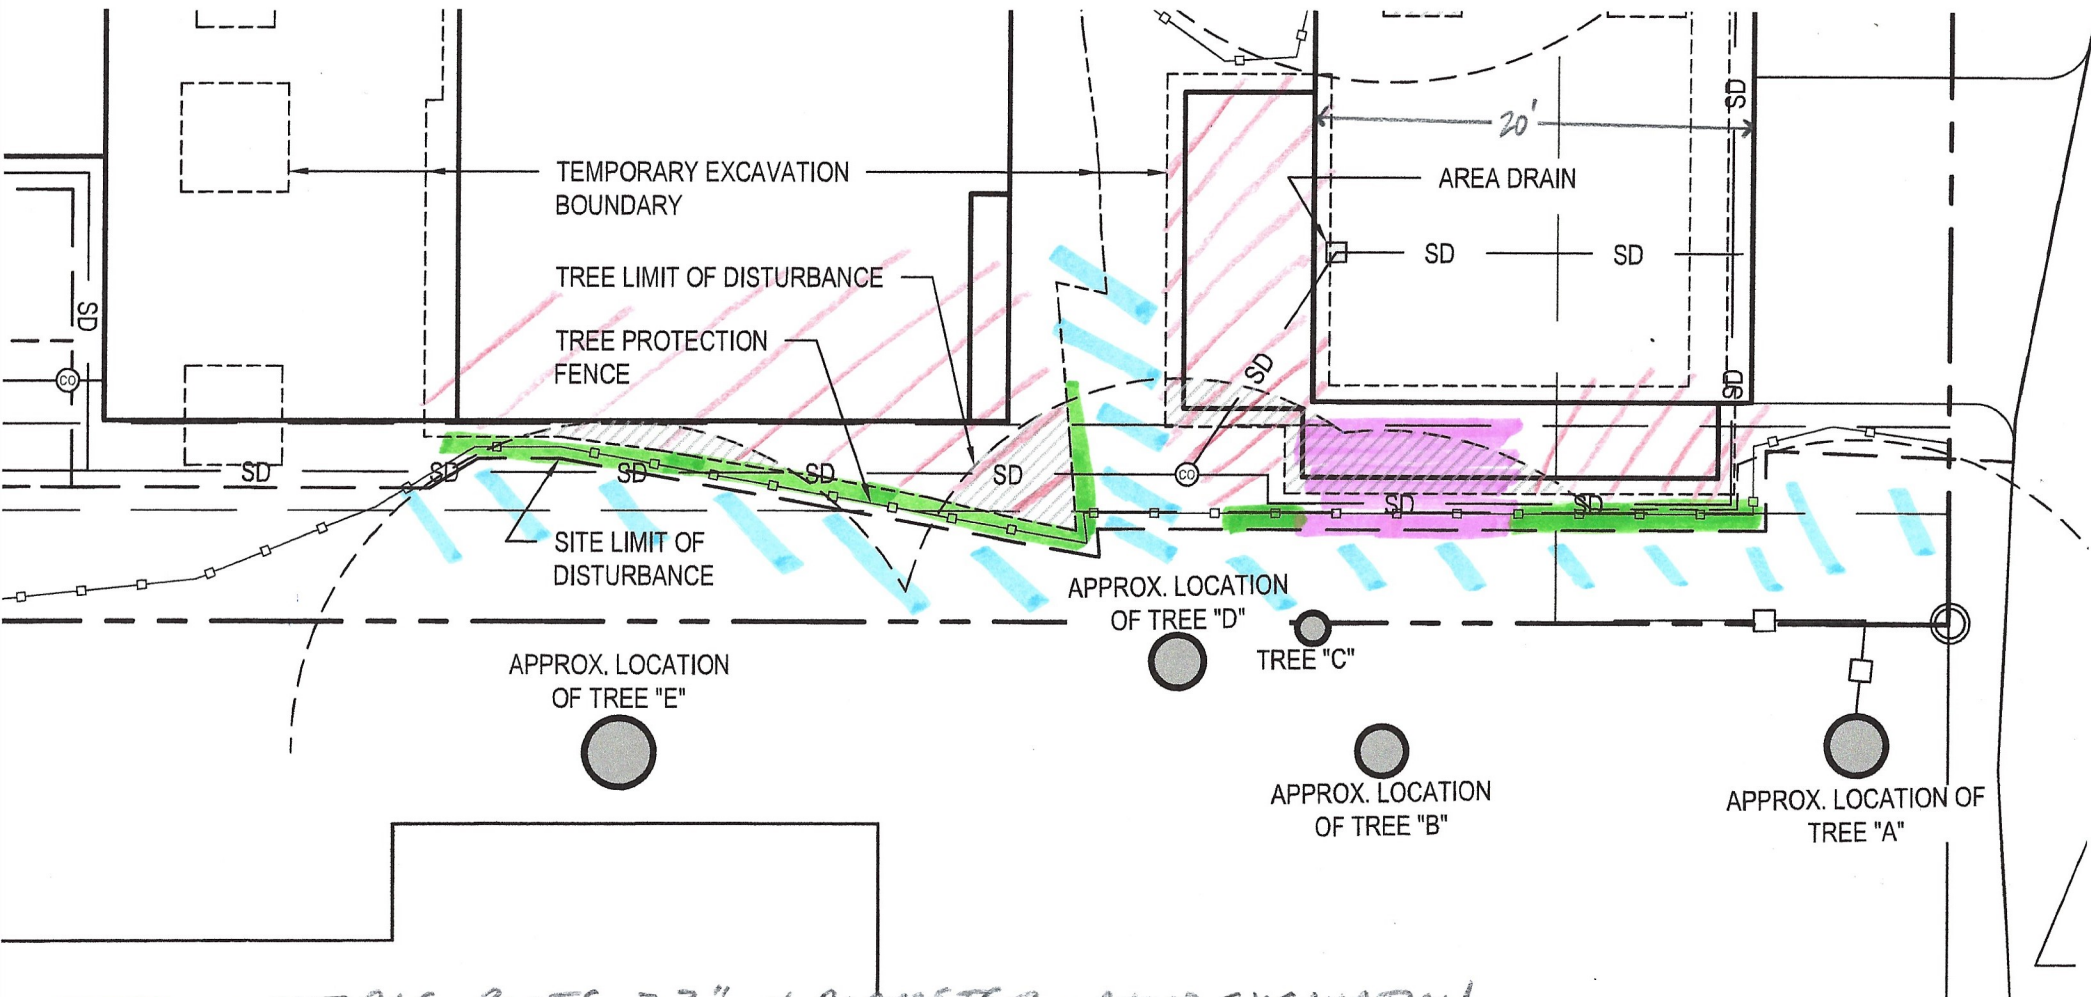
EAST PROPERTY LINE

- MULTIPLE ROOTS > 2" IN DIAMETER - AVOID EXCAVATION
- NO SIGNIFICANT ROOTS PRESENT - OKAY TO EXCAVATE FOR CONCRETE FOOTINGS
- PLACE +/- 6-INCH LAYER OF WOODCHIP MULCH OR HOG FUEL
- AREAS TO BE EXCAVATED
