**LEVEL ONE DRAINAGE ANALYSIS
CITY OF MERCER ISLAND**

**Bosveld Residence Mercer Grove
38XX West Mercer Way
Mercer Island, WA 98040**

LEVEL 1 DOWNSTREAM ANALYSIS

Bosveld Residence Mercer Grove
38XX West Mercer Way
Mercer Island, WA 98040

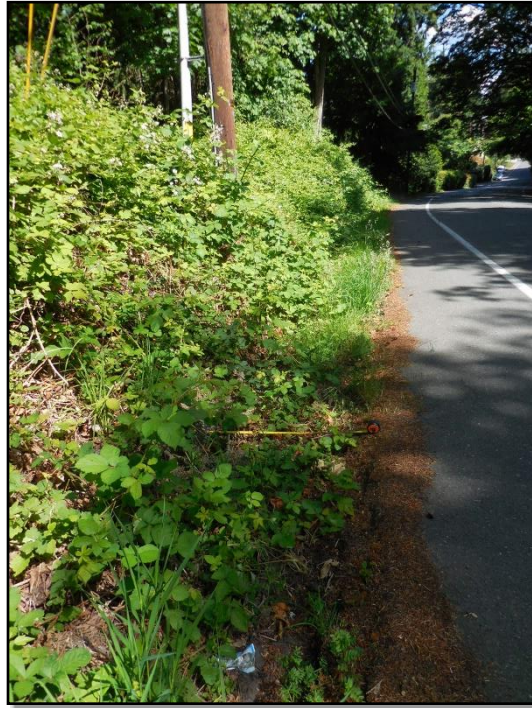
Picture #1: Existing Ditch; West Mercer way, facing east

Approx. 3' wide and 1' deep ditch along south property line with 2:1 or steeper slopes to property.

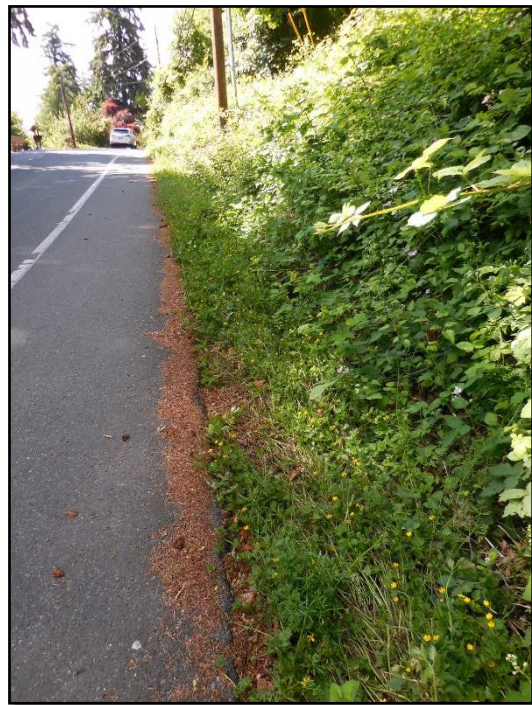
Picture #2: Existing Ditch; West Mercer way, facing west

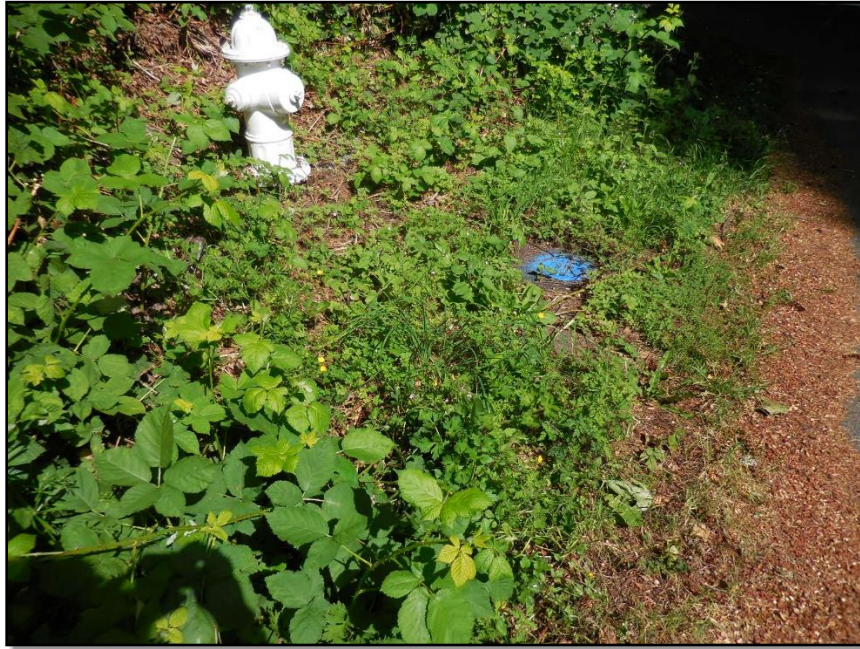
Picture #3: Existing Culvert under Fire Hydrant line

A new catch basin will be located just east of hydrant line to pick up this culvert, existing open ditch and storm from new development to the north.

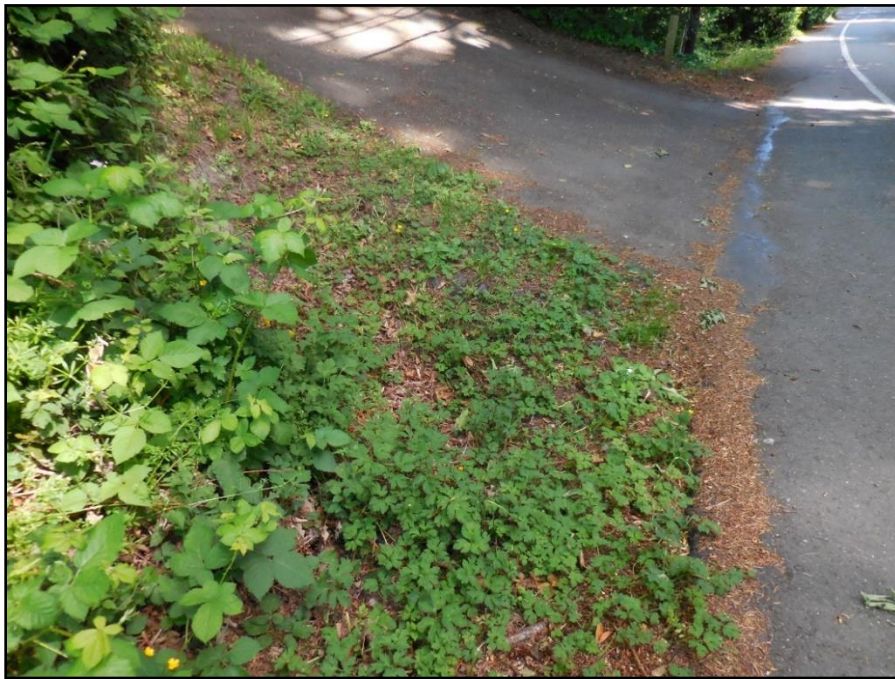
Picture #4: Existing Culvert under Driveway, facing east

A new 12" PVC pipe will replace existing 12" CMP culvert under neighboring driveway.

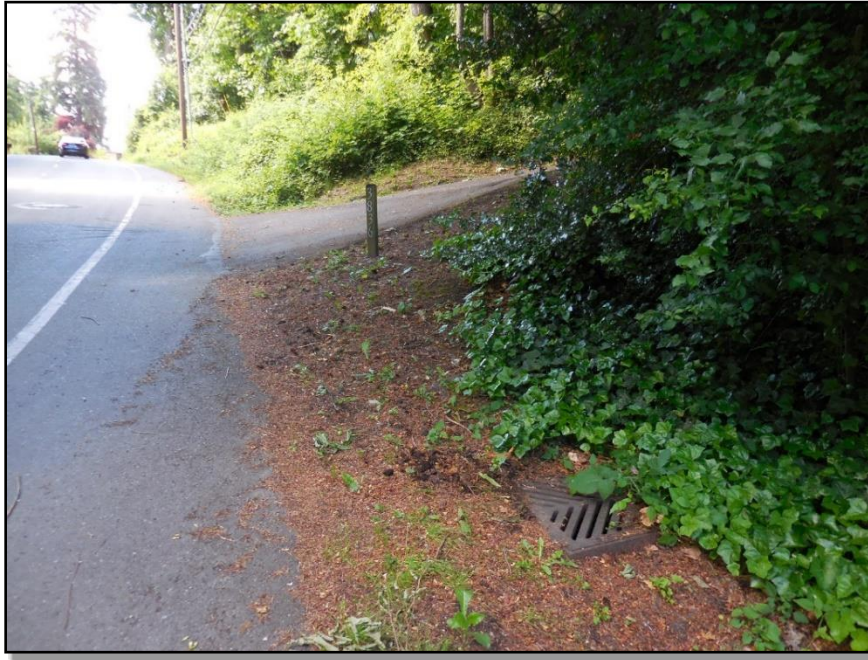
Picture #5: Existing Culvert under Driveway to CB 20-7 (MI GIS), facing west

This will be the first existing catch basin we connect to with a 12" PVC pipe which replaces the existing culvert under the driveway.

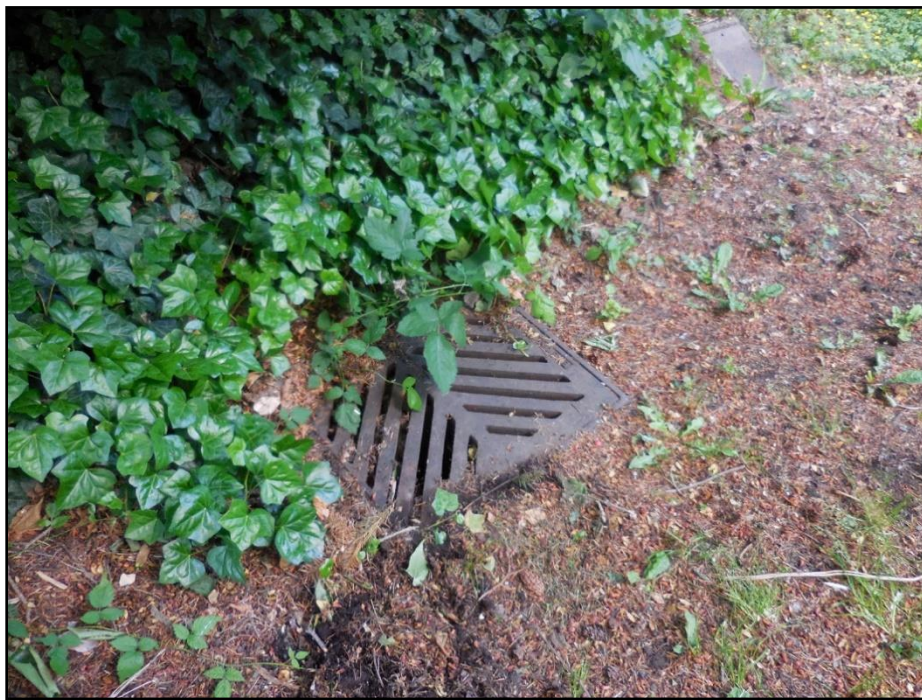
Picture #6: CB 20-7 (Labelled per Mercer Island GIS, Typical)

From this first existing catch basin, an 8" PE pipe crosses West Mercer Way to CB 20-56 on south side of West Mercer Way.

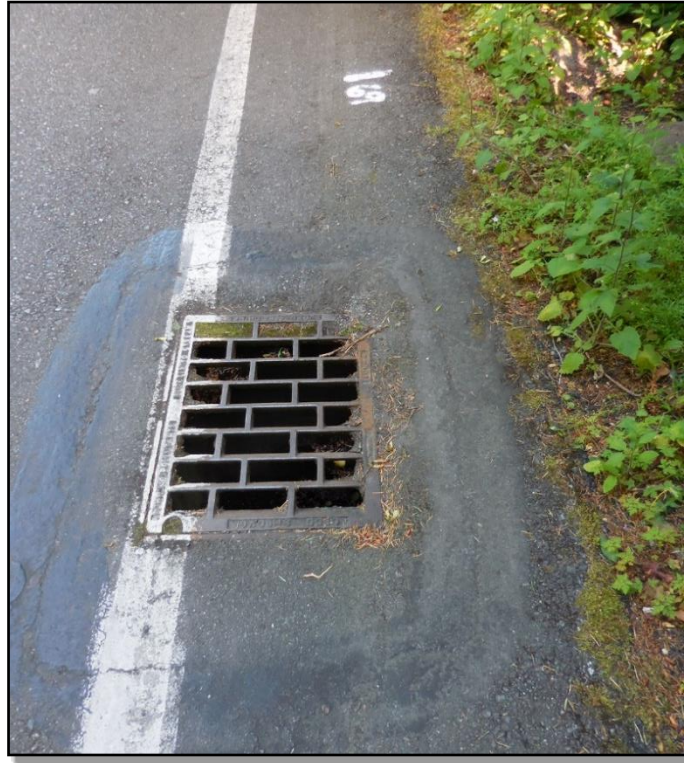
Picture #7: CB 20-56

An 8" PE pipe IN (from north, CB 20-7 across street) and OUT (east) along south side of West Mercer Way to next CB 20-57.

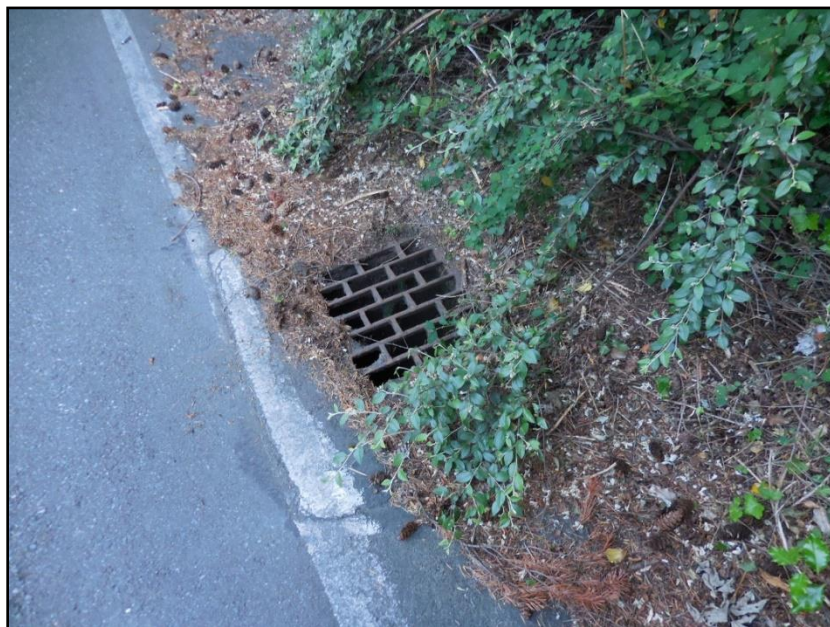
Picture #8: CB 20-57

With an 8" PE pipe IN and 12" PE pipe OUT, the main crosses the street to next CB 20-58.

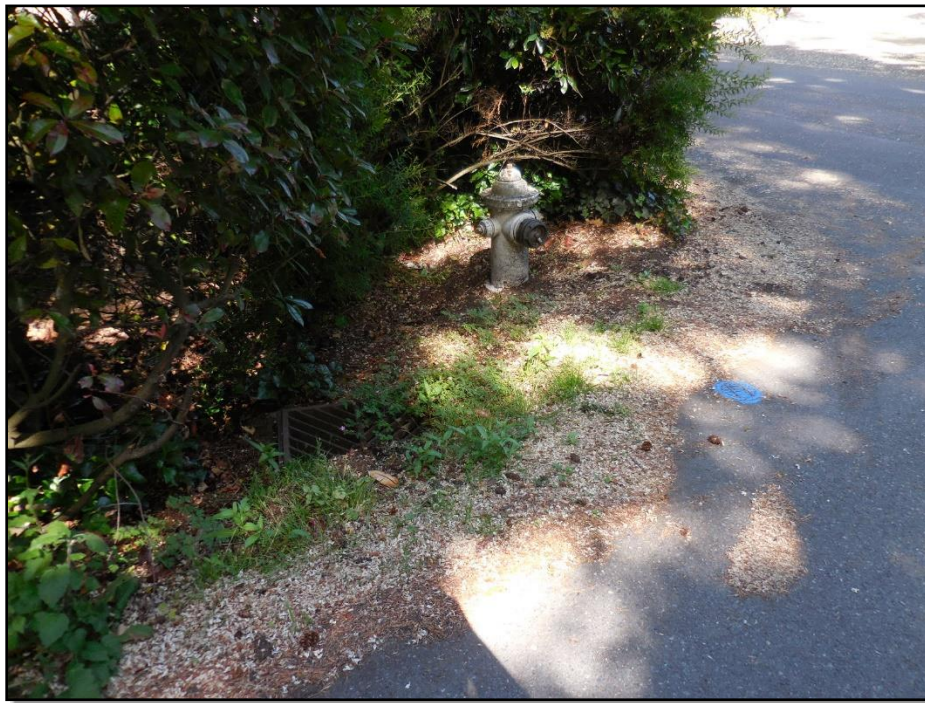
Picture #9: CB 20-58

Corner of West Mercer Way and private lane. 12" PE pipe IN and 12" Concrete pipe OUT

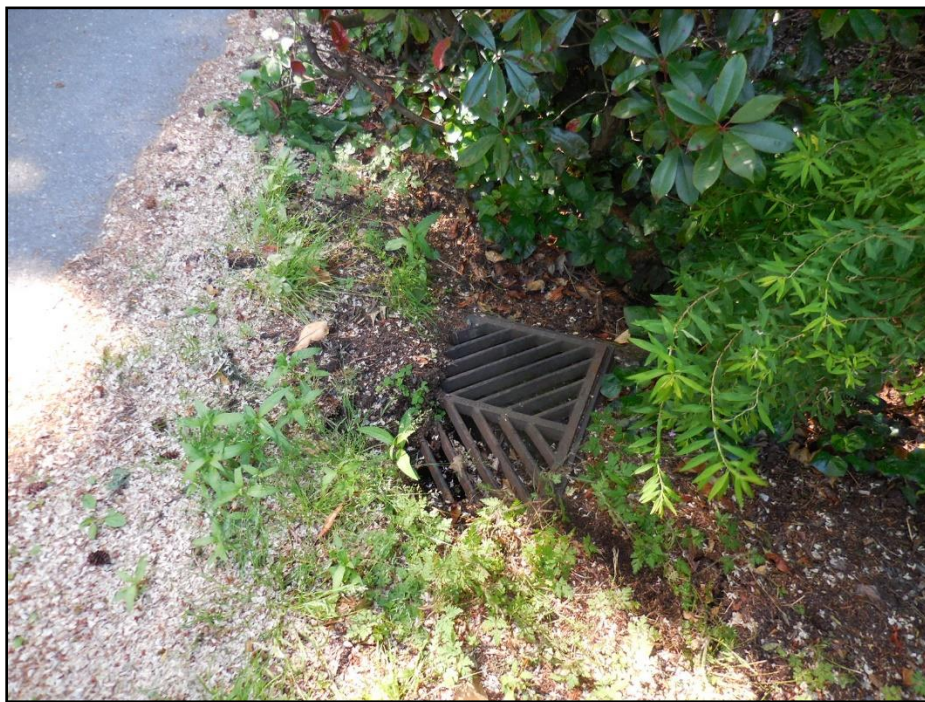
Picture #10: CB 20-58

Open ditch ties into catch basin (not visible in photo)

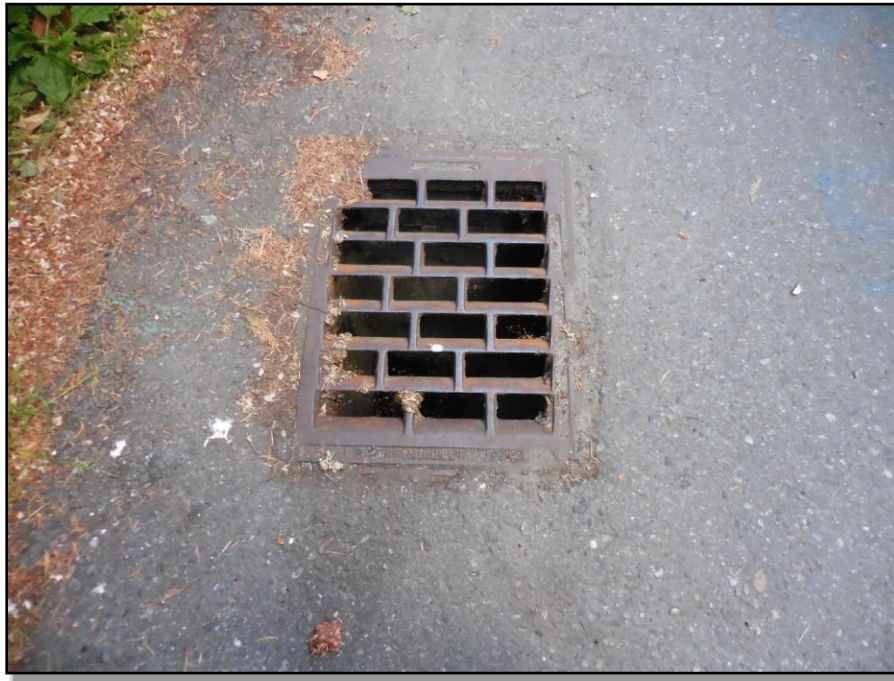
Picture #11: CB 20-24
12" Concrete Pipe IN and OUT

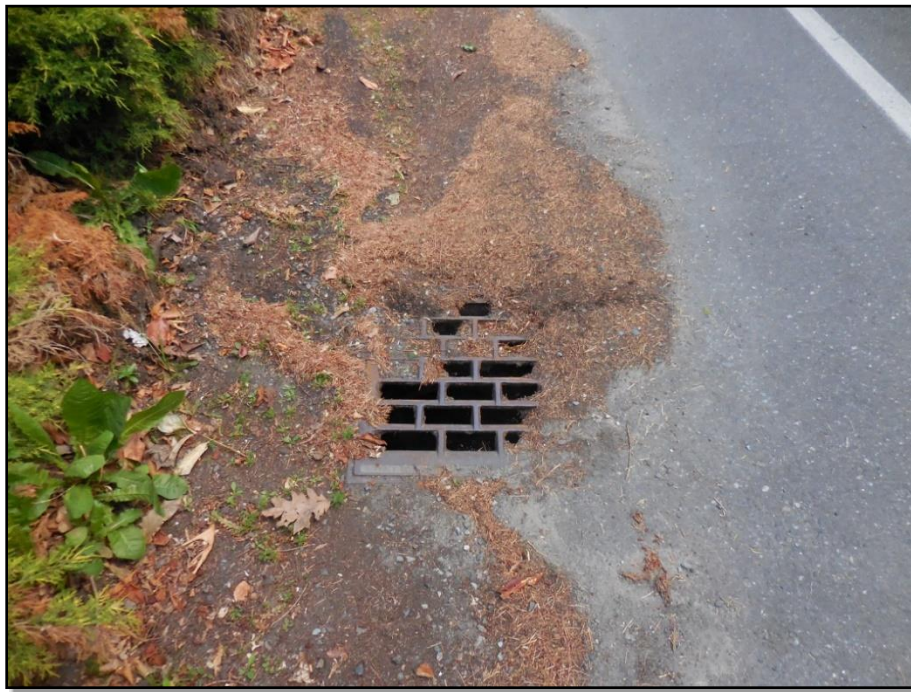
Picture #12: CB 20-30
12" Concrete Pipe IN and OUT

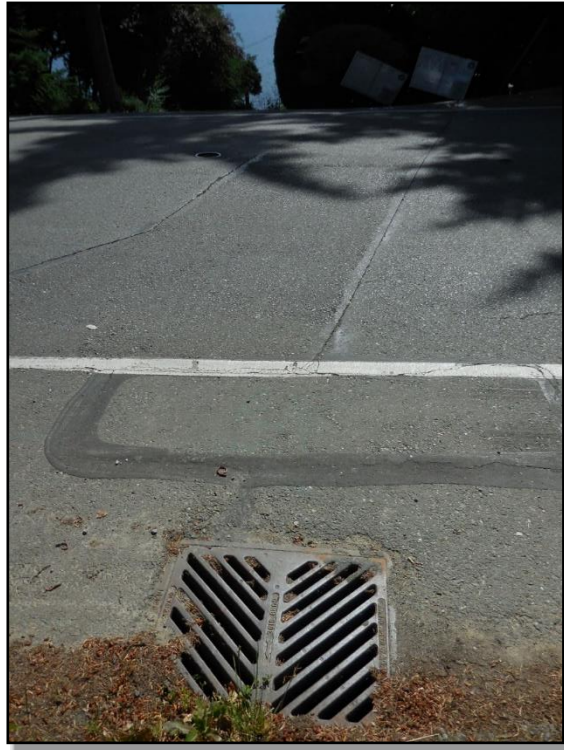
Picture #13: CB 20-31

12" Concrete Pipe IN from West Mercer Way and 18" Concrete pipe OUT to Freeman Avenue.

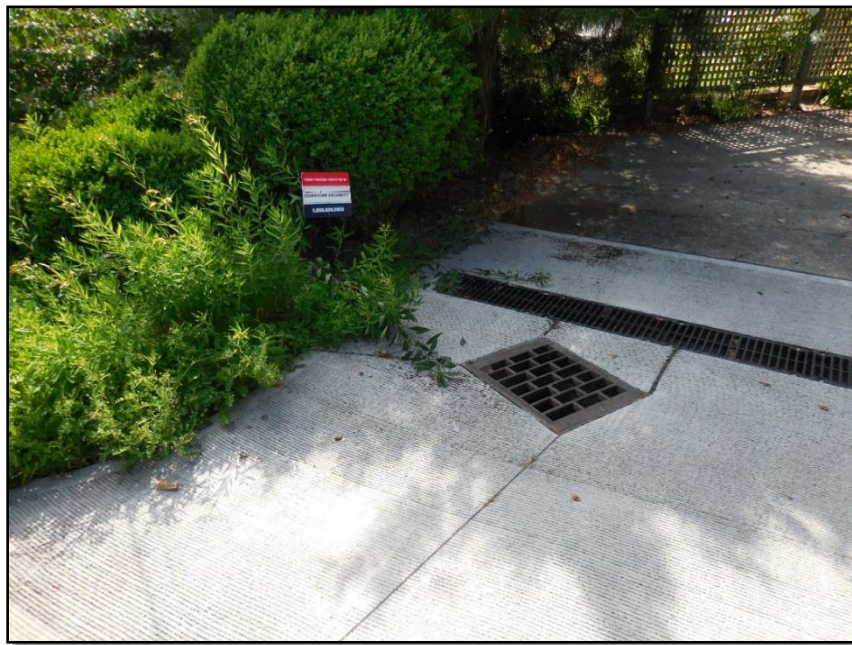
Picture #14: CB 20-33

18" Concrete Pipe IN and OUT

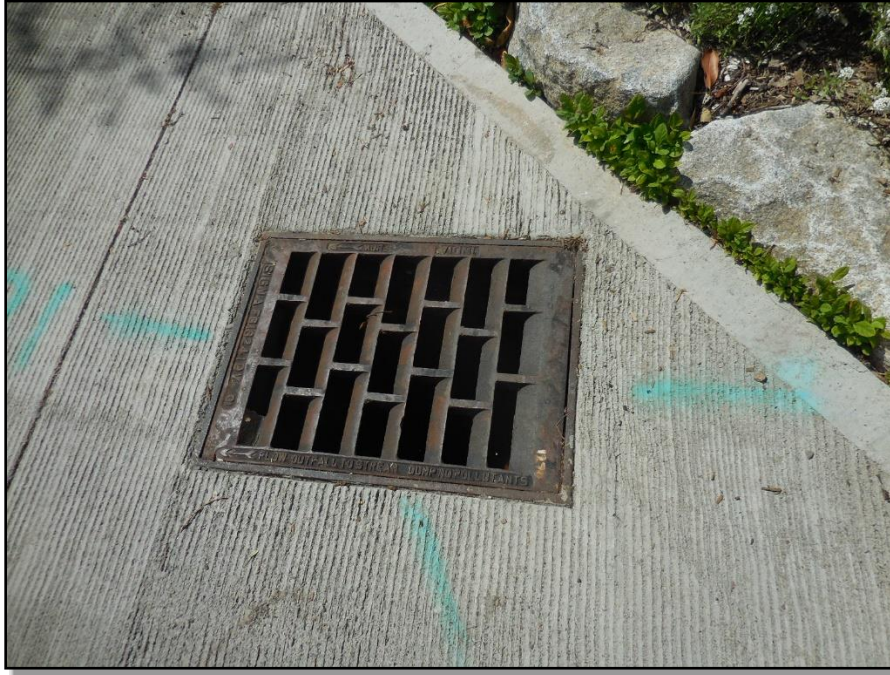
Picture #15: CB 20-27
18" Concrete Pipe IN and OUT

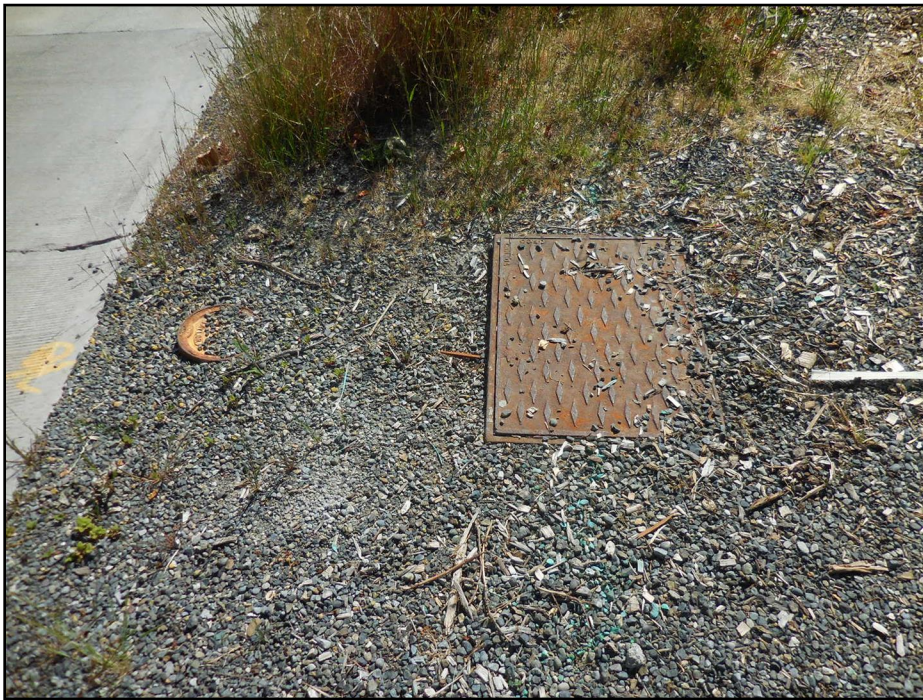
Picture #16: CB 20-61
18" Concrete Pipe IN and 18" CMP OUT

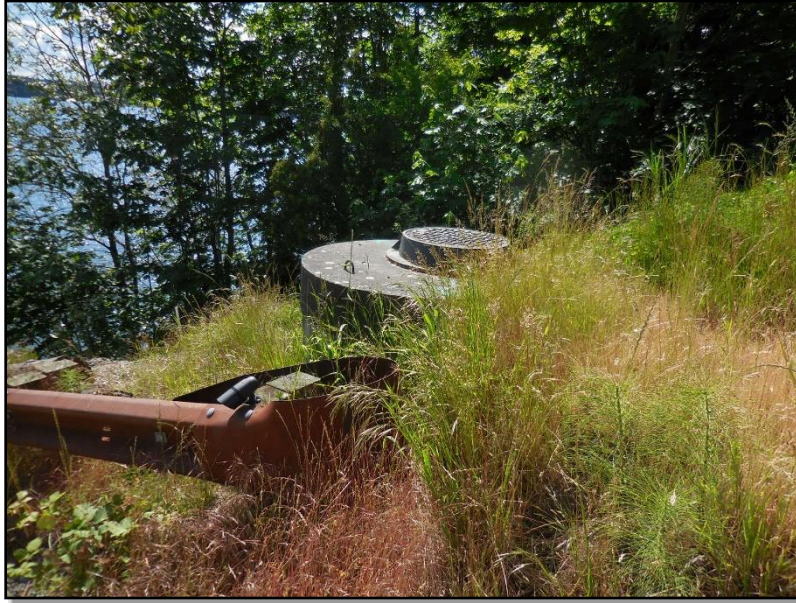
Picture #17: CB 20-26, Manhole Type 2
18" CMP IN and 18" Concrete pipe OUT

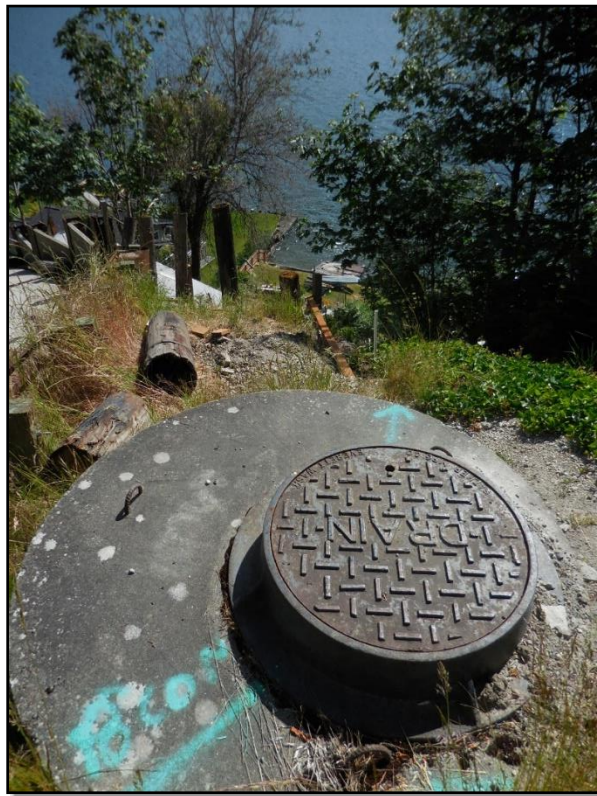
Picture #18: CB 20-26, Manhole Type 2
Private Property beyond this point, unable to access. Steep decline to Lake Washington.
