**Project:** Pre-construction assessment for lot re-development at 4220 91<sup>st</sup> Avenue SE, Mercer Island, WA. Parcel number 4457300070.

**Objectives:** Evaluate degree of impact for three neighboring firs and establish criteria for their preservation. Assess dying hemlock for risk.

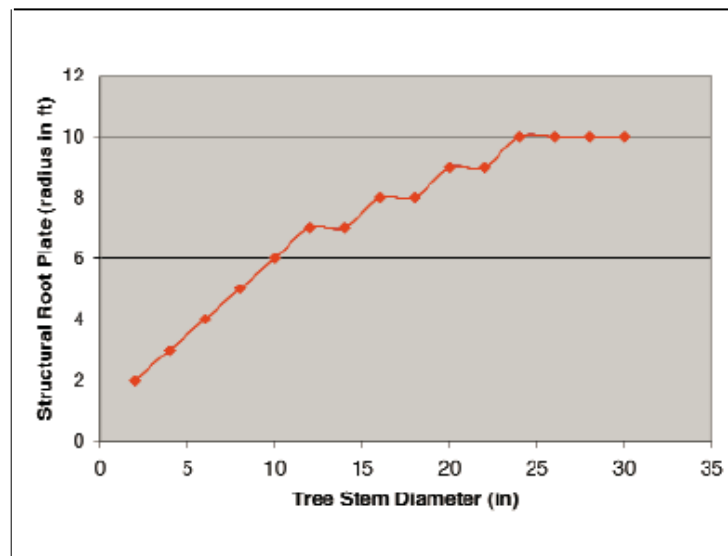
Figure 15. Size of the Structural Root Plate in relation to tree stem diameter. Note that the SRP levels off at 10' for any tree over 24" in diameter. (Coder 1996)

In the case of the #1 tree mentioned above, the excavation for the proposed sport court, including that of the infiltration trench, could come as near as 9.5' to the base of the tree. From Figure 15 the Structural Root Plate for a 27" DSH tree is given as the full 10' so the excavation technically slices through the edge of this tree's SRP.

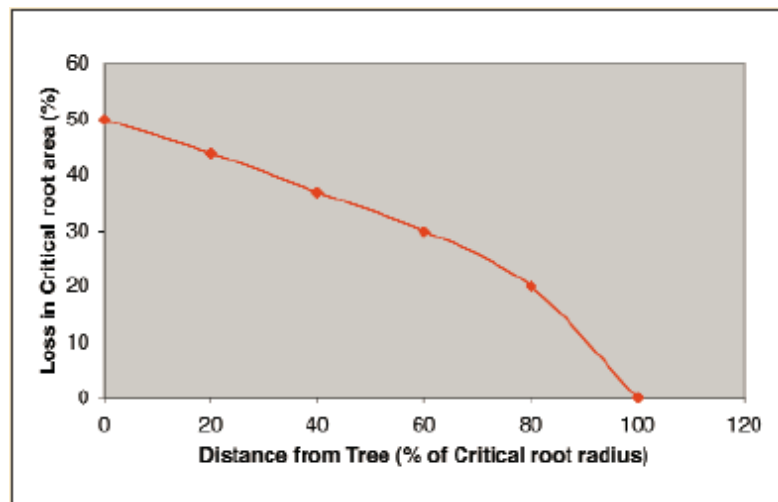
Figure 16. Chart giving the loss in critical root area as a function of the radial distance to the CRZ disturbance. (Coder 1996)

Using the #1 fir again as the example, with the excavation being 9.5' from the tree's base and it having a 27" DSH, there would technically be impact at a linear distance equal to 35% of the fir's CRZ ( $9.5'/27'$ ). The chart shows that this roughly equates to a potential 40% loss of the tree's Critical Root Area (CRA). If this was the first impact to a pristine rooting space it would be well beyond the maximum recommended impact guideline.

The #3 fir has a theoretical 34' radial CRZ and the east side of the excavation will be 23' off its base. From the chart in Figure 16 this corresponds to a maximum 28% CRA loss. Taking into account all the previous disturbance events it is much more likely that the real time impact will be considerable less. This tree should experience little to no long term detrimental effects from the proposed project.

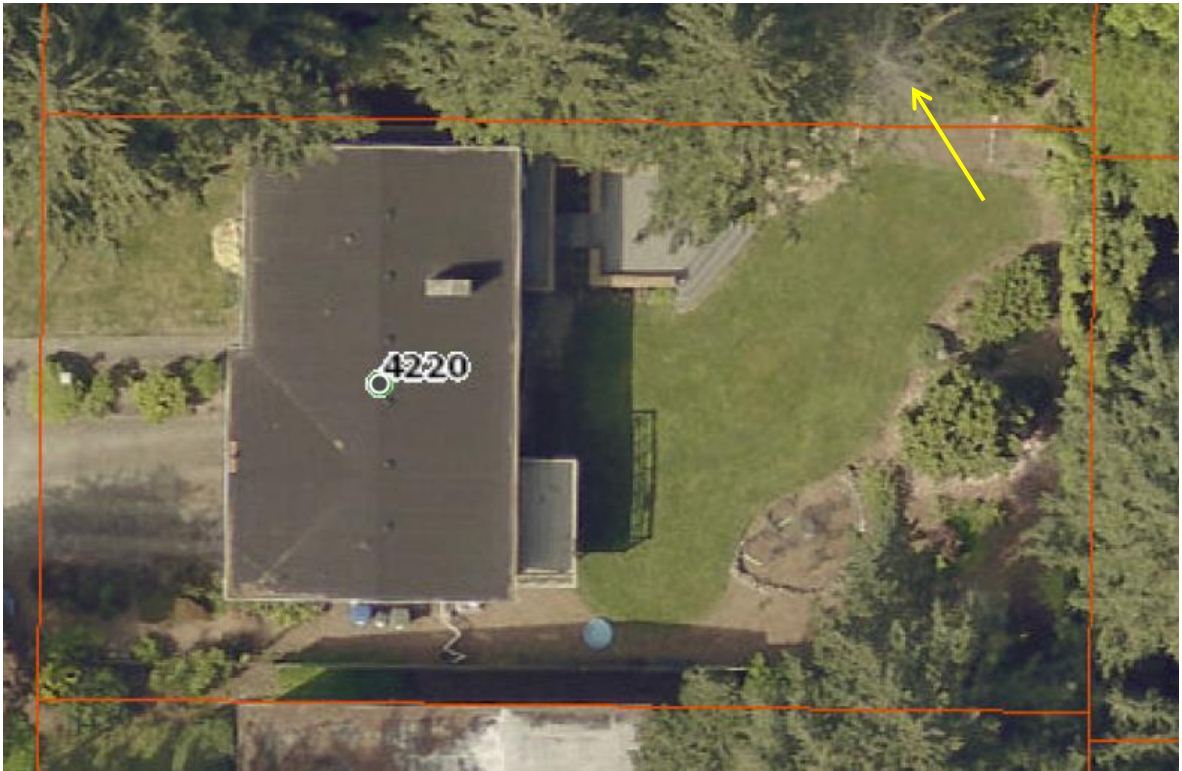
Figure 5. Aerial photo from 2019 showing the clearly dying #4 hemlock (yellow arrow).

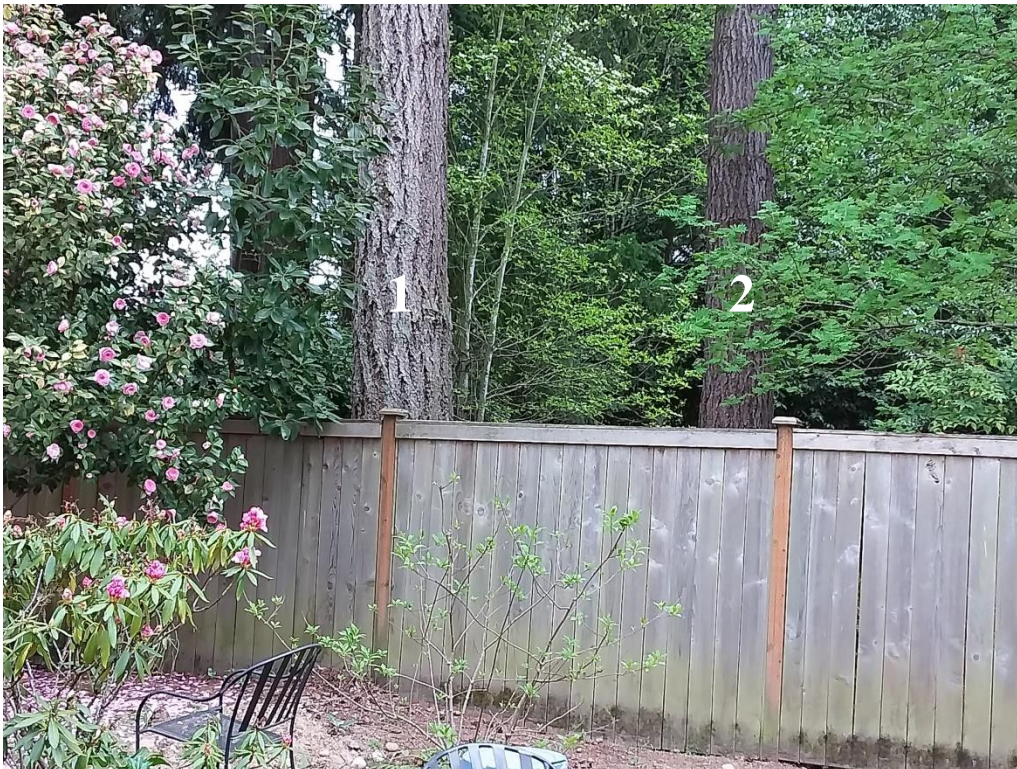
- 2) Douglas Fir 25" DSH, 75' tall standing 18'S of the fence and about 6' W of the #1 tree. It is in fair condition. Its canopy extends down below the halfway point but is almost entirely in the SW quadrant. This tree is Non-Exceptional under the City definition.

Figure 8. Photo taken during the April 2020 site visit showing the location of the #1 and #2 Douglas Firs standing in the southern neighbor's yard.

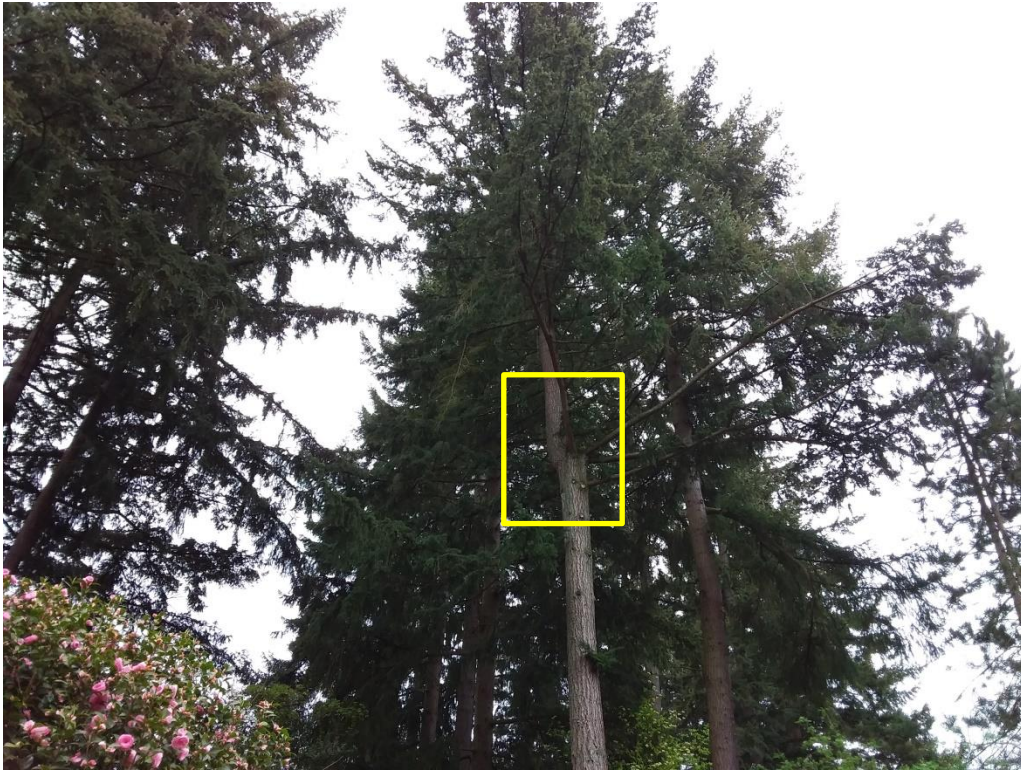
- 1) Douglas Fir (*Pseudotsuga menziesii*) 27" DSH, 80' tall standing 56" S of the south fence and 21' W of the SE fence corner (Figure 8). The tree has a structural fault at the 30' mark and the main leader is offset to the east (Figure 9). There are four larger caliper limbs originating at this point which beginning to form into subordinate spars as shown in Figure 10. The tree appears to be in fair health with average new growth and decent color. This tree is Non-Exceptional under the City definition.

Figure 9. Photo taken during the site visit showing the structural fault in the #1 fir.

To ensure that no destabilization event will occur in regards to the #1 Douglas fir either the project should be shifted at least 6" to the north or some form of exploratory work should be done prior to onset to discover whether roots are present in the excavation zone. The home owner and/or contractor can decide which route is easier to pursue.

Post construction it may be beneficial to deep root feed the #1 tree.

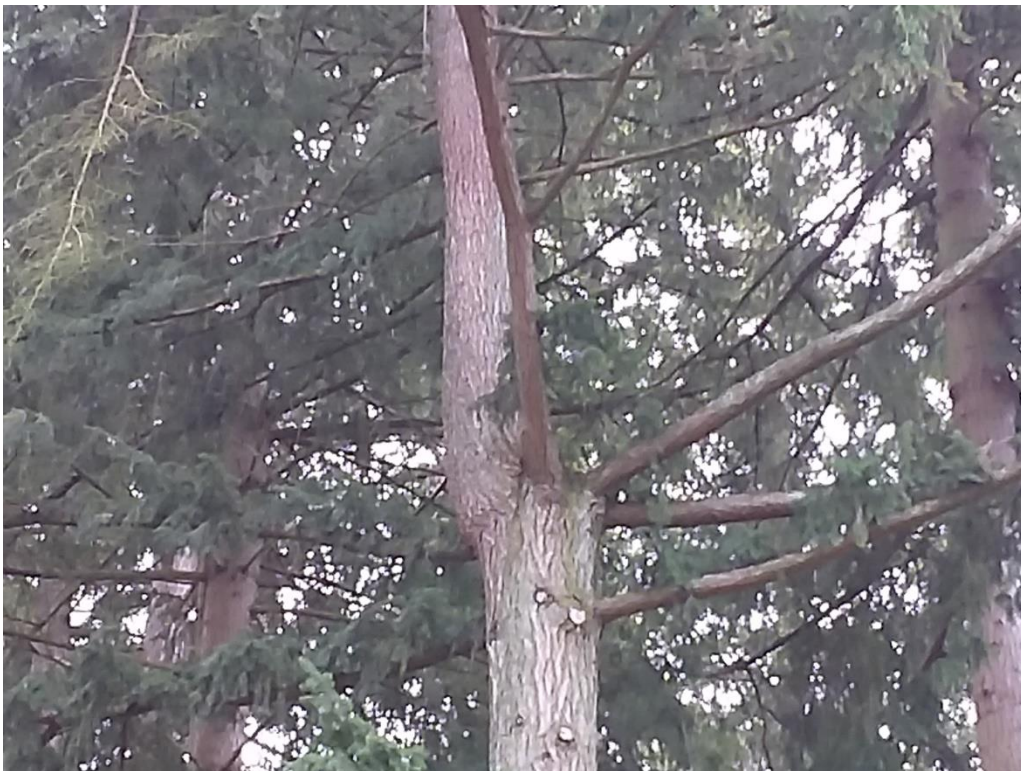
Figure 10. Close up of the area boxed in Figure 9 showing the limbs which are beginning to convert to subordinate spars.

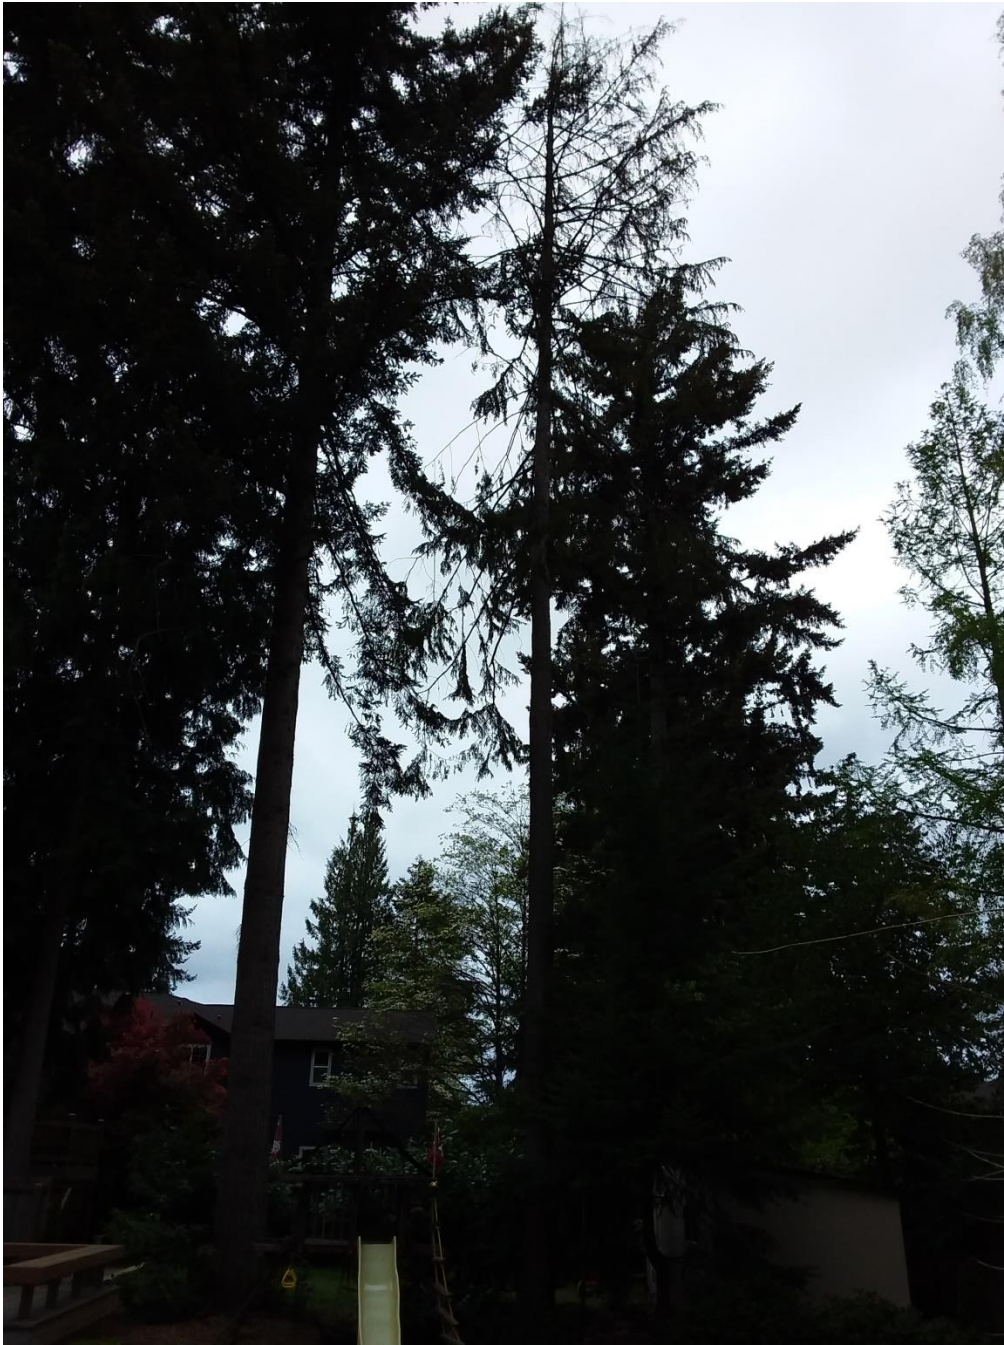
- 4) Western Hemlock (*Tsuga heterophylla*) 18" DSH, 65' tall standing near or on the north property line 20' W of the NE corner of the property. The tree is in advanced decline and the upper half of the canopy is dead (Figure 11). It appears mostly live in the 2017 aerial (Figure 12) and mostly dead in the 2019 aerial (see Figure 5). This tree is Non-Exceptional under the City definition.

**Risk Assessment:** At this point in time the #4 hemlock is not so much at risk of falling over as having a large section of its upper column break free. When hemlocks go into these rapid decline spirals the structural integrity of their dead/dying sections are significantly compromised. It is extremely common for them to break free. Thus the hemlock has a **probable likelihood of stem failure**. The subject home and the northern neighbor's home are less than 45' from the hemlock so are within range of a failed piece. A failed section has about an equal chance of falling in the backyards of either home without hitting. This gives a spar a **medium likelihood of striking** a significant target making it **somewhat likely to fail and impact**. If the spar does fail and hit it would cause **significant consequences**. Therefore at this time the hemlock would be characterized as having a **moderate risk** component.

By next year this tree's circumstance will change considerably. Because of how fast they degrade the entire tree would have a **probable likelihood of failure** and a case could be made for it being classified as **imminent**. The larger section would place two more homes in range giving the tree a **high likelihood of striking** a significant target making it **likely to fail and impact**. This will shift the tree into the **high risk** category.

Figure 11. Photo showing the upper canopy of the #4 hemlock. Tree is in advanced decline and should be mitigated this year.

**Recommendations:** The #4 hemlock should either be removed entirely or at least have the dead portion excised at this time. This arborist does not deem it safe to wait another year to deal with the tree. It also makes the most sense to deal with it during the proposed construction project as much of the client's back yard will be torn up anyway.

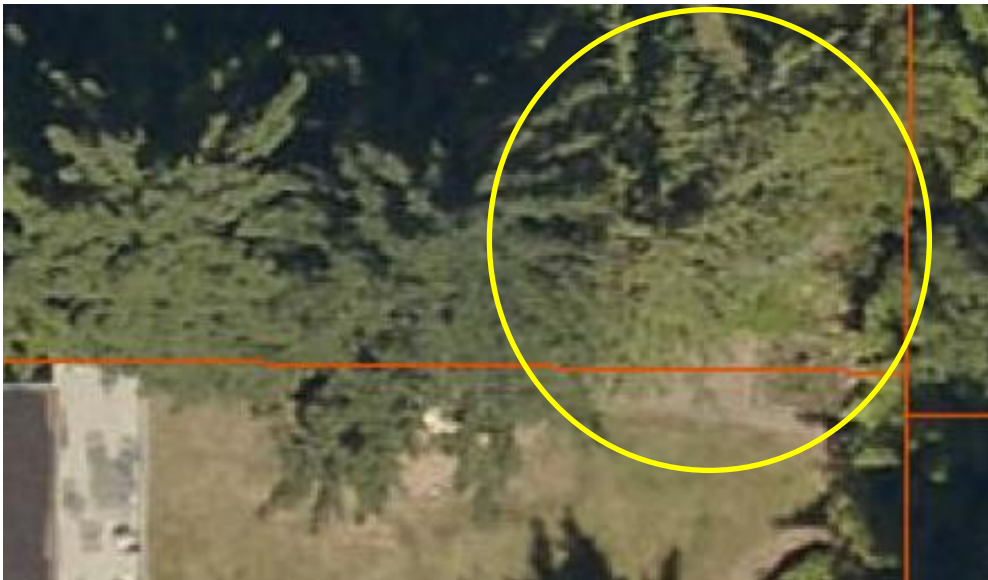
Figure 12. Aerial photo close up (circa 2017) showing the still viable condition of the #4 hemlock. There is no sign of dieback at this time.
